Frescoed wall conditions assessment with non-invasive GPR survey: the case of the Crypt of San Francesco in Irsina (Basilicata, Southern Italy)

Capozzoli L.¹ Boccia M.P.³, De Martino G.¹, Gizzi F.T.², Sileo M.², Masini N.²

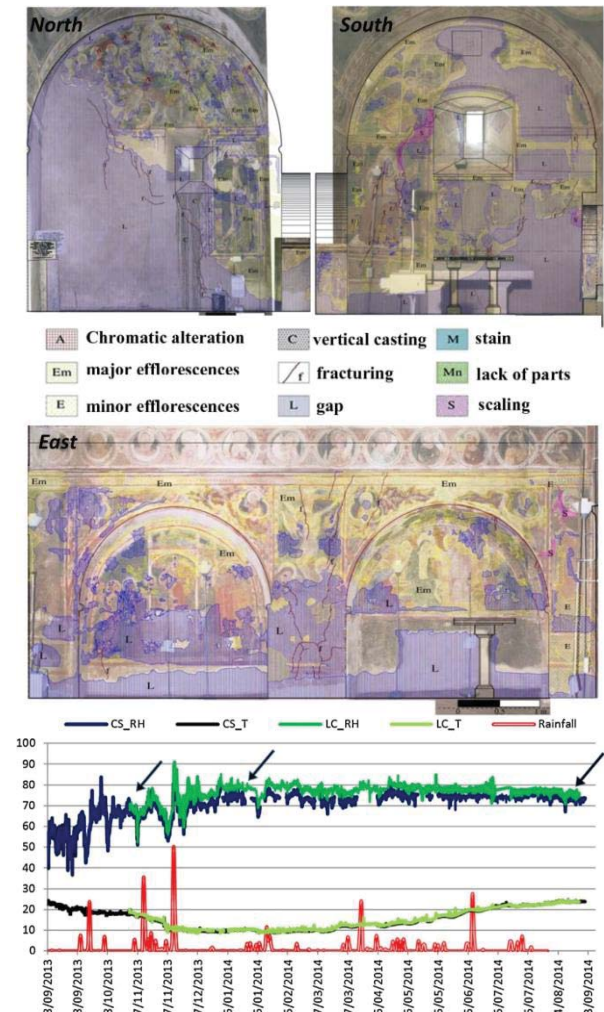
The degradation mapping study revealed that the different types of decay as efflorescence; fracturing, gap, lack of parts and scaling are widespread on the frescoes in particular in the lower parts of the walls where the presence of water and humidity is stronger. In fact, from the monitoring of the environmental parameters, it has been ascertained that the presence of large quantities of water is due to condensation on the walls in the cold winter and spring periods [14], infiltration from above due to percolation from the flow system of the waters not always effective especially in the periods of the most intense thunderstorms (spring and autumn).

Fig. 2. Mapping of the decay forms on the orthorectified photo of the walls and thermos-hygrometric condition into the crypt, modified by [Sileo et al 2017].

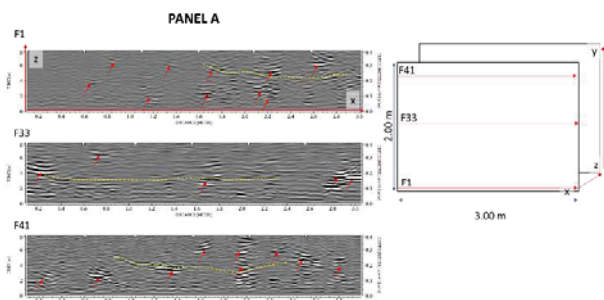
B-Scans carried out on the panel A, have permitted to detect different reflections chaotically distributed in the full thickness of the wall. The data obtained have allowed to investigate the walls for a total thickness of 40cm, approximately, showing the presence of punctual reflections associable, presumably, to voids, detachments and fractures in the panel (red arrows in Fig.5). Moreover, some linear reflective layers, highlighted in figure with yellow dashed lines, are identified at different depths. They are, supposedly, to be associate to discontinuities charactering the walls and constitute a non-negligible risk for the safeguard of the structure. Finally, for all the acquired datasets, we have noted a stronger attenuation of the e-m signal in proximity of the bottom portion of the radargrams, due to a higher water content and a lower drying capacity of the walls in these areas.

Figure 5: B-Scans F1, F33 and F41, acquired at the different heights of 5cm, 1.55m and 1.95m of the Panel A (on the left) with their localizations (on the right)

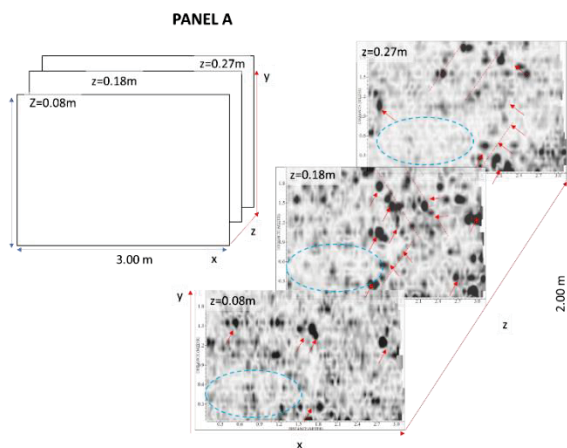
The depth-slices highlighted the reflections imputable to the discontinuities (red arrows) present in the panel that are often aligned according preferential directions inclined of about 45°-50° (red dashed lines) (Fig.6). Furthermore, it is evident the presence of areas less reflective where it is expected a higher water-content (blue dashed circles). Similar results are obtained as regarding the panel B confirming the presence of a widespread decay characterizing all the masonry structures of the Crypt, also confirmed by the

Figure 6: Depth slices extracted every 10 cm, approximately (as showed in the sketch plotted on the left) by the C-Scan of the Panel A with indication of the most evident anomalies occurring at the depths of 8cm, 18cm and 27cm (more details in the text).
