The Effect of Exposure Condition on the Composition of the Corrosion Layers of the San Carlone of Arona

Abstract: The Colossus of San Carlo Borromeo, named San Carlone for its large dimensions, represents a unique opportunity to study the long-term effects of atmospheric corrosion on patina formation on historic copper sheets. The sculpture’s large dimensions, complex geometry, direct visitor interaction, and exposure conditions generate different microclimates. The purpose of this study is to understand how and to what extent these microclimates affect the formation of the copper patinas. The results show that microclimates play a key role in patina formation: in external surfaces exposed to rain, the main constituent is brochantite, whereas a wider variety of corrosion products have been found in sheltered and internal surfaces, such as antlerite, atacamite, copper oxalate, posnjakite, and anglesite.

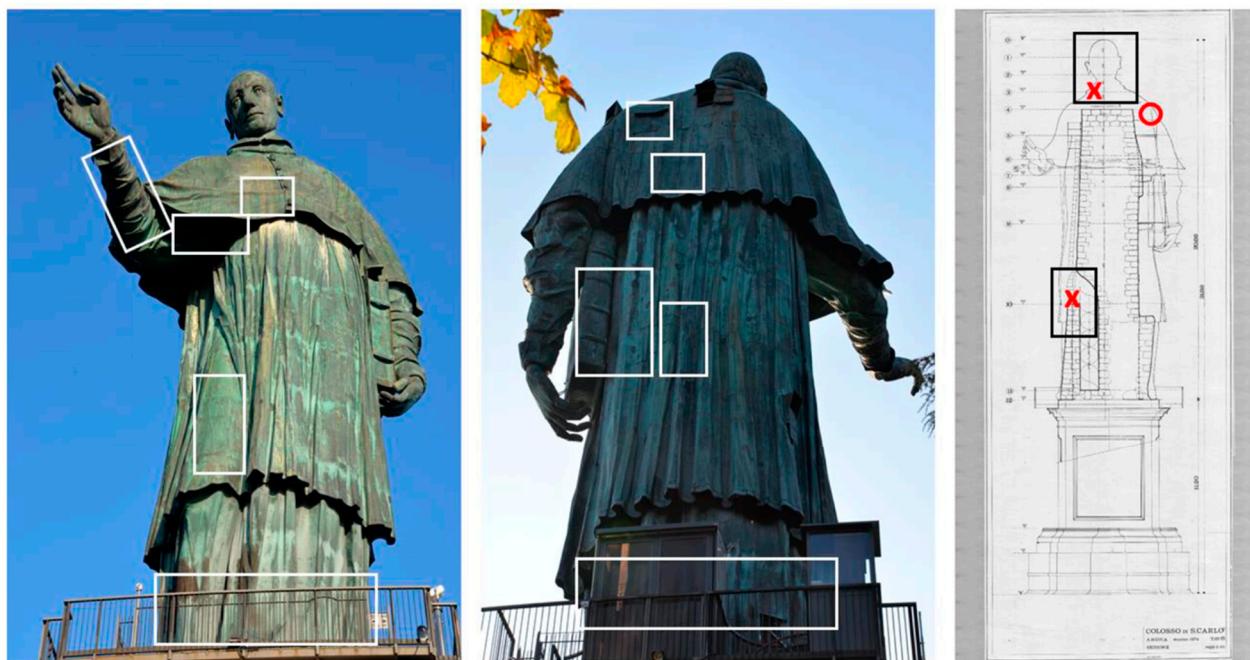
An extensive in situ diagnostic campaign was carried out on representative areas of the *San Carbone* (Figure 1) by means of portable non-invasive techniques. The investigated areas are divided into *external*, referring to those of the outer section of the sculpture, and *internal*, meaning the analyzed areas inside the *San Carbone*. The external surfaces were further

Figure 1. Colossus of San Carlo of Arona, named San Carlone. The white frames indicate the studied areas, while the red marks indicate the location of temperature and relative humidity sensors.

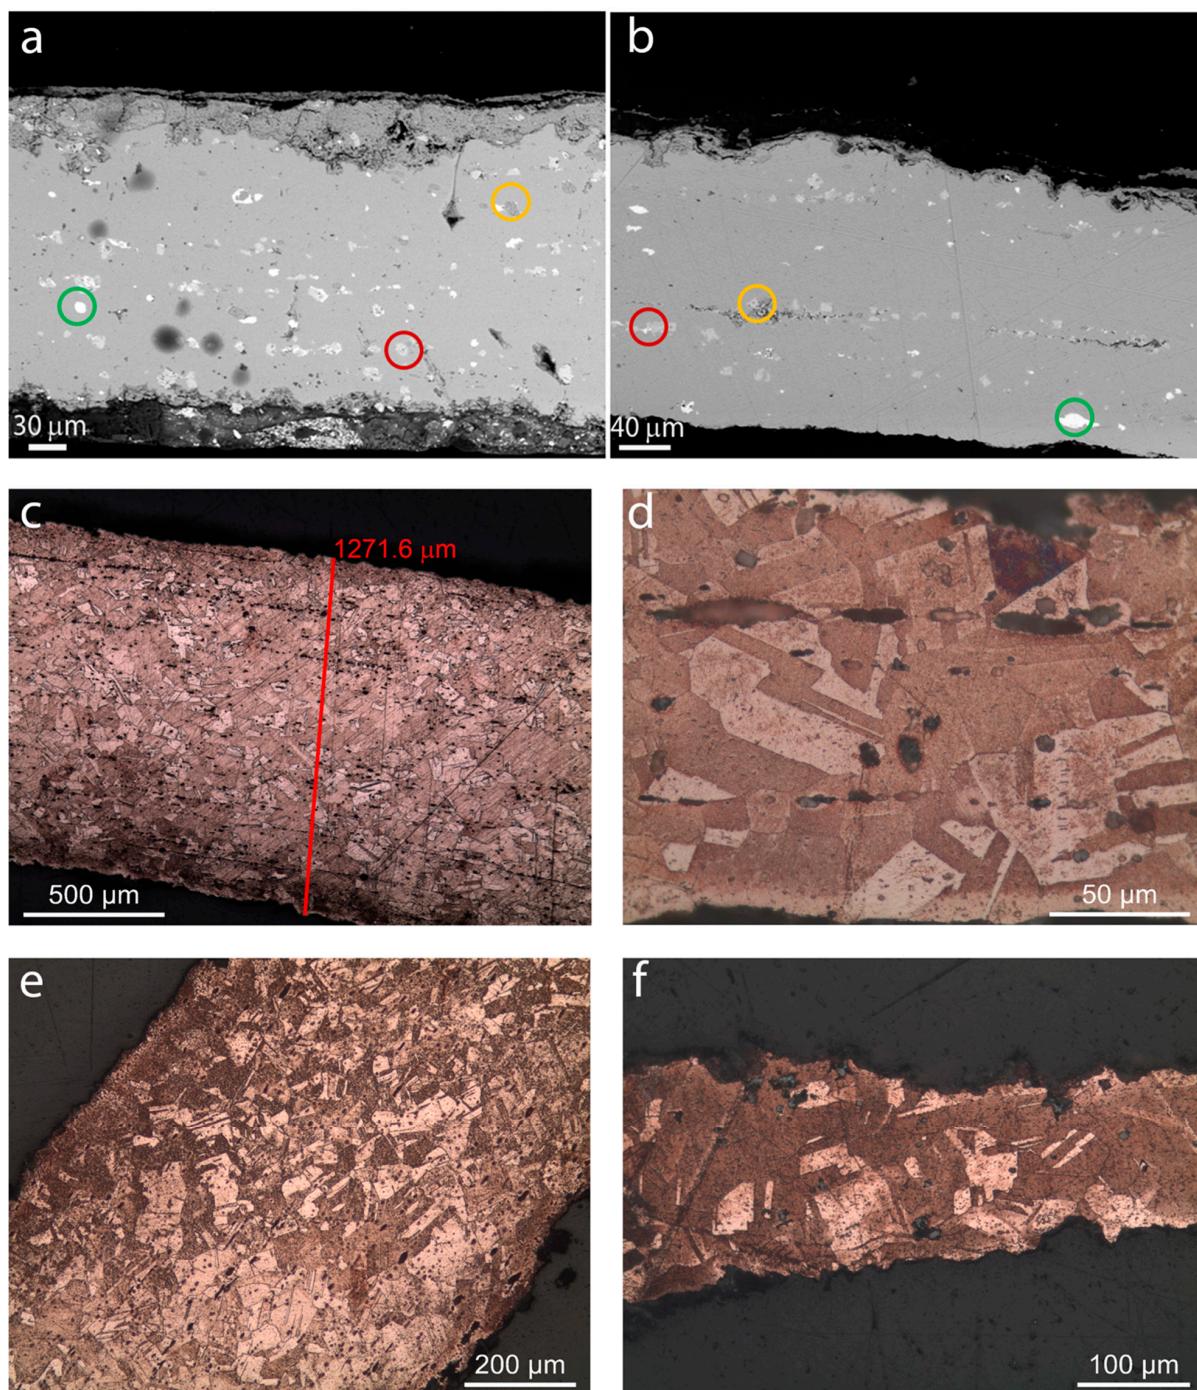
ferent techniques, although some variability was observed among different samples. This variability may be ascribed to the fact that the collected samples belong to different copper sheets and that historical copper typically exhibits inherent compositional variability. The analysis revealed the presence of minor elements, such as Pb (from 0.4% to 1.45%), Sn (up to 0.4% according to SEM-EDX analysis), and Sb (up to 0.25% according to LA-ICP-MS analysis). Unfortunately, the compositional analysis did not provide enough information to formulate hypotheses on the origin of the copper ore. SEM-EDX analysis (Figure 2a,b) highlighted the presence of oxide inclusions within the copper matrix, consisting of Cu oxides (yellow circles), Pb/Sb oxides (green circles), and Sn oxides (red circles). These inclusions follow a clear orientation parallel to the surface of copper sheets, observable both through electron and optical microscopy (Figure 2). This characteristic is attributed to the manufacturing process involving hammering and embossing of the copper sheets. Metallographic observations revealed the presence of round-shaped, non-oriented (equiaxed), and twinned grains, indicating that copper plates underwent final annealing during the working process (Figure 2e,f).

Figure 2. SEM images (a,b) of cross-section of copper samples from the San Carlone. EDX analysis revealed the composition of inclusions in the copper matrix: Cu oxide (yellow circles), Pb/Sb oxide (green circles), and Sn oxide (red circles). Optical microscopy images of cross-section of copper samples (c–f) are also included, where oriented inclusions (c,d), non-oriented inclusions (equiaxed), and round-shaped grains can be observed (e,f).

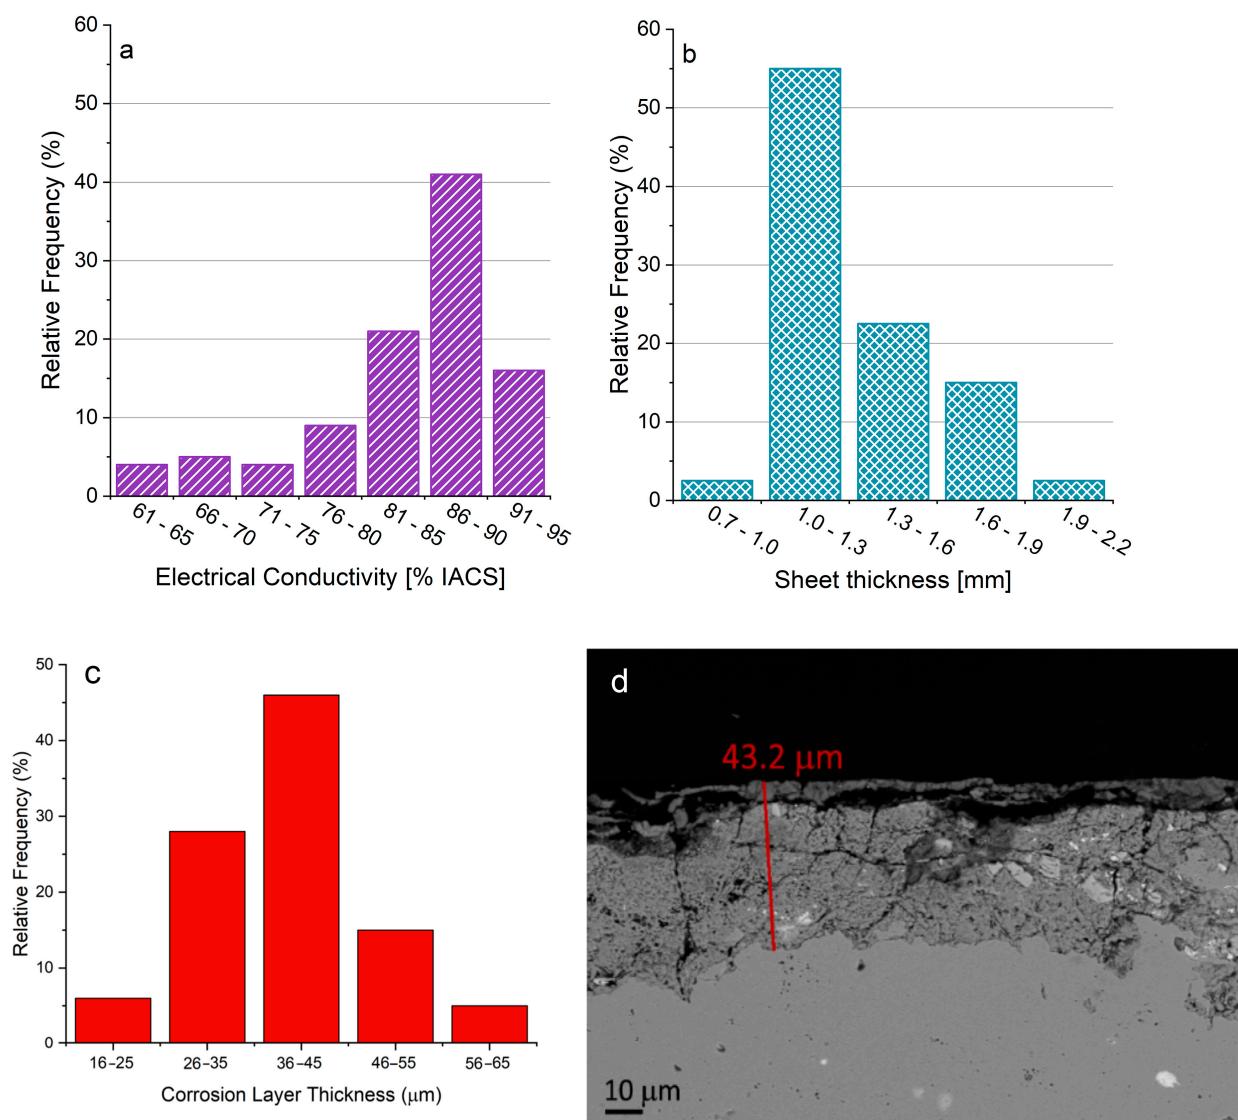
The compositional analysis revealed high purity of the copper, with a percentage of Cu above 98.5%. This was confirmed by the on-site electrical conductivity measurements on ca. two hundred points across the statue (Figure 3).

Microscopic observation of the copper samples (Figure 2c,d) and on-site ultrasound measurements of the sheets' thickness, performed on more than 200 points (Figure 3), revealed that the copper sheets have an average thickness of around 1.2 mm. The thickness of the single plates can range between 0.7 and 2.2 mm (Figure 3). Such irregular thickness is expected considering the époque of realization and the working process.

The corrosion layers of the *San Carlone's* copper elements were investigated in terms of morphology, color, thickness, and composition. These were studied by means of both laboratory and on-site techniques. The thickness of the corrosion layers was evaluated on more than two hundred points in all the statues by eddy currents measurements, considering both internal and external surfaces. The resulting thickness of the corrosion layers ranges between 16 and 65 µm (Figure 3), and, in 46% of the cases, the thickness ranges between 36 and 45 µm.

Figure 3. On-site measurements of (a) electrical conductivity; (b) thickness on the copper sheets of the San Carlone; and (c) thickness of corrosion layers by means of eddy currents and (d) SEM observations.

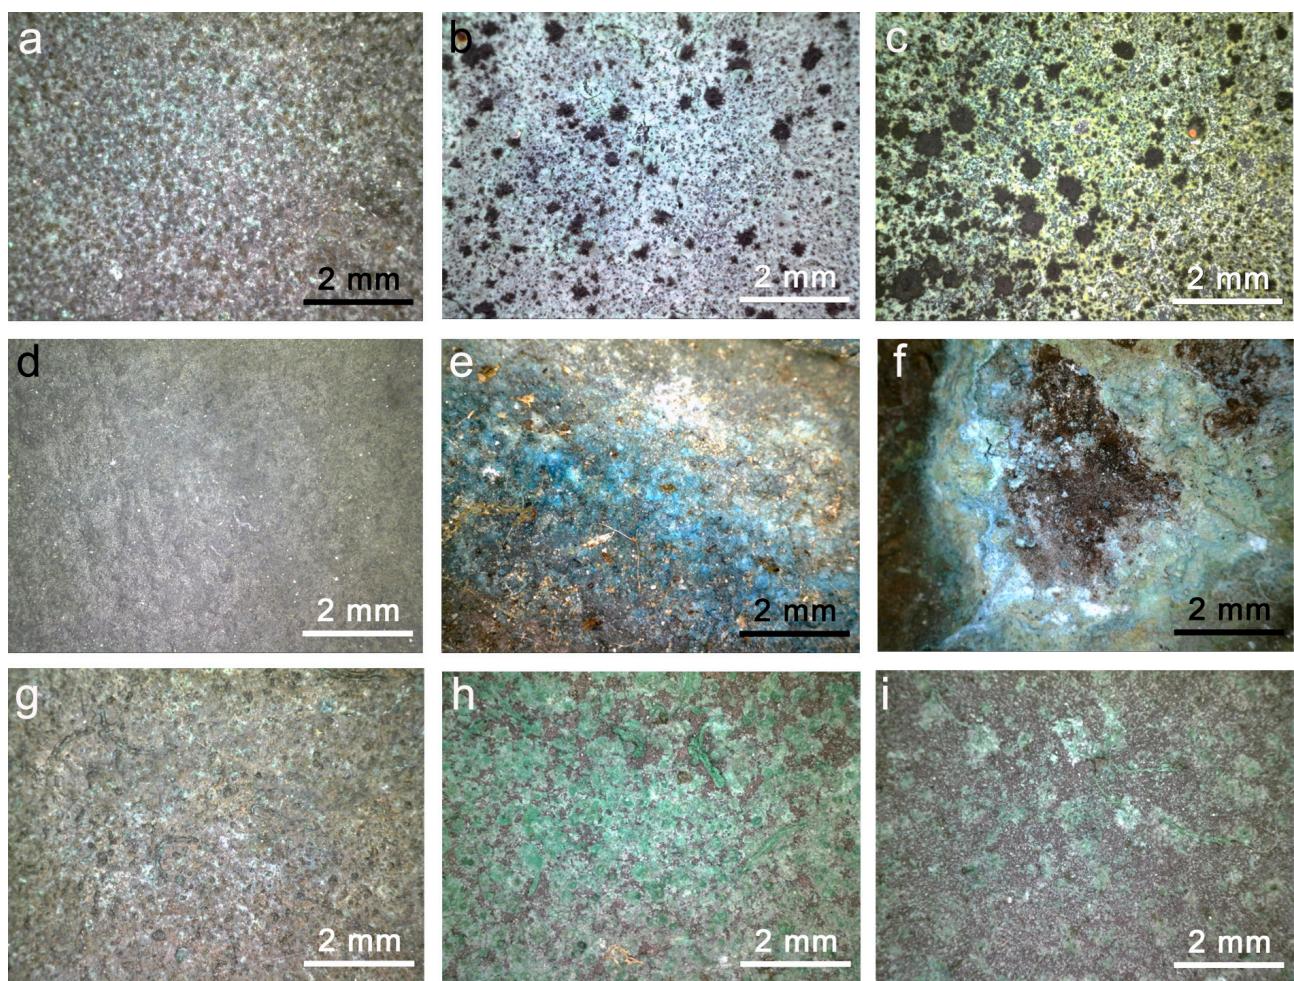
The on-site microscopic observation of the surfaces highlighted an evident variability in the aspects of the corrosion layers (Figure 4). Black and green patinas are predominant, as expected for corrosion layers formed in outdoor environments [7,9]. Compact and adherent patinas have also been observed on unsheltered surfaces (Figure 4a–d), with no significant differences related to the surface's cardinal orientation or height. These patinas showed a typical two-layered structure, widely documented in the literature for copper natural patinas [2,4,16]. EDX analysis confirmed that the internal layer (Figure 5), normally referred to as primary patina, is mainly constituted by copper oxides, in agreement with

Figure 4. Portable microscopy images of surfaces of the colossus of San Carlo of Arona. (a–d): images acquired on unsheltered surfaces; (e,f): images acquired on peculiar corrosion products found only in limited and small areas; and (g–i): images acquired on sheltered areas.

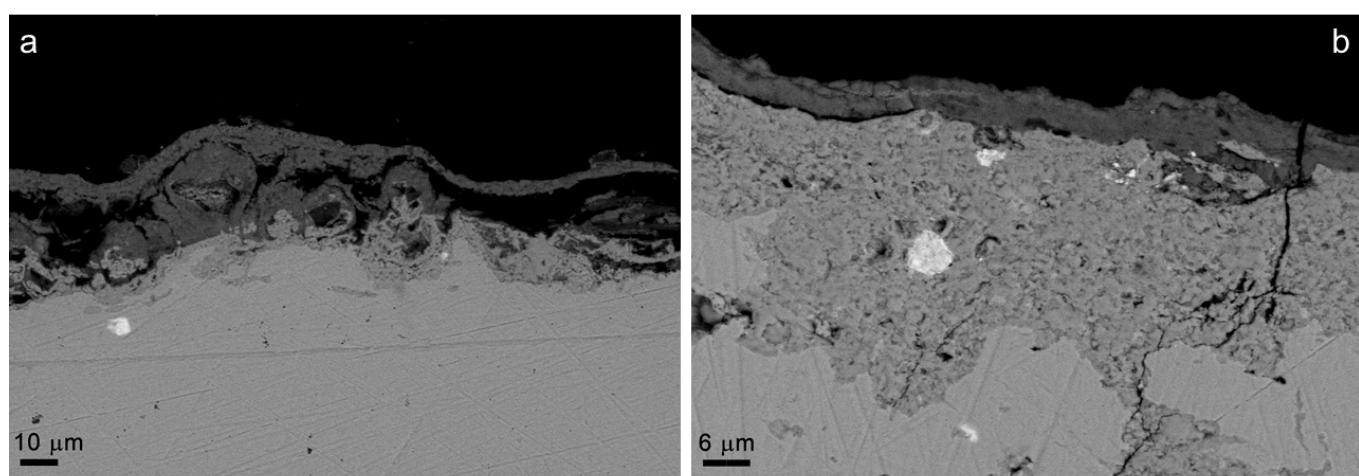
the literature. The outer layer (Figure 5), also known as the secondary patina, is rich in sulphur, suggesting the presence of sulphate-based compounds on the surface of the samples. Additionally, the oxide-based inclusions, observed in bulk copper, are still visible in the corrosion layers (Figure 5b). These inclusions were probably incorporated as the corrosion proceeded [17].

Figure 5. SEM images of cross-section of copper samples of the San Carlone: (a) The presence of two distinct layers (primary and secondary patinas) of corrosion products is visible. (b) The inclusions observed in the bulk copper are also present in the corrosion layers.

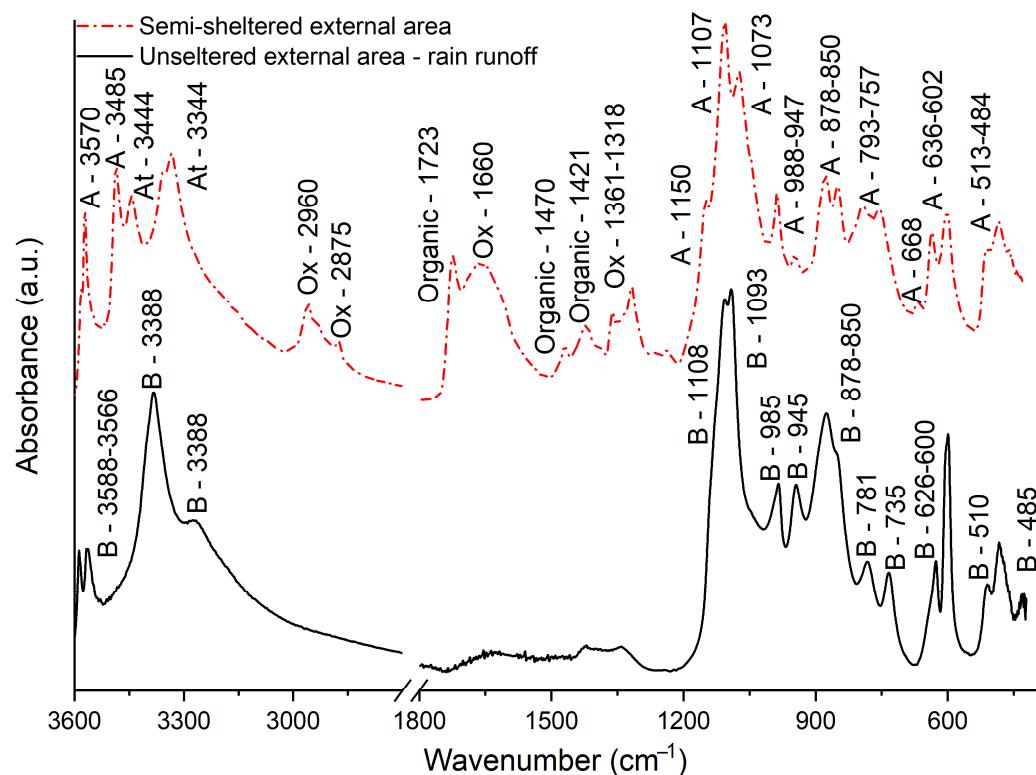
Figure 6. FTIR spectra of samples collected from the external surfaces of the San Carlone. Red line: sample collected in a semi-sheltered area; black line: sample collected in an unsheltered area. A: antlerite; B: brochantite; At: Atacamite; Ox: copper oxalate.

Antlerite was the main corrosion product detected by FTIR on sheltered and semi-sheltered surfaces. Its characteristic peaks are visible in the fingerprint region of the spectrum and at 3570 and 3485 cm^{-1} [18]. Moreover, a wider variety of corrosion products with respect to the unsheltered areas can be clearly identified. In the spectrum reported as an example in Figure 6, the distinctive signals of copper oxalate (2960 , 2875 , 1660 , 1361 , and 1318 cm^{-1}) and the main peaks of atacamite (3444 and 3344 cm^{-1}) [18] can be identified.

The predominance of different corrosion products depends on the sheltering conditions of the surfaces: brochantite is found in unsheltered areas and antlerite in sheltered ones, which can be explained by the higher solubility of antlerite (a precursor of brochantite) [4]. Brochantite is considered the most stable copper hydroxysulphate in less polluted environments. Rain action likely solubilized the antlerite on unsheltered surfaces, promoting the formation of brochantite, whereas, in sheltered areas, the transformation of antlerite into brochantite took longer. Notably, the *San Carlone* underwent an extensive restoration in 1974–1975 involving sandblasting and cleaning of the copper surfaces to remove existing corrosion layers [12,19]. Therefore, the present patina is much younger than the statue itself since it started to form in 1974–1975. The analysis did not allow for the detection or recognition of the layers related to the artificial re-patination process. It can thus be assumed that the artificial patina converted into the typical corrosion products that can be found after exposure to the atmosphere.

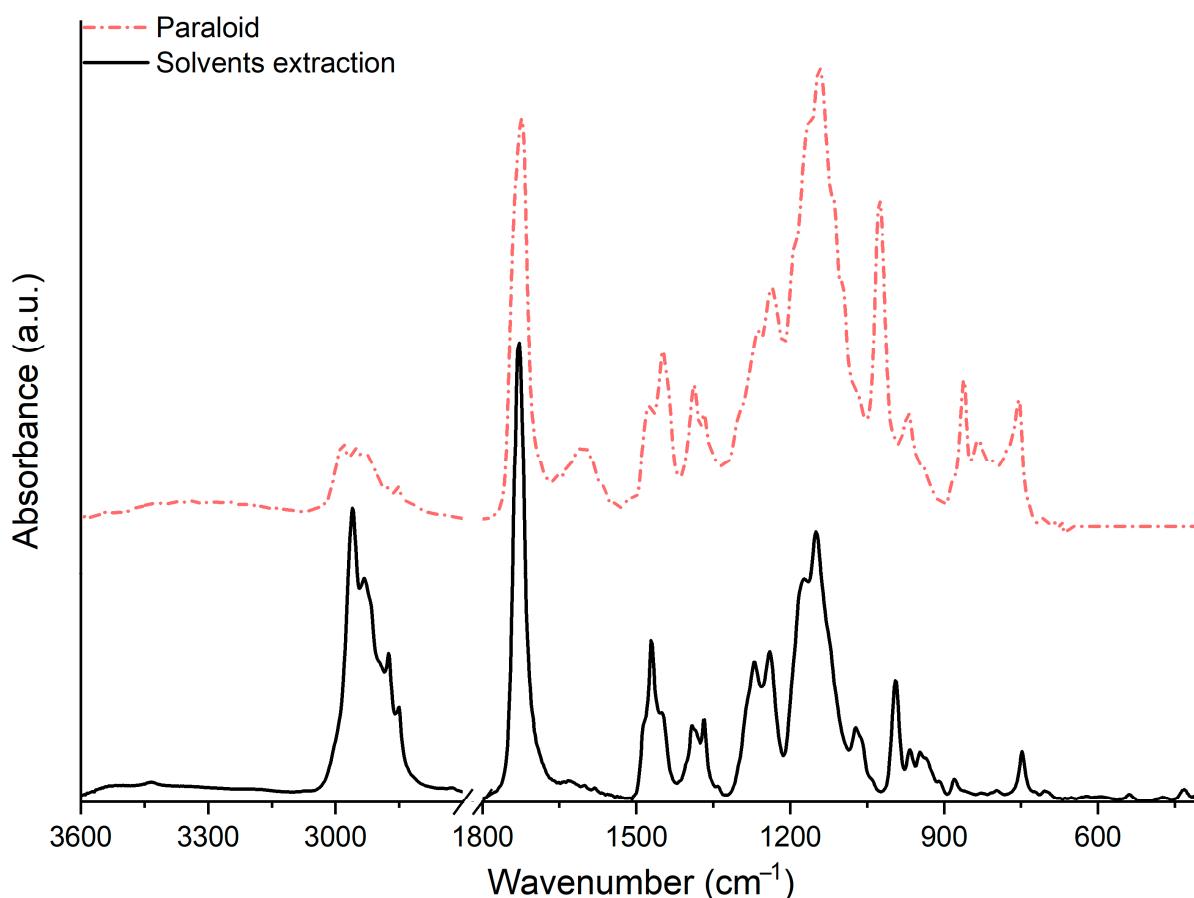
The organic fraction of a powder micro-sample has been extracted and analyzed by FTIR as described in the methodology. The resulting spectrum of the extracted substances resembles the one of Paraloid (Figure 7), an acrylic-based protective coating widely diffused in the conservation field. The small differences that can be observed between the spectra are probably due to the degradation of the coating or to the use of a similar but different acrylic-based protective coating.

Figure 7. FTIR spectrum of organic substances extracted in acetone, ethanol, and hexane by a sample of the colossus of San Carlo of Arona with the reference spectrum of Paraloid.

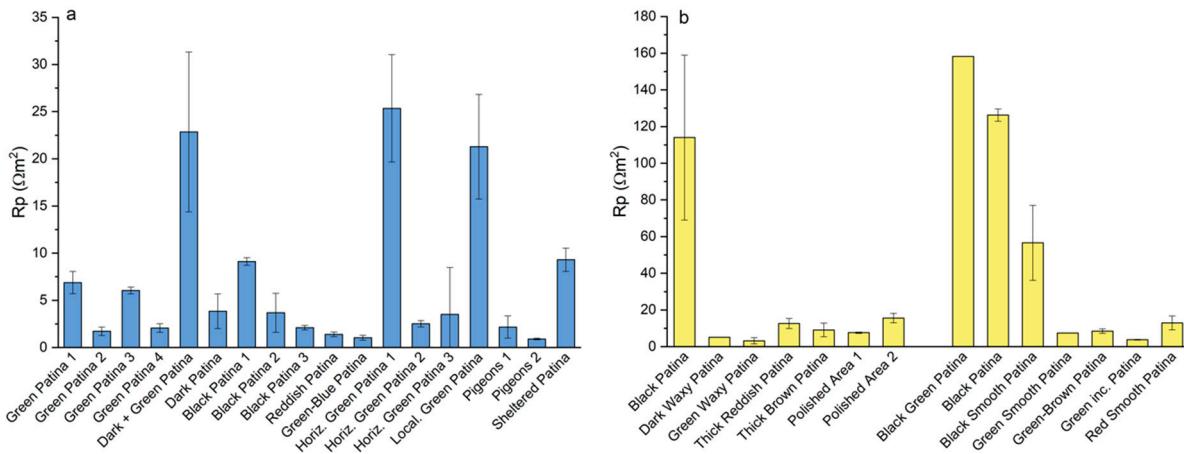
The corrosion behavior of the external copper surfaces has been investigated by means of electrochemical measurements. As can be observed in Figure 8a, the R_p values differ significantly among the studied areas, ranging from $25 \Omega \cdot \text{m}^2$ to less than $1 \Omega \cdot \text{m}^2$. On average, an R_p of about $5 \Omega \cdot \text{m}^2$ was measured, in agreement with the R_p values reported

in the literature for non-protected copper-based surfaces exposed in a mildly aggressive environment [13,26–29]. This suggests that the coating applied during the last restoration did not provide any further protection.

Figure 8. Results of electrochemical measurements on (a) external copper surfaces and (b) internal copper surfaces of the San Carlone: Rp values calculated from LPR and EIS measurements.

Rp values significantly lower than $5 \Omega \cdot m^2$ have been measured in some specific cases. These low values, even lower than $1 \Omega \cdot m^2$, correspond to the presence of relevant amounts of dejections of birds. It is known that these are corrosive substances; therefore, their effect on the corrosion behavior must be considered as wide external areas of the statue are affected by their presence. Other Rp values lower than $5 \Omega \cdot m^2$ have also been measured in correspondence with peculiar corrosion products, observed only in a few localized areas (Figure 4e). These Rp values were obtained on some areas whose patina appeared to be uniform and stable (Figure 8a; values labelled as “green patina 2” and “4”, “green-blue patina”, and “reddish patina”). Such differences do not appear to be correlated to a different composition of the corrosion layers. It can be supposed then that such low protectiveness of these patinas may be related to morphological characteristics like adhesion and porosity.

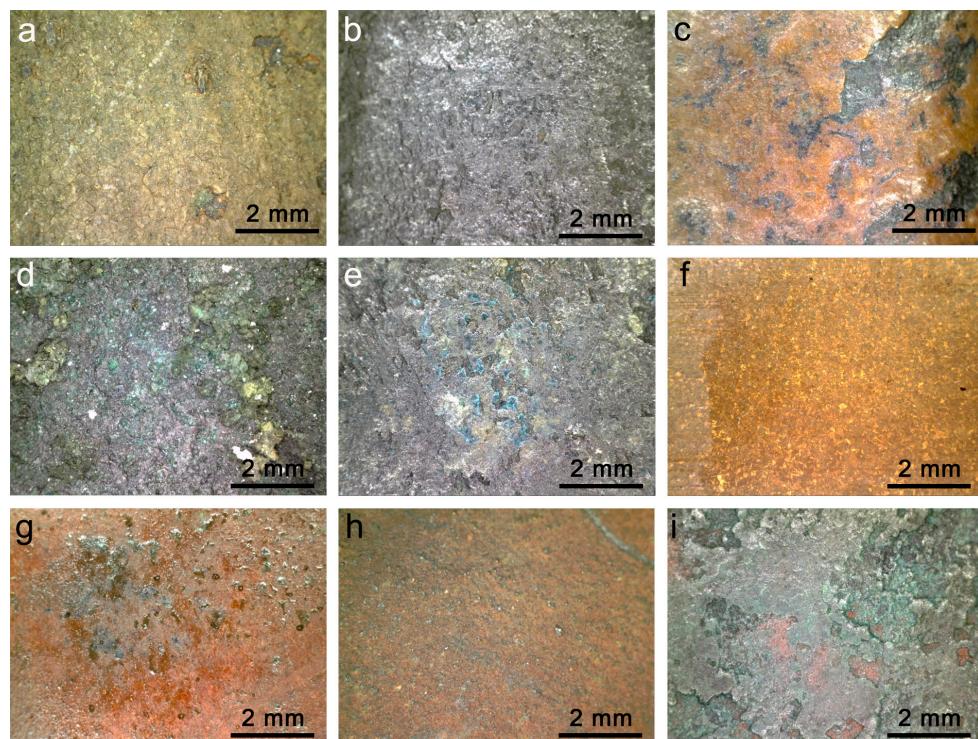
The on-site microscopic observation of the surfaces (Figure 9) highlighted a higher variability in the aspect of the corrosion layers. In this case, the predominance of reddish, brown, or black corrosion layers can be observed. It must be highlighted that the aspect, morphology, and composition of the patinas on the internal surfaces are also strongly affected by the interaction of the visitors, particularly in the hand-touched areas affecting the aspect of the observed black (Figure 9b,e) or reddish patinas (Figure 9c). Also, a specific area, named area S and located inside the head that is completely sheltered from rain action but exposed to the external environment, has been studied due to its peculiarity. Such a surface presents apparently thick and powdery corrosion layers, characterized by a brownish (Figure 9a) or bright green (Figure 9d) color.

Figure 9. Portable microscopy images of surfaces of the colossus of San Carlo of Arona. (a–e): Images acquired in correspondence of an intermediate landing of the internal ladder; (f–i): images acquired on internal surfaces of the head of the statue.

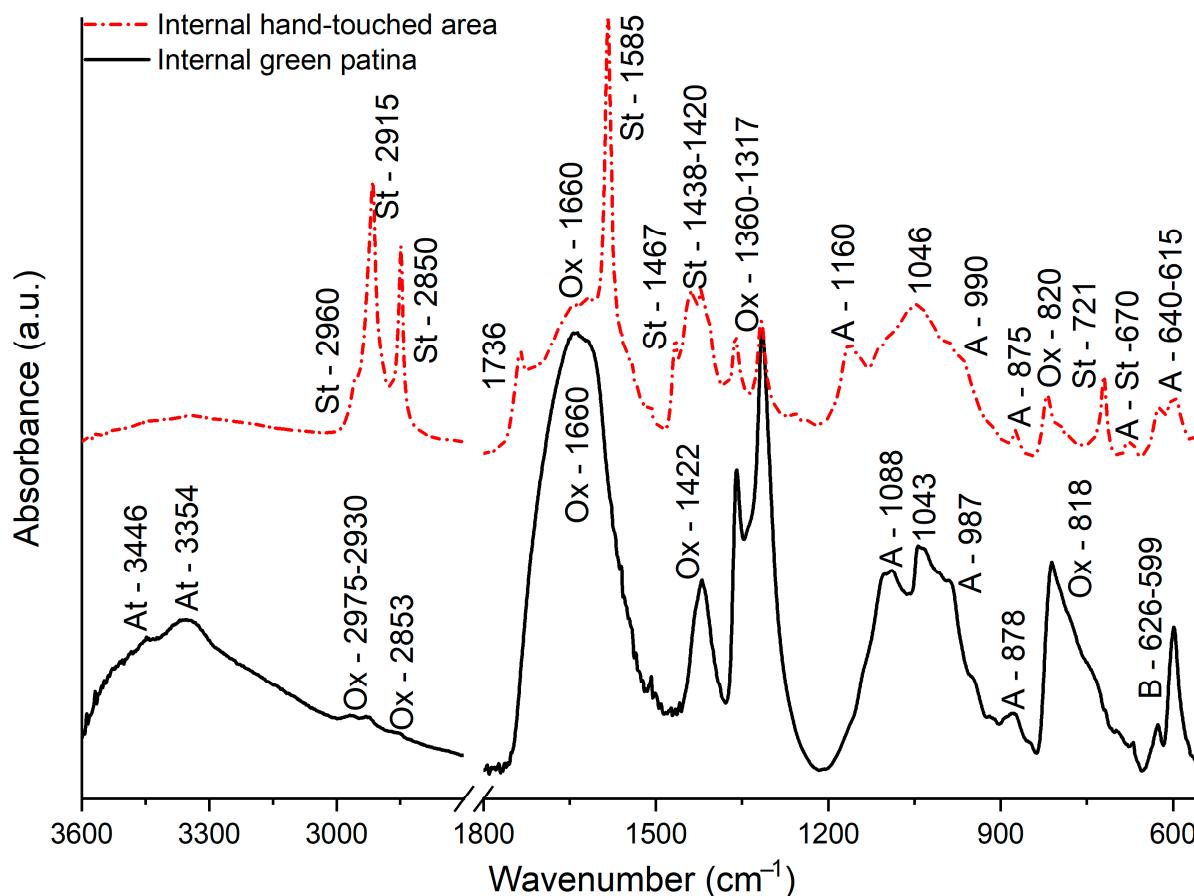
On the hand-touched areas (Figure 10), instead, a peculiar composition has been detected: besides antlerite and copper oxalate, the signals of copper stearate were clearly identified. This is probably the product of the reaction between copper ions and stearic acid, one of the most abundant fatty acids normally present on the human skin. Moreover, a higher presence of lead compounds (anglesite) with respect to the external surfaces is suggested by FTIR and XRD analysis. The presence of lead-based compounds is more relevant in correspondence to area S, characterized by thick powdery patinas, apparently heavily affected by deposition phenomena. Their presence may then have a pollution/deposition-related origin.

Figure 10. FTIR spectra of samples collected from the internal surfaces of the San Carbone.
