Ambient Vibrations of Age-old Masonry Towers: Results of Long-term Dynamic Monitoring in the Historic Centre of Lucca

Riccardo Mario Azzara, Maria Girardi, Valerio Iafolla, David M. Lucchesi,
Cristina Padovani & Daniele Pellegrini

The paper presents the results of an ambient vibration monitoring campaign conducted on the so-called “Clock Tower” (Torre delle Ore), one of the best known and most visited monuments in the historic centre of Lucca. The vibrations of the tower were continuously monitored from November 2017 to March 2018 using high-sensitivity instrumentation. In particular, four seismic stations provided by the Istituto Nazionale di Geofisica e Vulcanologia and two three-axial accelerometers developed by AGI S.r.l., spin-off of the National Institute for Astrophysics, were installed on the tower. The measured vibration level was generally very low, since the structure lies in the middle of a limited traffic area. Nevertheless, the availability of two different types of highly sensitive and accurate instruments allowed the authors to follow the dynamic behaviour of the tower during the entire monitoring period and has moreover provided cross-validation of the results.

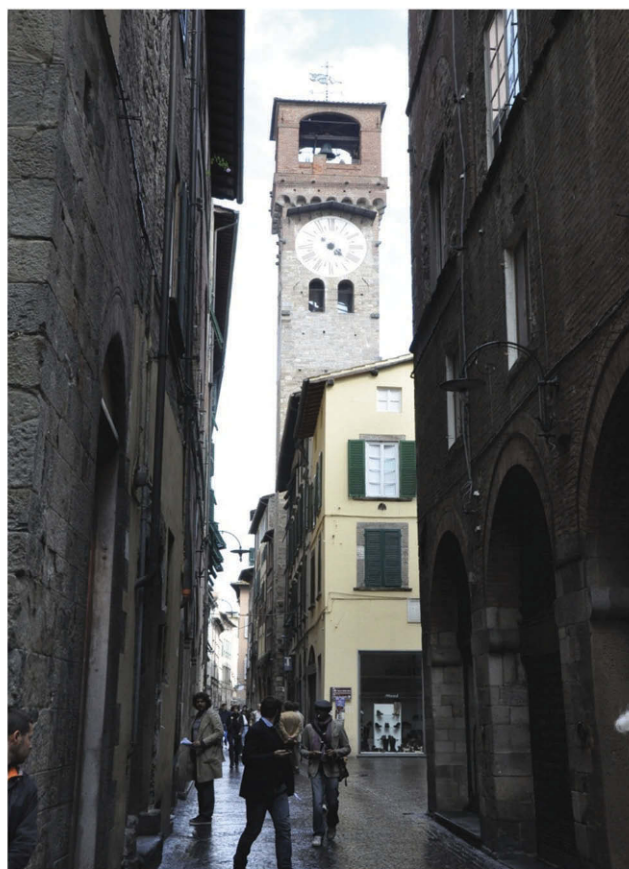
Figure 2. The Clock Tower: view from Via Fillungo.

Lucca was renowned in the past for a large number of towers in its skyline: of more than 100 during Middle Ages, only 10 or so of these fascinating monuments have survived until today (Figure 1). The Clock Tower is one of the best known and most visited age-old towers in Lucca, thanks to the peculiar shape of its bell chamber, which is clearly visible and recognizable throughout the entire historic centre. Built by local families (Concioni 1988), since the last decade of the 15th century, the Clock Tower has been used as a civic building, taking its name from the big clock visible on its southern façade (Figure 2). The Clock Tower rises at the corner between the roads named Via Arancio and Via Fillungo, one of the most popular in Lucca's historic centre; the adjacent buildings abut the tower on two sides for a height of about 13 m and constitute asymmetric boundary conditions for the tower's structure. The Clock Tower is 48.4 m high at the top of the bell chamber; it has a rectangular cross section of about 5.1×7.1 m and walls of thickness varying from about 1.77 m at the base to 0.85 m at the top. Two barrel vaults are set inside the tower at heights of about 12.5 and 42.3 m. The bell chamber, made up of four masonry pillars connected by elliptical arches, stands on the upper barrel vault and is covered by a pavilion roof constructed of wooden trusses and rafters. With regard to the materials constituting the masonry tower, visual inspection reveals that the masonry from the base up to a height of 15 m is made up of regular stone blocks and thin mortar joints. The upper walls are instead composed of regular stone blocks and bricks, also with thin joints. The pillars of the bell chamber are made of brick masonry.

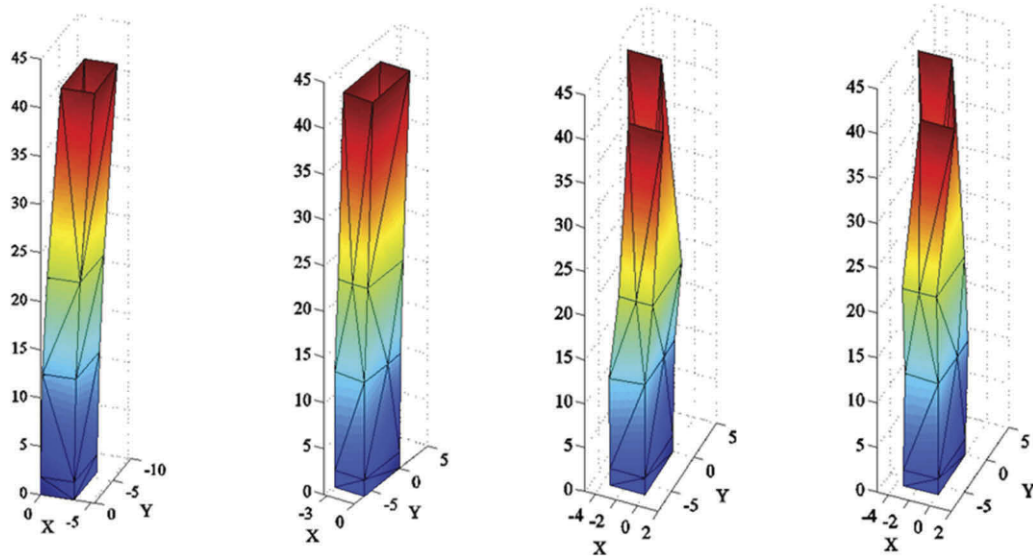
Figure 3. The tower's first four mode shapes.

described in (Girardi et al. 2019). Table 1 summarizes the frequencies calculated in the preliminary campaign of November 2016 (Pellegrini et al. 2017). The mode shapes of the tower corresponding to the first four frequencies determined by taking advantage of the different layouts used for mapping the tower's vibrations are shown in Figure 3. The first two frequencies refer to bending modes along the x (first) and y (second) directions, while the third is a torsional mode and the fourth is a torsional-bending mode involving movements of the structure's upper parts. Since the tower is located in the historic centre, in a limited traffic area, the environmental vibrations are quite low and do not allow to estimate frequencies and mode shapes higher than the fourth.

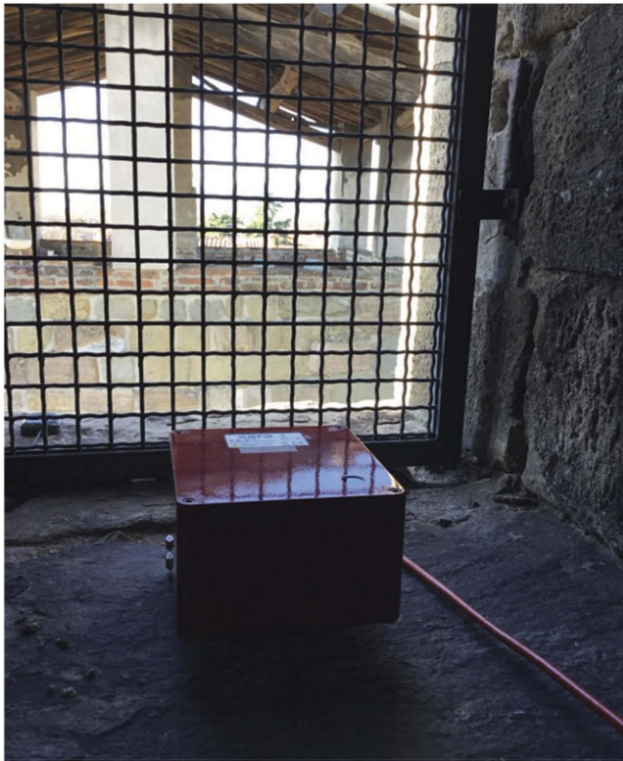
Figure 4. Sensor S.943 at level +24 m inside the tower.

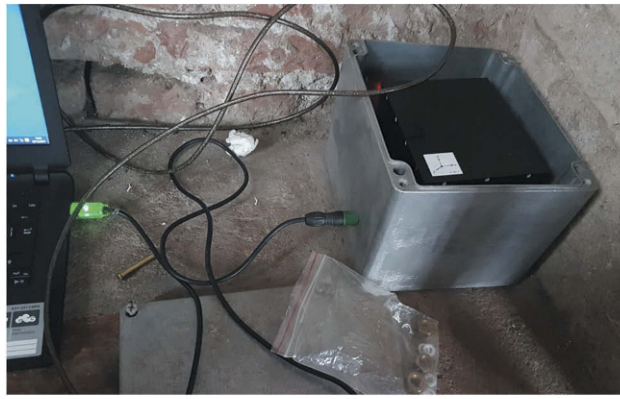
Figure 5. Sensor S.2 at level +37 m inside the tower.

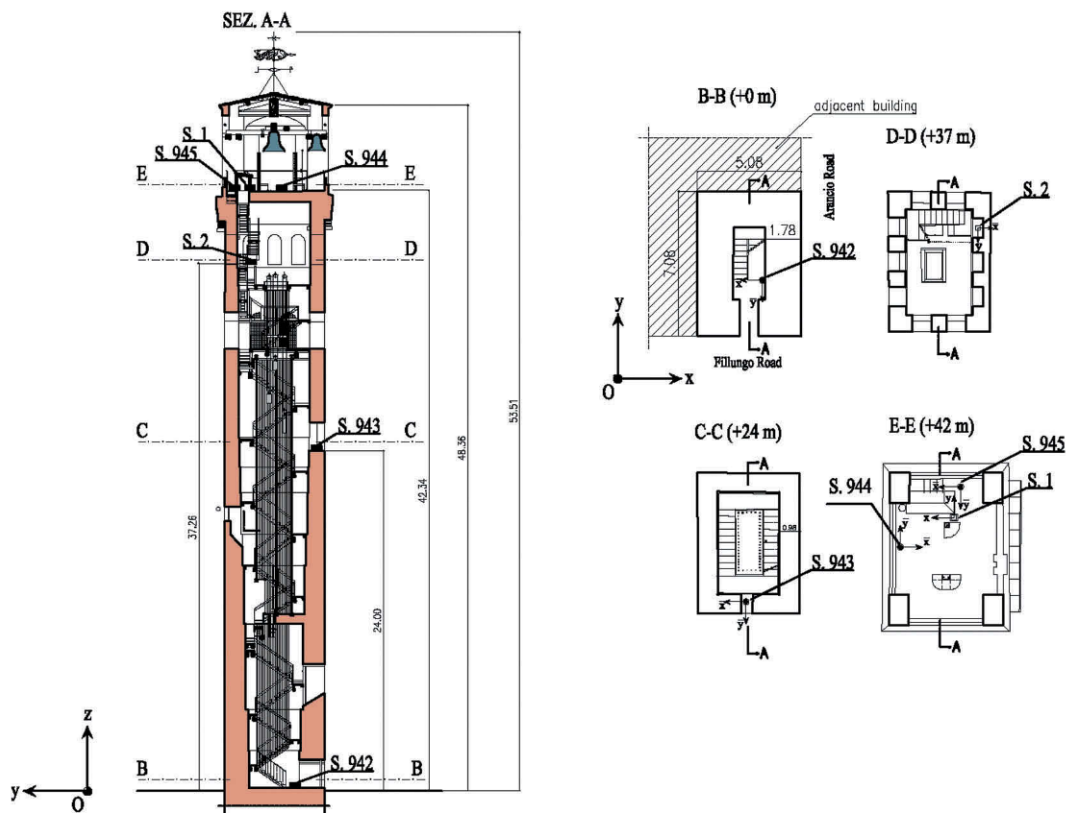
Figure 6. Sensor arrangement on the Clock Tower: sensors S.942, S.943, S.944, S.945 (SARA), sensors S.1, S.2 (AGI).

The instrumentation was kept running on the tower up to March 2018. Figure 6 shows the layout of the sensors along the tower during the experiment: seismic station S.942 was placed at the base, collecting data from the ground, S.943 was at the height of 24 m above street level, the remaining two stations S.944 and S.945 were placed on the bell chamber, at about +42 m above street level. The AGI stations were both installed in the upper part of the structure, S.2 at +37 m and S.1 on the bell chamber level.

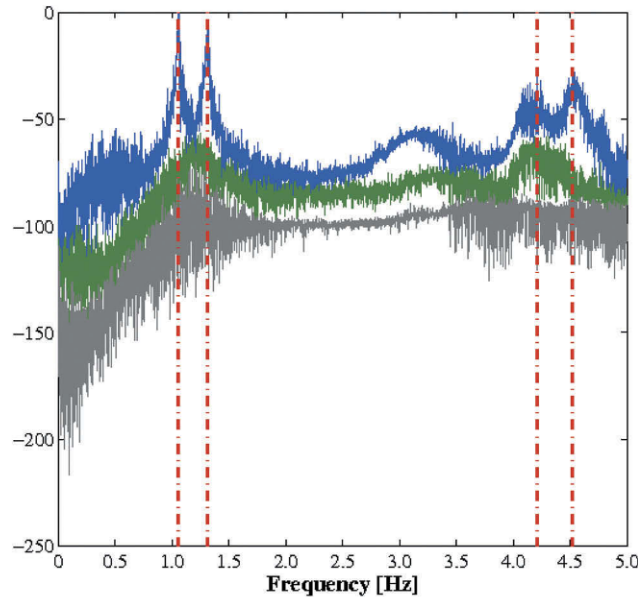
Figure 7. The three eigenvalues of the matrix $H[j\omega]^H H[j\omega]$ vs. the frequency on a log-magnitude scale.

via Experimental Modal Analysis (EMA), by applying the Complex Mode Indicator Function (CMIF) method (Shih et al. 1988) implemented in TruDI (Pellegrini 2019) and considering the seismic station at the base (S.942) as input signal. These last analyses were needed to take into account the composition of the signals at the base of the tower, whose spectrum shows a clear energy accumulation at about 3 Hz in the x -direction, along Via Fillungo. This same frequency was also recorded in the same direction by the station installed in the flat adjacent to the tower. In the authors' opinion, it represents a natural frequency of the building next to the tower and does not belong to the tower structure itself. Such conclusion is confirmed by the CMIF analysis, shown in Figure 7, where the three eigenvalues of the matrix $H[j\omega]^H H[j\omega]$ are reported vs. frequency, with $H[j\omega]$ the Frequency Response Function matrix of the system, estimated by the H_1 estimator (Maia and Silva 1997) and ω the circular frequency. Figure 7 refers to the analysis of a 1-h-long dataset recorded by the INGV seismic stations: the four peaks represent the identified four frequencies of the tower, the 3 Hz frequency being much less accentuated.

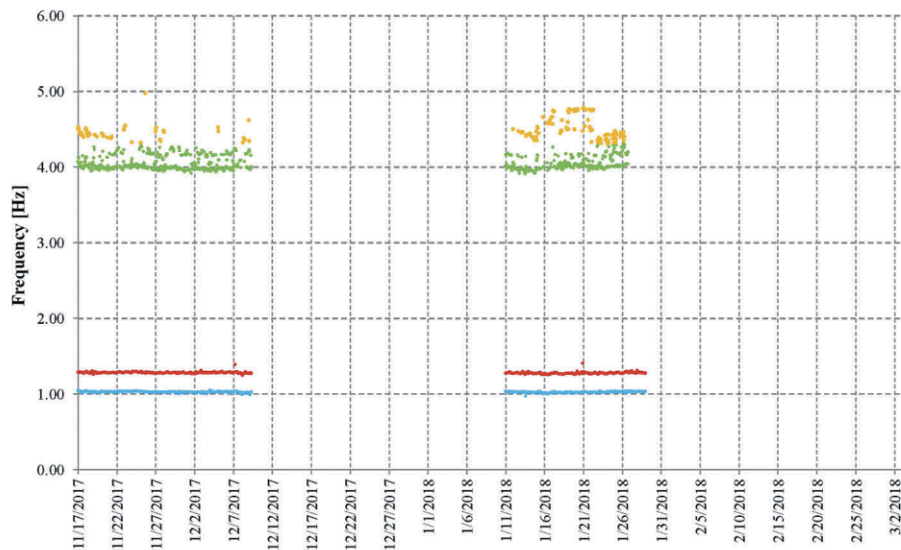
Figure 8. The tower's first four natural frequencies [Hz] detected by SS20 velocimeters during the monitoring period.

vs. time are reported in Figures 8 and 9 for the SS20 and the AGI instruments, respectively. The mean values evaluated by the two instruments are in very good agreement. The first and the second frequencies were detected by the two instruments in all records, and the variation in the two frequencies is on the order of 3%. This variation is also in good agreement with the findings of another long-term dynamic monitoring conducted on the San Frediano bell tower in Lucca (Azzara et al. 2018a). The third frequency was also detected by the seismic stations in almost all records, while the fourth frequency only appears when the excitation level in the tower's structure was increased (it was detected in about the 30% of the records), and its values appear to be widely dispersed. A fifth frequency at about 5.7 Hz was also detected in about 30% of the records. With regard to the modal damping ratios, reported in Table 3, they are widely dispersed with variations on the order of hundreds of percentage points. Their values vary from 4% for the highest frequency, to 0.5% for the first. The values yielded by the seismic stations are generally higher than those from the accelerometers.

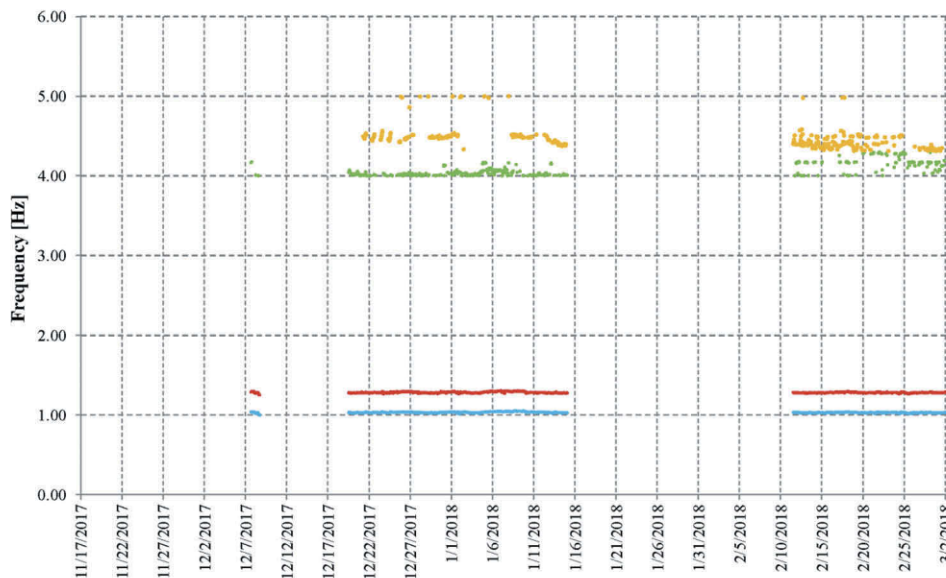
Figure 9. The tower's first four natural frequencies [Hz] detected by AGI accelerometers during the monitoring period.

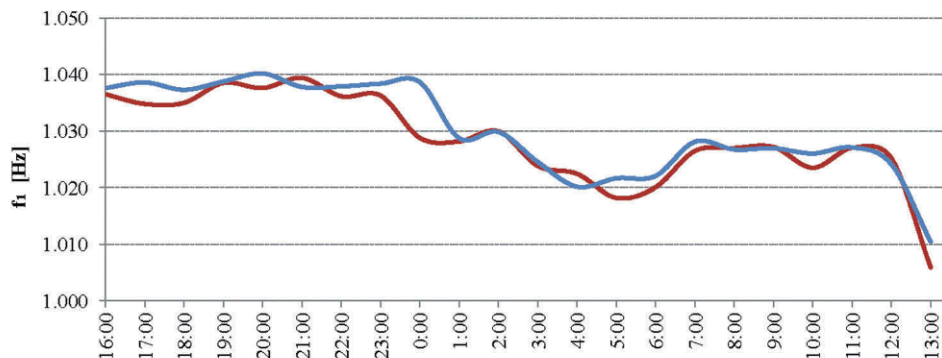
Figure 10. The tower's fundamental frequency obtained via AGI stations (blue) and SS20 stations (red) data from 7 to 8 December 2017.

Figures 10 and 11 show further comparisons of the results obtained via the two instruments. In particular, Figure 10 shows the trend of the tower's fundamental frequency from 7 to 8 December 2017, extracted from the AGI (blue) and the SS20 (red) devices. The very good agreement between the two measurements indicates that the fluctuations exhibited in the frequency values do not depend on the instruments' functioning, but are rather due to environmental factors. Figure 11 shows a comparison of the hourly maximum accelerations

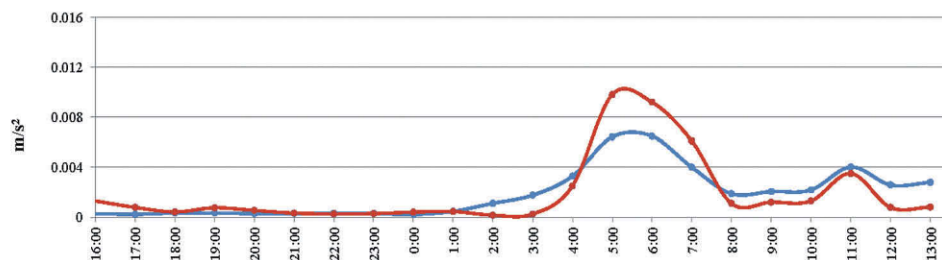
Figure 11. Maximum absolute accelerations along x recorded by the S.1 station (blue, +42 m) and the S. 945 station (red, +42 m) from 7 to 8 December 2017.

(absolute values) recorded by the instruments during that same period. It is worth noting that maxima in the acceleration values correspond to minima in the frequency values. In fact, a look at the weather those days revealed very bad conditions, with strong wind velocities (see also Figure 15), thereby suggesting a connection between the frequency reduction shown in Figure 10 and the action of the wind, which due to the masonry's inability to withstand large tensile stresses, tends to decrease the tower's stiffness (see also Figure 16).

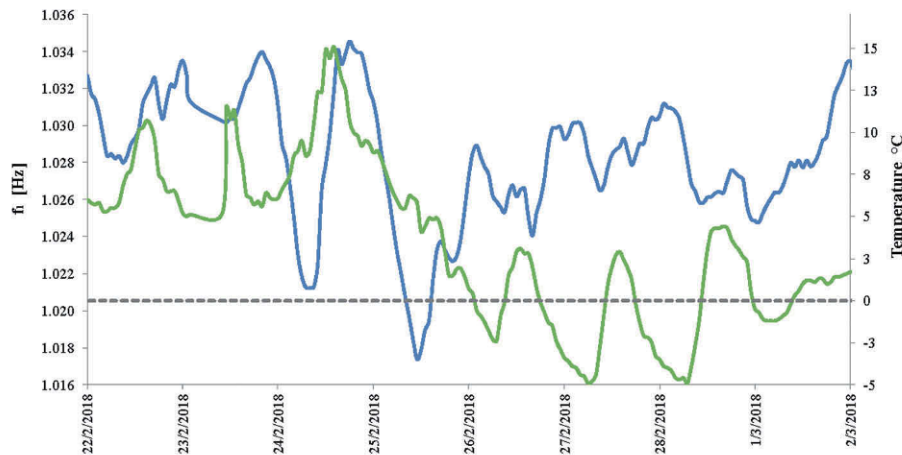
Figure 13. The tower's first (blue line) natural frequency [Hz] vs. temperature [°C] (green line), during February 2018.

thermal inertia of the tower, while, below zero, the frequency and temperature appear to be in phase.

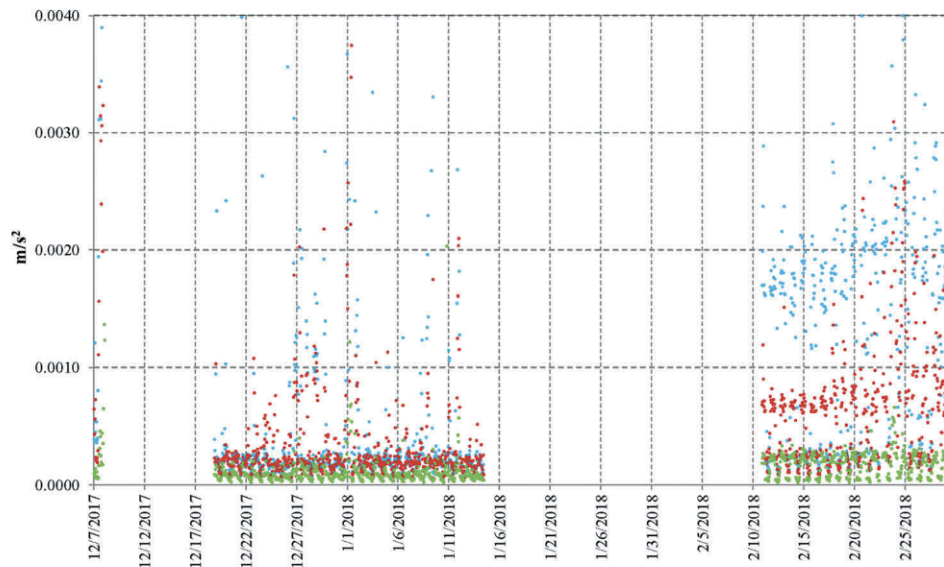
Figure 14. Maximum absolute values per hour of the accelerations recorded by AGI stations (S.2, +37 m) in the x (blue dots), y (red dots) and z (green dots) directions.

The trend over time of the maximum accelerations recorded by AGI sensors, after high-pass filtering of the signals (with a cutoff frequency of 0.1 Hz), is shown in Figure 14. The vibration level in the tower is very low, generally under $2 \cdot 10^{-3}$ m/s², thanks to restrictions to vehicular traffic in force in the Lucca historic centre. The figure highlights an increase in the tower's vibration level during the Christmas holiday period (from 22 December to 1 January), connected to the increased pedestrian

traffic in the historic centre, with a peak on New Year's Day. The figure also reveals a systematic increase in the accelerations, on average of 1 order of magnitude, from 9 February onward. This is due to the ringing of the tower bells, which had been suspended for the restoration of the ancient clock and was restarted on 16 January 2018. The bell system is composed of three bronze bells, fixed at their supports and rung by hammers each quarter an hour in the x direction (along Via Fillungo). Indeed, Figure 14 shows significant amplification along x (blue dots).

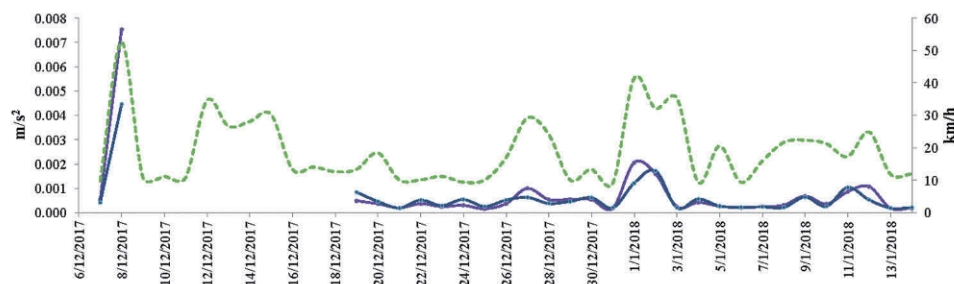
Figure 15. Daily average of the maximum hourly accelerations measured by S.2 vs. time along the x (blue) and y (red) directions. The dashed green line stands for the daily maximum wind speed. The correlation coefficients are $R^2 = 0.5654$ (daily average x — wind speed) and $R^2 = 0.5018$ (daily average y — wind speed).

With regard to the environmental parameters that could influence the acceleration levels on the tower, **Figure 15** plots the daily average values of the maximum hourly accelerations in the x (blue) and y (red) directions, for about a month, together with the daily maximum wind speed recorded at Pieve di Compito, about 10 km from the Lucca historic centre (data available at www.sir.toscana.it). The figure clearly shows a correspondence between the peaks in the acceleration levels and those in the wind speed.

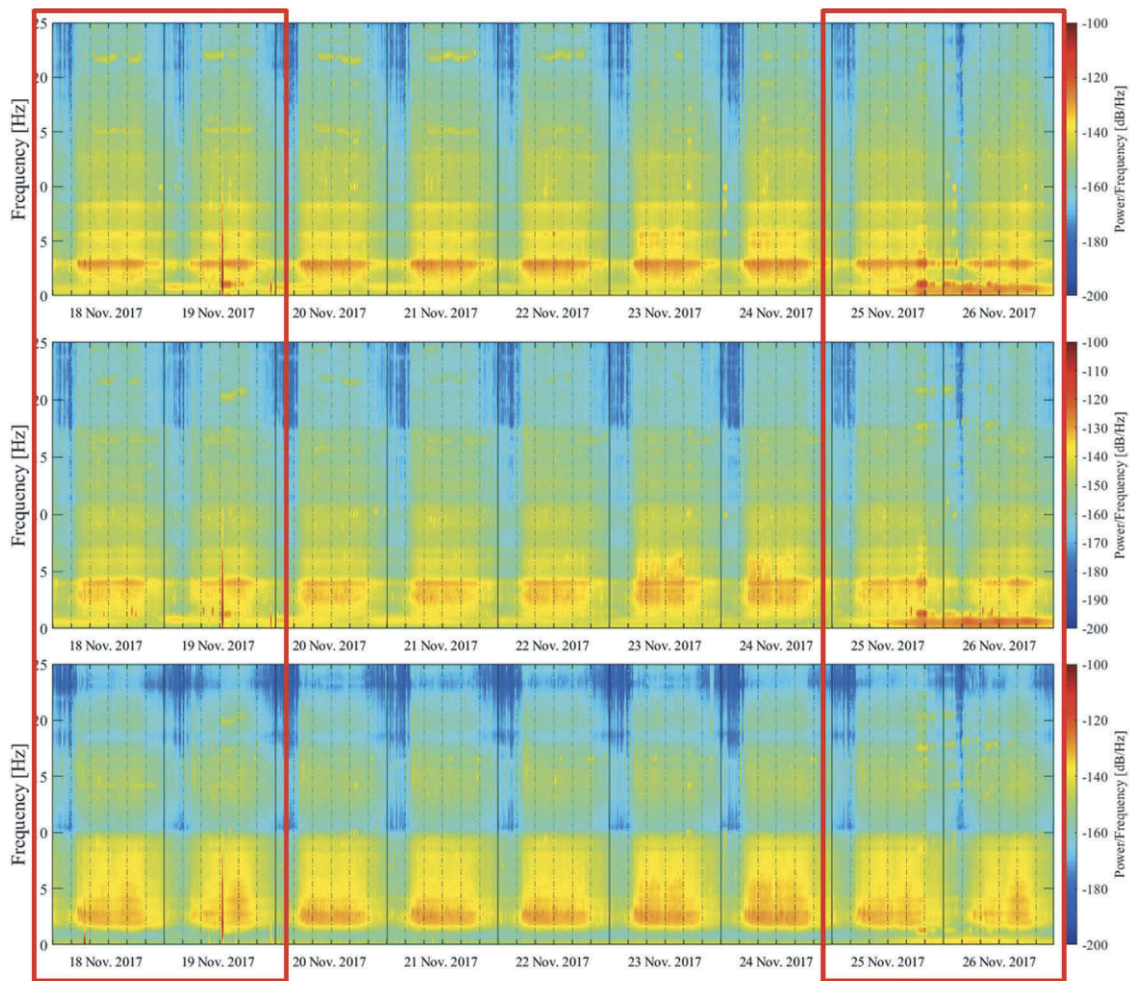
Figure 17. Spectrogram of the signal recorded by S.942 (+ 0.00m) in the x (up), y and z (bottom) directions from 18 to 26 November 2017. Weekends are highlighted by the red boxes.

Figures 17 and **18** provide information on the tower's vibrations over time in the band [0, 25] Hz. In particular, **Figure 17** shows the spectrogram of the signal recorded by S.942, at the base of the tower, in the period 18 November to 26 November 2017, for the three channels x (up), y and z (bottom). The tower's natural frequencies are clearly visible in the band [0, 10] Hz (horizontal lines), as well as the 3 Hz frequency of the building adjacent to the tower, along the x direction. As a result of anthropogenic activity, the power frequency increases in the entire band during the daytime, in particular during weekends (18–19 November, 25–26 November). The three-dimensional spectrogram of channel x plotted in **Figure 18** also highlights other anthropogenic activity between 20 and 25 Hz, which could be attributed to traffic in the historic centre. At about 12:30 (UTC)

on 19 November, there is a clear frequency peak, which can be attributed to the M4.4 Parma earthquake reported in Table 4.

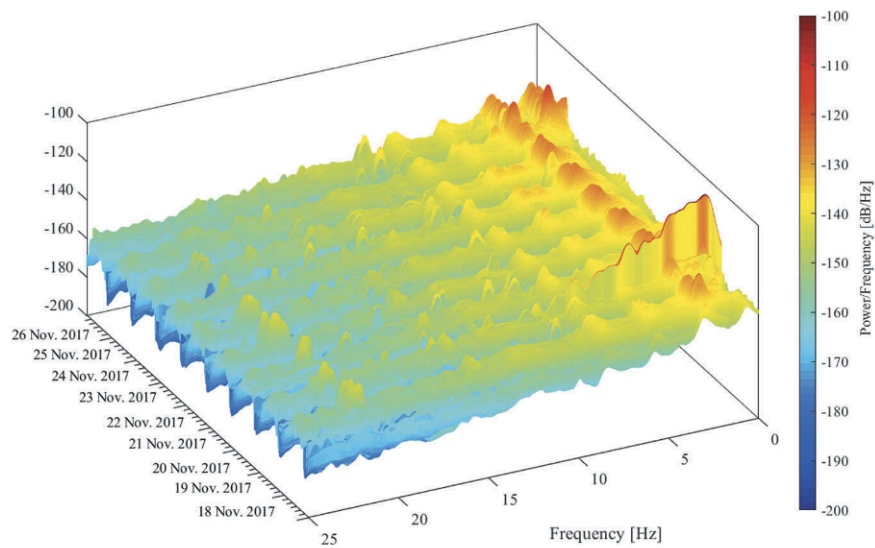
Figure 18. Three-dimensional spectrogram of the signal recorded by S.942 (+0 m) in the x direction from 18 to 26 November 2017.

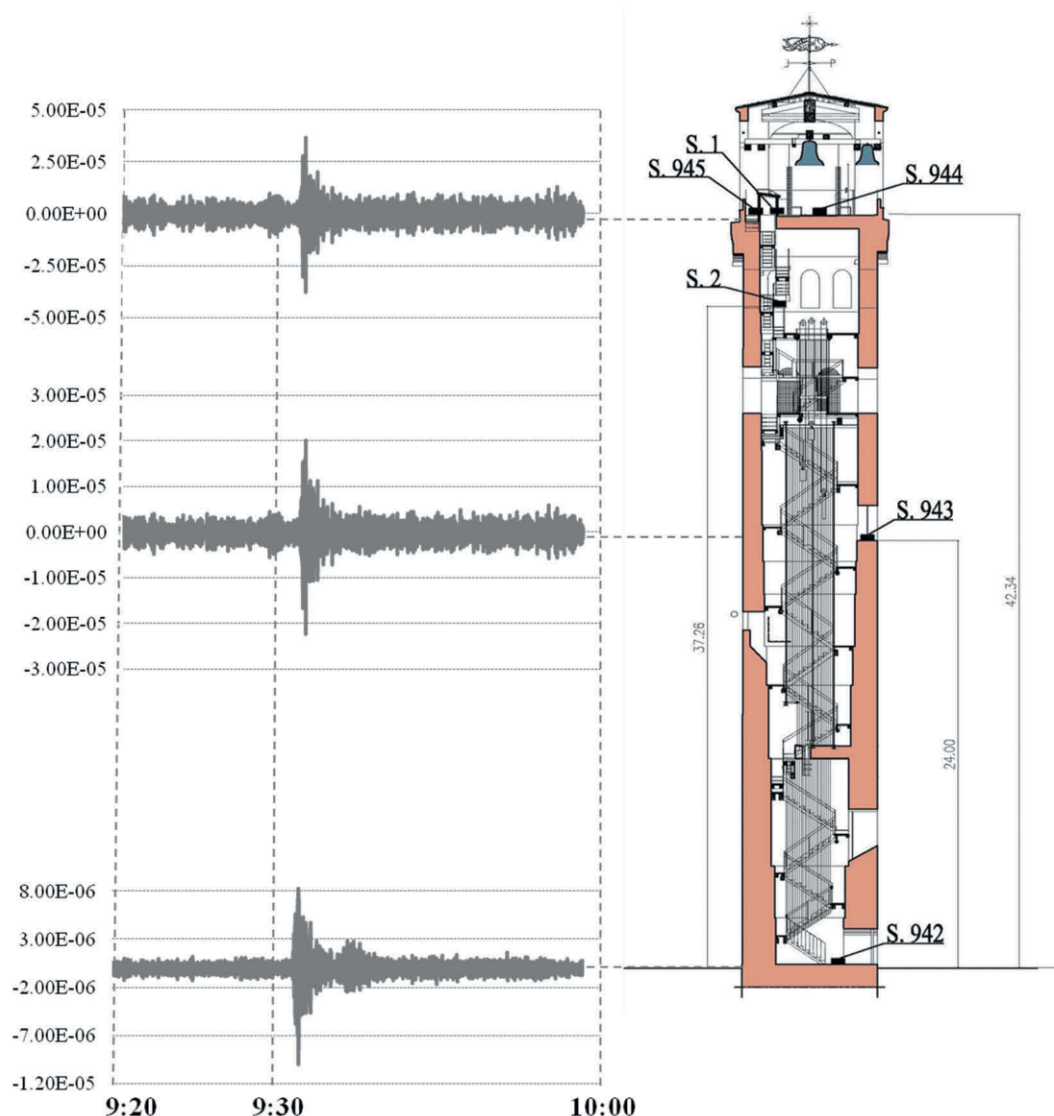
**Figure 19.** Signal of the Peru earthquake recorded on the tower in the x direction by S.942, S.943, S.944 on 14 January 2018 from 9:33 (UTC) onward. Signal amplitude is in m/s^2 .

Many seismic events have been detected on the tower during the monitoring period. Table 4 shows the main earthquakes recorded, while Table 5 reports the teleseismic events identified in the signals. Figure 19 shows the teleseismic record of the Peru earthquake, which occurred at 09:18.44 (UTC) with a magnitude of 7.1, and was recorded at about 09:33 (UTC) by the instruments on the tower. In particular, the figure shows the signals recorded by the SS20 seismic stations at different levels along the tower's height in the x direction. The same event was also recorded by the S.2 accelerometer. At such a considerable distance from the epicentre, the seismic signal loses its high-frequency content and becomes recognizable only at low frequencies. The records in the Figure were obtained by filtering the signals via a Butterworth band-pass filter with a lower cut-off frequency of 0.04 Hz and a higher cut-off cut at 1 Hz. It is worth noting that after the first arrival of the waves the event remains clearly recognizable in the signals for a long time.

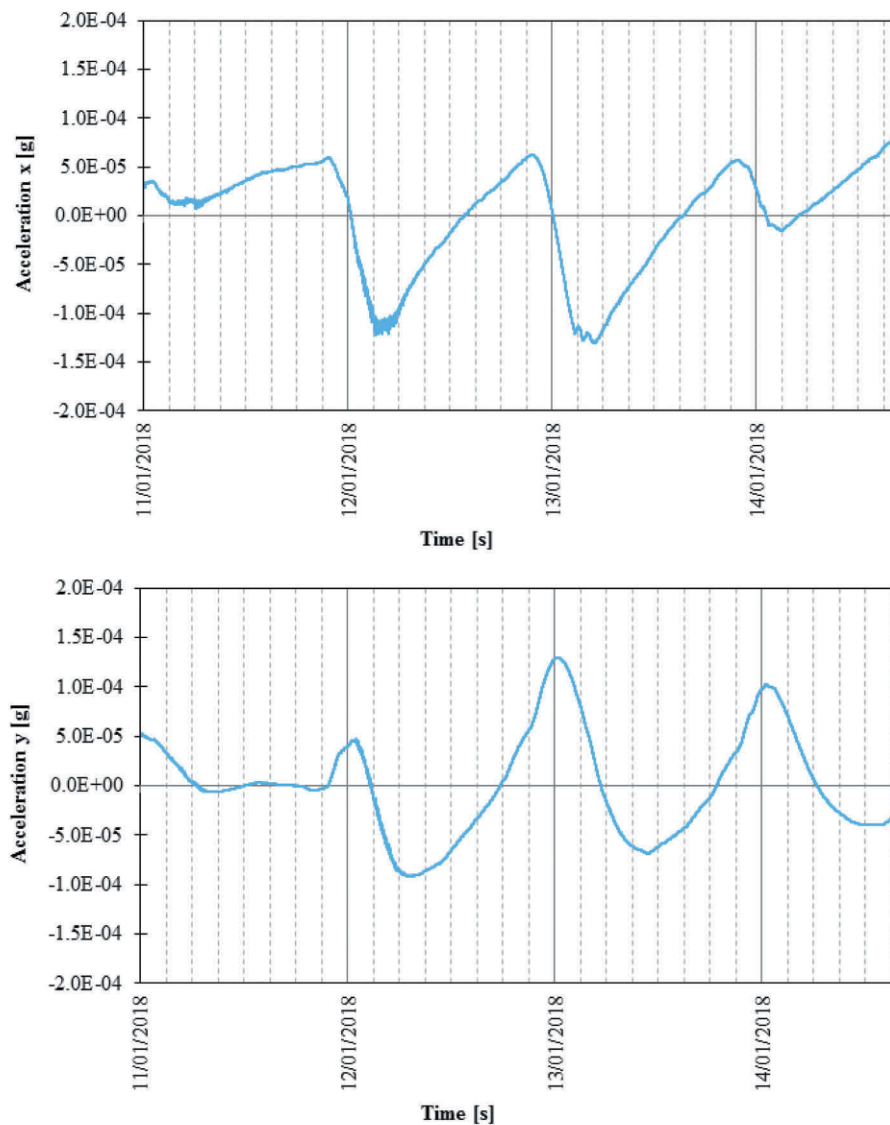
Figure 20. Low-pass filtered accelerations recorded by S.2 along the x and y (bottom) directions from 11 to 14 January 2018.

Analyzing the low-frequency content of the recorded signals can provide further information on the movements of the tower. Figure 20 shows the signals recorded by the S.2 accelerometer from 11 to 14 January 2018 along the x (up) and y (bottom) directions. The signals in the figure were low-pass filtered with a cut-off frequency of 0.5 Hz, and clearly reveal a slow oscillation with a period of about 24 h. The same oscillations can be detected in the temperature signal (Figure 21) measured by the sensor inside the instrument. The temperature signal is however not in phase with the accelerations, thus demonstrating that the oscillations of the accelerometric signal are not a direct effect of temperature on the instrument. It is also worth noting that the signals along the x (North-South direction) and y (East-West direction) directions present a phase shift of 3 to 6 h, and the y signal is delayed with respect to that along x . A possible interpretation of these oscillations lies in the daily temperature variations caused by exposure of the tower to the sun. As the exposure of the façades changes during the day, the tower appears to twist as shown in the figures. A measure of the displacements induced by this effect at the top of the tower can be easily obtained from the figures. In fact, for small oscillations, the modulus of the

horizontal acceleration expressed in g coincides with the inclination angle of the tower in radians. Thus, taking into account the actual position of the instrument (at +37 m), horizontal displacements turn out to be on the order of 3–4 mm for both directions. These low-frequency displacements seem to be the main components of the total horizontal displacements experienced by the tower in normal conditions (i.e. in the absence of earthquakes, other strong dynamic actions, etc.). In any case, these data should be complemented by further measurements at the ground and static measurements as well.

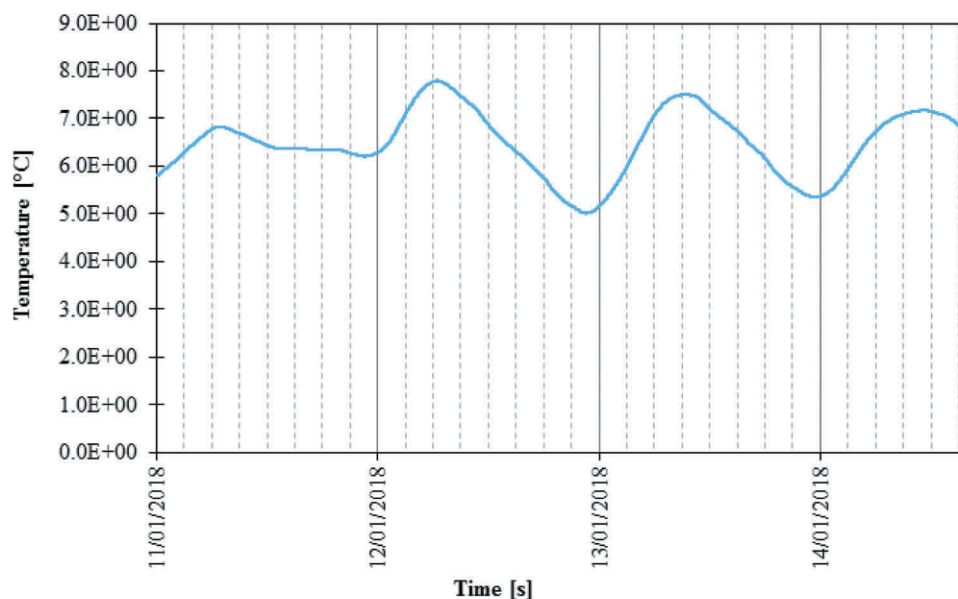
Figure 21. Temperatures recorded by the sensor installed inside S.2 from 11 to 14 January 2018.
