# A preliminary study for a marker-based crack monitoring in ancient structures

The aim of the presented work is propose a methodology for tracking, over time, a representation of the variations of the fissure patterns in buildings and to show its applicability in a challenging case study, namely the *Fortezza Vecchia* – an ancient fortress in Livorno (Italy). The study was carried out in the framework of MOSCARDO project ([8]), which aimed at developing an autonomous monitoring system, able to collect and process data about the structural health of ancient buildings. Also, the acquired data

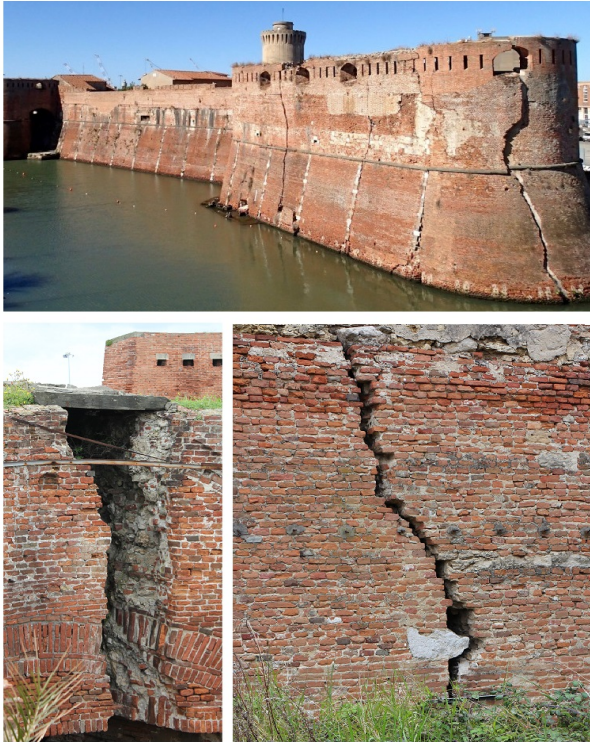
**Figure 1: Evident structural defects in the walls of the ancient fortress, in the area named *Bastione della Capitana* (Fortezza Vecchia, Livorno, Tuscany, Italy).**

Our case study is the Fortezza Vecchia, an ancient fortress in Livorno (Italy): the majority of the defects on its walls are difficult to be monitored, as the fortress is partially surrounded by the sea (see Fig. 1). The peculiarity of the fissures in the Fortezza Vecchia, Bastione della Capitana, is that the sides of each fissure are quite far from each other (as is visible from the bottom images of Fig. 1); also they show a depth offset of at least 0.06 m. The non planarity of such defects makes it very difficult to obtain an absolute and accurate measurement of the separation of the sides with standard

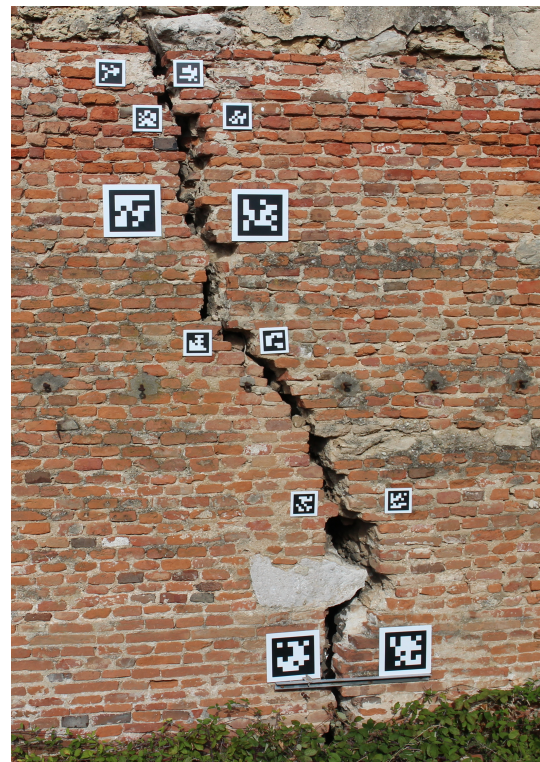
**Figure 2: ArUco fiducial markers have been placed along the crack in the most critical points.**

As regards the visual impact of the markers placed on an ancient structure, such as the wall of the Old Fortress in Livorno, we printed markers with two different side lengths: 0.1 m and 0.2 m. We found that, as all of them were detected correctly (Fig. 2), the smaller ones may be used for the next experimentations, without losing in accuracy.

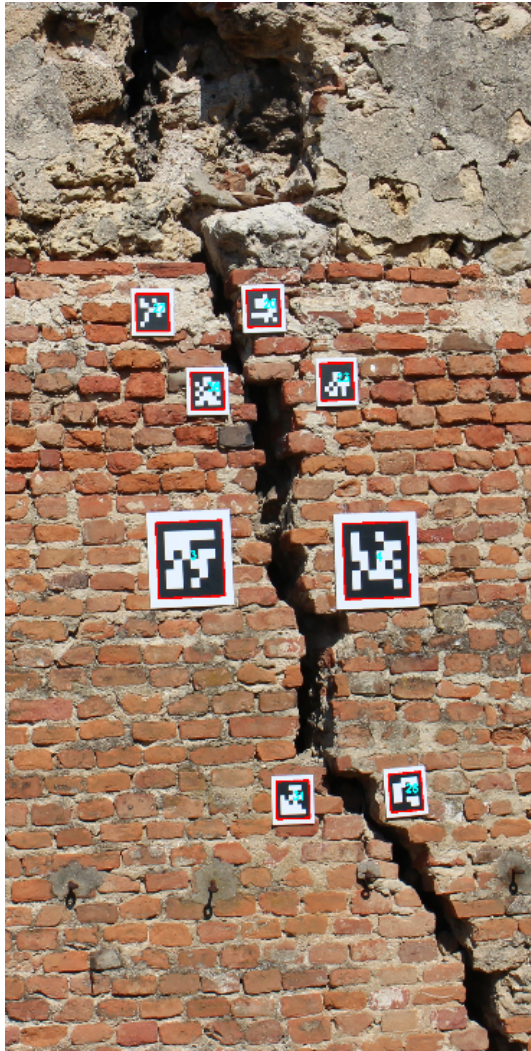
**Figure 3: Four pairs of markers, correctly detected and identified.**

As shown in Fig. 3 all markers are correctly detected, and the corners’ detection is used to compute the barycenter distances in order to roughly check the correlation with the measures performed with a flexible meter, inherently not accurate because of the peculiarity of the defect inspected, previously mentioned in Section 3.
