UAV, Structural Health Monitoring, Crack monitoring.

EXPLORING UAVs FOR STRUCTURAL HEALTH MONITORING

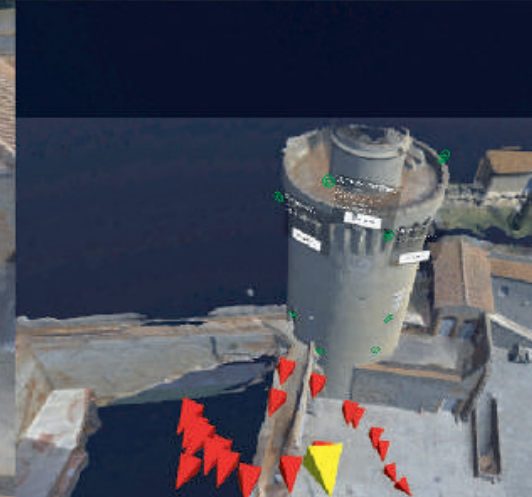
Figure 3. *Bastione della Capitana*. This area of the *Fortezza Vecchia* complex has been considered for long time monitoring of cracks and damages in building by AUV inspection. A configuration of markers has been placed around a crack to perform quantitative 3D measurements.

At first, under the suggestion and guidance of an expert such as a civil engineer or architect, a configuration of planar markers is installed around the crack pattern or damage to be monitored. Notice that this is the only step, which, at the moment, requires physical access to the damaged part, while the actual monitoring can be executed remotely, thanks to the use of the UAV.

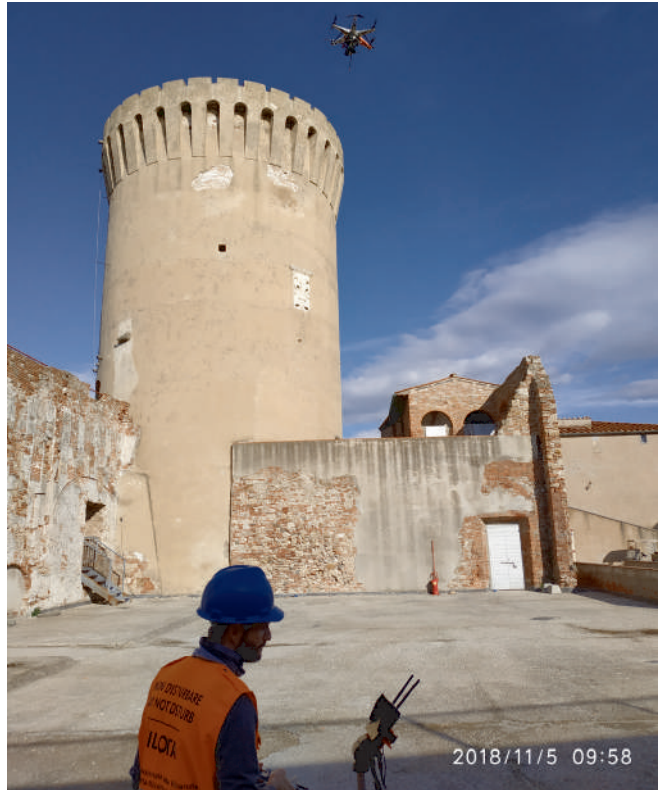
Figure 2. The operator pilots the AUV around Mastio di Matilde, a tower in the *Fortezza Vecchia* complex in Leghorn, which has been considered as a case study in the framework of Moscardo project.

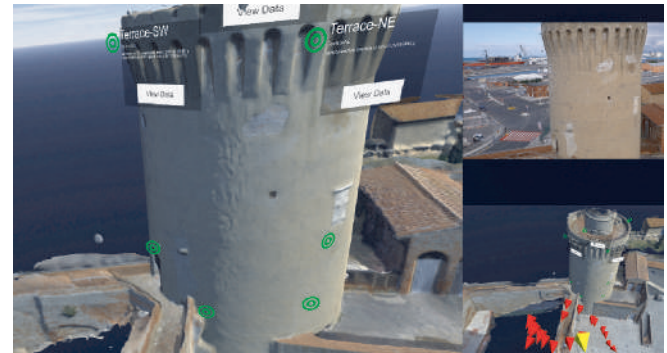
Figure 4. On the cover: The VR interface is composed of three elements: (i) the central part shows reconstructed virtual scene with installed sensors and their gathered values; (ii) in the upper right side of the screen, the video recorded by the AUV during the inspection operations is shown; (iii) in the lower right side, a panoramic view of the virtual scene is displayed reporting also AUV actual position (yellow pyramid) and followed path (represented as a set of smaller red pyramids). Please, see <http://moscardo.isti.cnr.it/> for an interactive demo.

UAV and possible obstacles surrounding the vehicle. In this modality, the interface is composed of three parts:

- The central and main one is devoted to showing the subjective 3D scene from the vehicle. From here, it is possible to view near sensors and acquired measurements;
- The upper right side displays the direct view of the UAV acquired by the onboard camera;
- The lower right portion shows a perspective view of the entire scene with the actual position of the UAV.
