Time evolution of landslide damages to buildings: the case study of Lungro (Calabria, southern Italy)

Loredana Antronico · Luigi Borrelli ·
Roberto Coscarelli · Giovanni Gullà

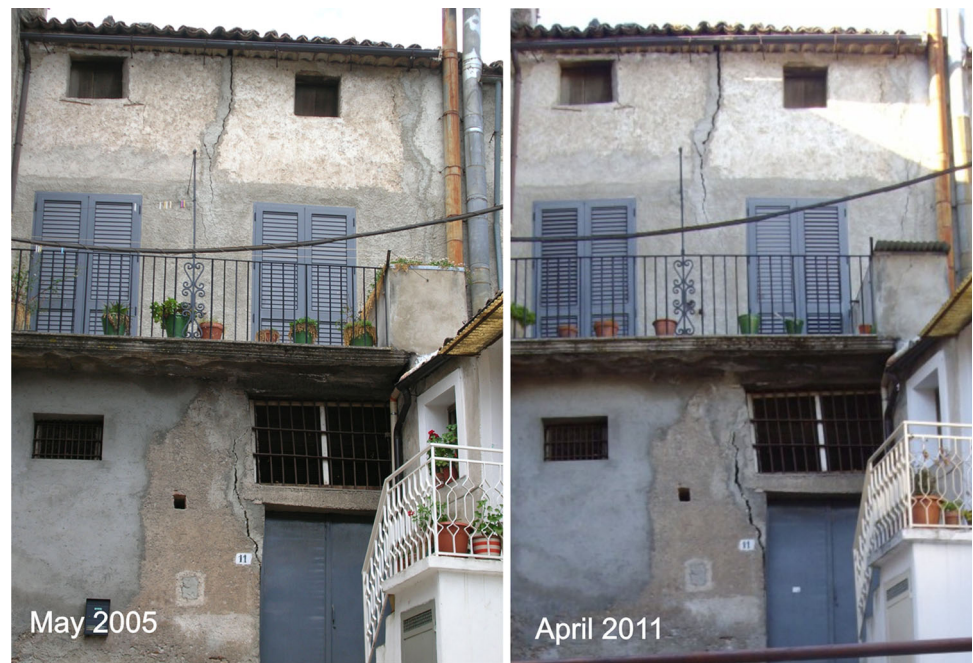
Fig. 4 Photo survey clearly indicating the increase in lesions, across the 2005–2011 period, affecting a building located in the historical centre

in this area, such as the Town Hall and a school. After the survey that ended in 2011, some of the damaged buildings underwent works to increase their level of safety and reduce the risk of collapse. The analysis of the available data has pointed out that, in the 2006–2011 period, an increase in the degradation of the buildings was registered in the left portion of the landslide classified as slide with uncertain boundary (Figs. 4, 5).

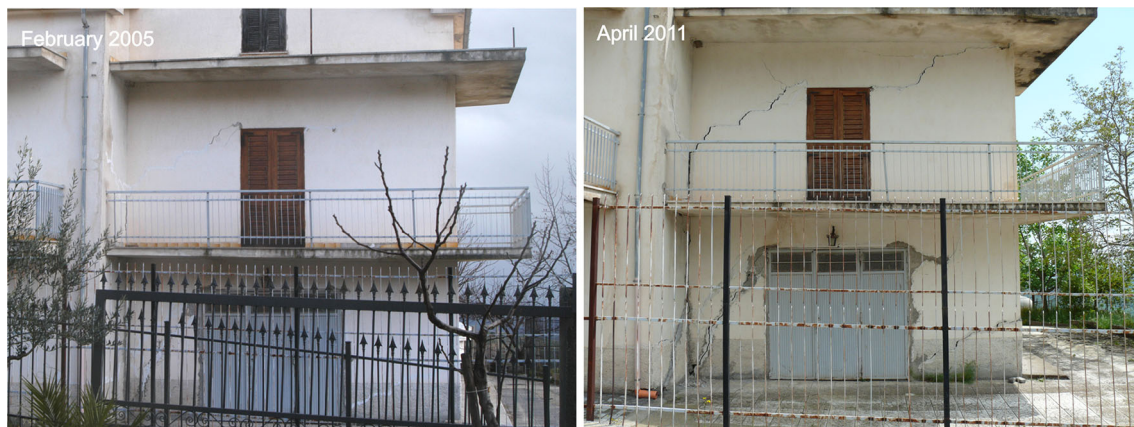
**Fig. 6** Photo comparison showing an increase during the analysis period in the crack pattern of a building located in the Cemetery area

For example, Fig. 6 shows damage evolution on a building located in the Cemetery area. In 1980, a football ground had been built here, but, successively, due to the severe damage suffered in 2000, it has been substituted by a car wash area. Another example is represented by the area of San Leonardo: over the period taken into account (2005–2011), the buildings show a significant worsening of their structural conditions, as indicated by an increase in their tilt angles, as well as by new cracks on previously undamaged buildings (Fig. 7). For the neighbourhood of San Leonardo, it is important to clarify that it already underwent stabilization measures; despite this, the results of this work indicate that such measures have not reduced the landslide activity. Moreover, as Gullà et al. (2006) reported, the presence of galleries of a salt mine located at the slope foot and disused since the 1980s seems not to have produced any effect on building degradation.

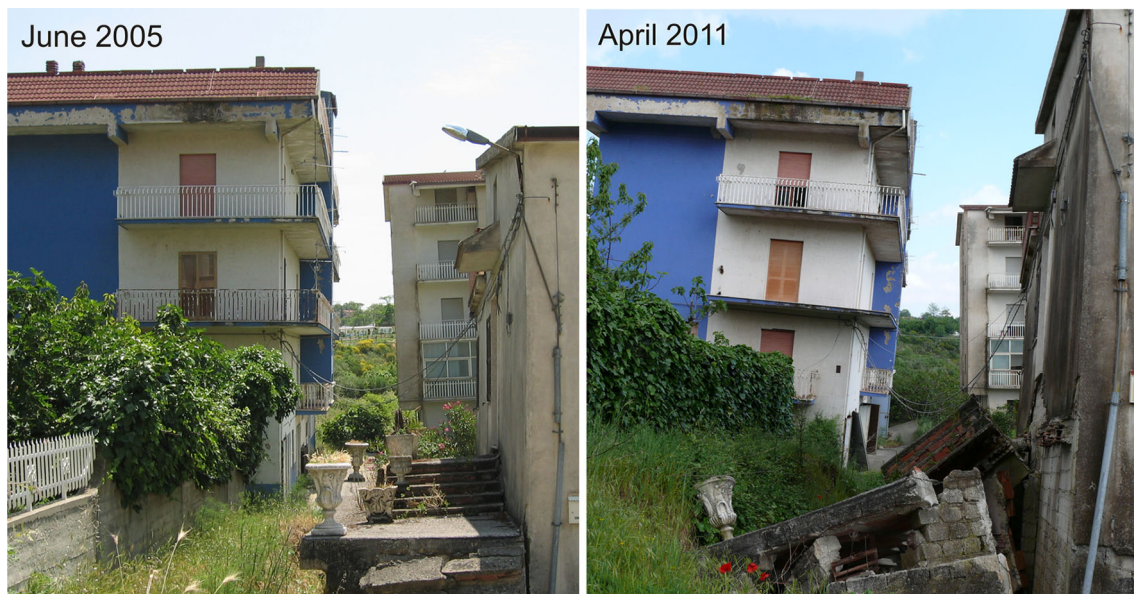
Fig. 7 Photo comparison showing an increase during the analysis period of tilt angles of buildings located on the edge of the landslide slope in the area of San Leonardo

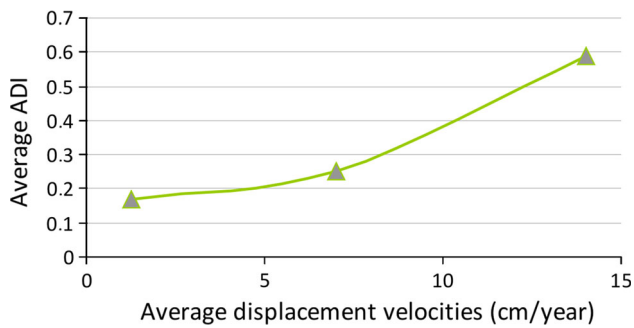
Fig. 9 Average damage index over the whole period of observation versus average displacement velocities of mass movements

On the other hand, a positive correlation seems to exist between landslide medium velocity and the macrodamage index. In fact, for the area of San Leonardo, showing higher displacement velocities (from 10 to 18 cm/year), an ADI with the highest values (up to 0.66) of the area under investigation has been observed. For the area of Cemetery, affected by the same landslide category but with slower displacement velocities, (6.66 cm/year on average), lower ADI values have been recorded (up to 0.28). This is also explained in Fig. 9, which shows the damage index, averaged over the investigation period, relative to the Cemetery area, San Leonardo and historical centre, related to the average displacement velocity of mass movements. The increasing trend of the interpolation curve, despite its inference from a few experimental data, clearly shows that for velocity values higher than 7 cm/year, average damage indexes significantly increase. This critical value (7 cm/year) can be considered, relative to the study case, as a threshold of the average displacement velocity of mass movements, above which it could be necessary to increase the frequency of the monitoring activity and to adopt preventive measures for ensuring public safety.

The results showed an inverse correlation between the macrodamage index and the depth of the mass movement. Vice-versa, a positive correlation seems to exist between average displacement velocity of landslides and the macrodamage index.
