# An HBIM Integrated Approach Using Non-Destructive Techniques (NDT) to Support Energy and Environmental Improvement of Built Heritage: The Case Study of Palazzo Maffei Borghese in Rome

## Special Issue

Energy Efficiency and Multi-Objective Optimization in Building

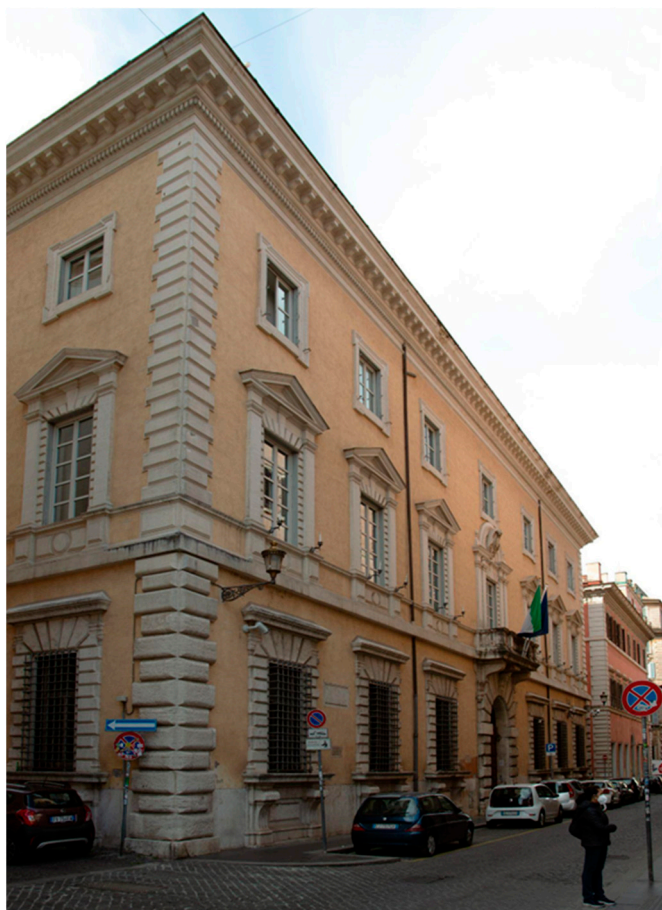
**Figure 2.** Palazzo Maffei-Borghese, Rome, Italy.

Figure 2 shows the façade that overlooks via del Clementino, formerly Via Trinitatis, near the junction with Via di Ripetta. In 2004, the building went through a restoration that involved a structural consolidation, which rebuilt part of the slabs and roofs, consolidated walls and changed the internal room distribution, adding new toilets and a new internal stairwell. The HVAC (Heating Ventilation Air Conditioning) layout was renovated by installing a coupled gas boiler and heat pump generator system with fan coils as main terminals, although keeping radiators in some spaces; a mechanical ventilation system was added, but never put into operation.

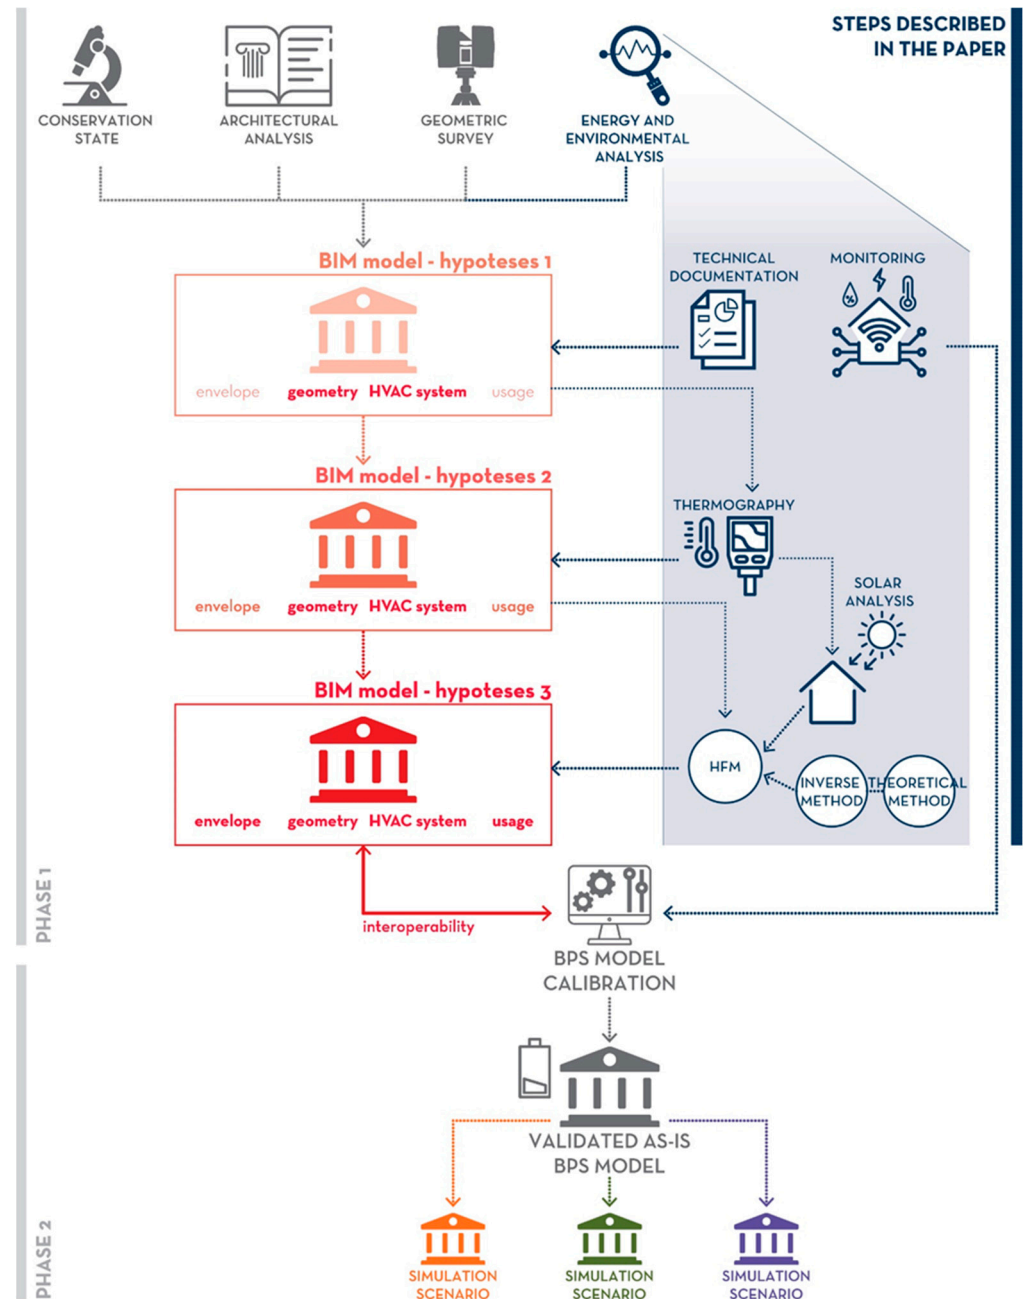
**Figure 3.** Graphic representation of the methodology workflow. The blue colour highlights the steps of the methodology that pertain to the current paper.

As shown in the left heading in Figure 3, the entire process was divided into two main phases. Phase 1 consisted of developing a solid understanding of the building characteristics through a series of analyses: a historical and architectural analysis, a geometric survey with both traditional and innovative techniques, a general conservation state analysis (materials and structure survey) and a robust environmental and energy analyses, which comprised several interdisciplinary activities through the application of NDT techniques. These diagnostics pipelines, advanced over different periods, were integrated within an HBIM model in a CDE, which was developed and revised iteratively by the interdisciplinary team each time new data were gathered. The first model is based on historical

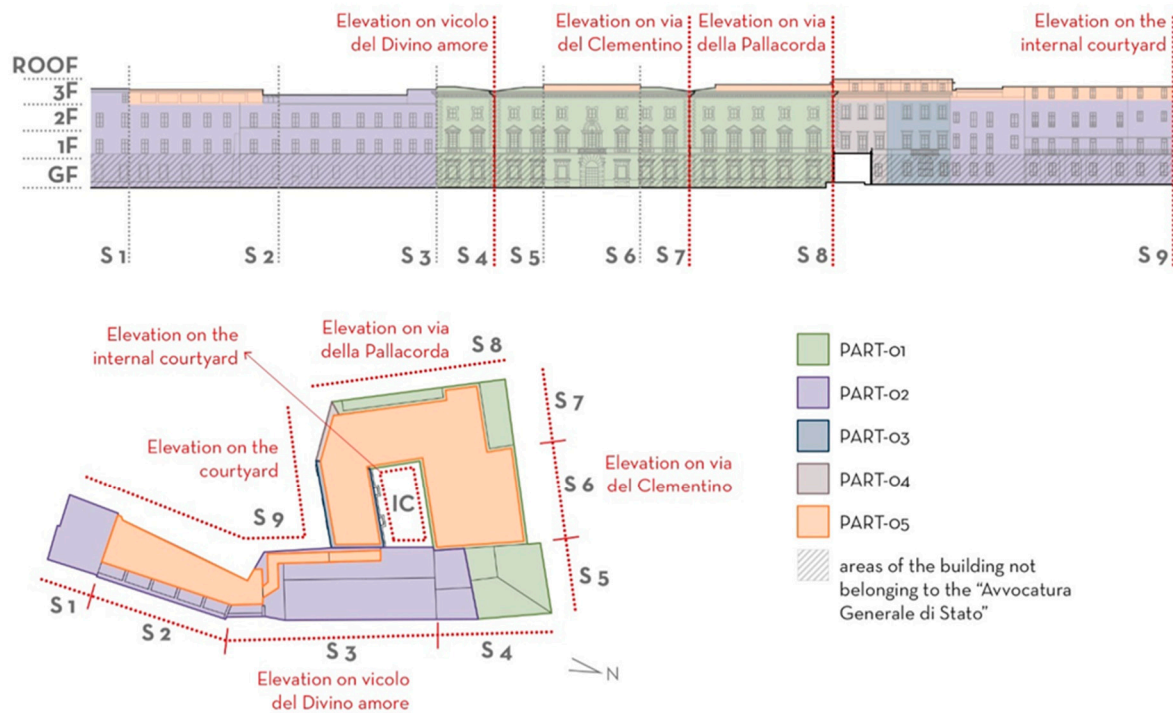
**Figure 4.** Plan and façade of the building, representing the first subdivision into parts and sections (S) resulting from preliminary analyses.

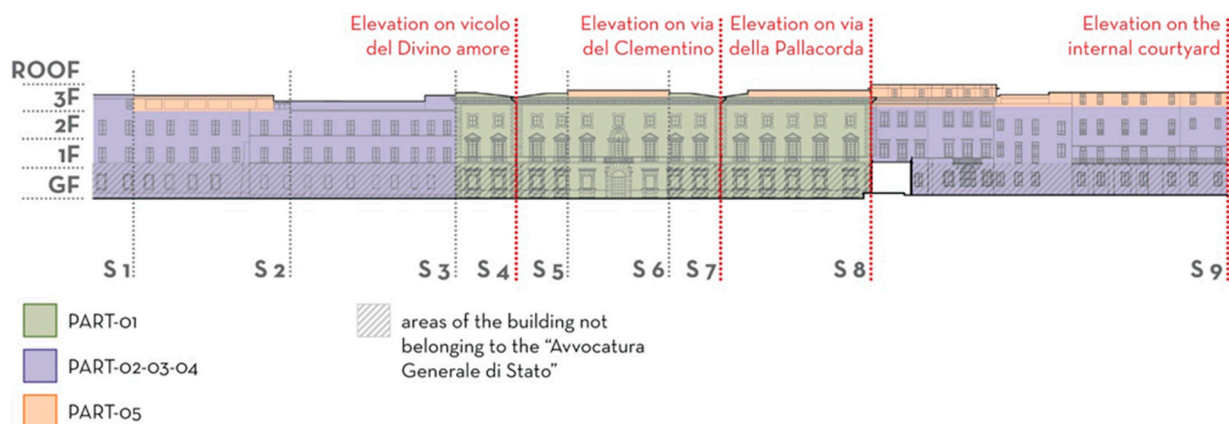
**Figure 5.** Updated hypothesis of subdivision of the building into 3 parts and 9 sections (S).

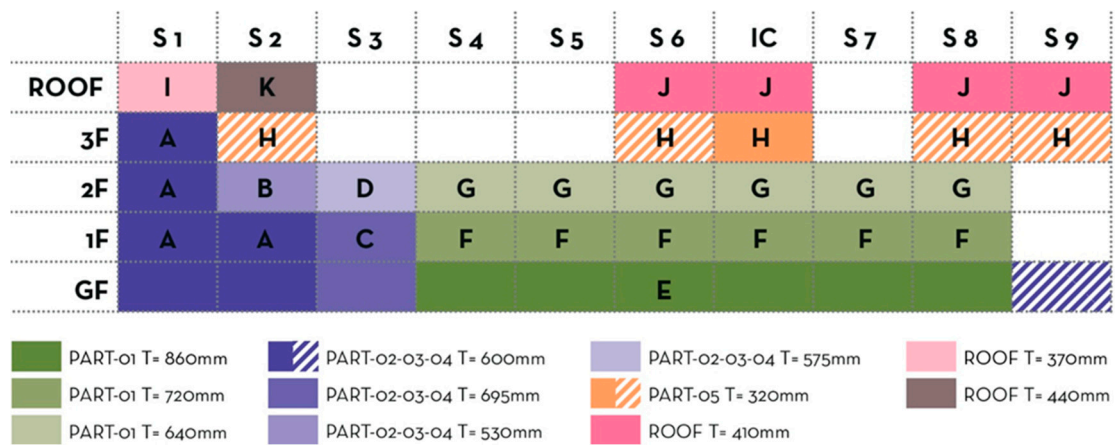
Figure 6. Matrix of the building façades’ subdivision.

Figure 6 shows a matrix depicting the subdivision of the façade, with the columns representing the building sectors and the rows representing the floors and roof of the building. The table summarises the consolidated hypothesis of homogeneous envelope

types according to the IRT field study. Portions (cells) belonging to the same part have the same colour shade; a difference in the lightness of colour indicates a different thickness, attributable to a narrowing of the wall section of the same construction system. The pattern of diagonal lines denotes a construction typology derived from similar wall elements. Each stratigraphy within the parts (identified at this stage of the analysis) is represented by a letter.

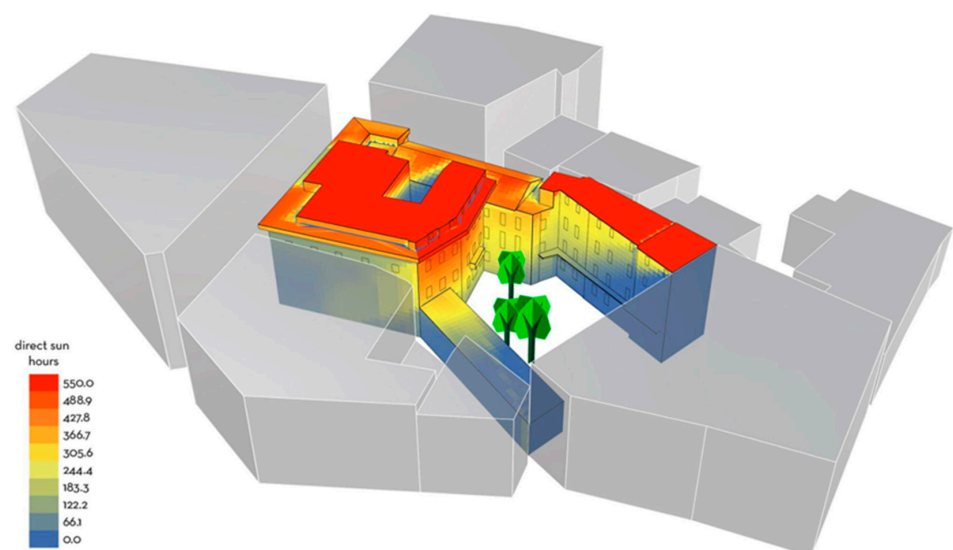
Figure 7. Graphical output of the sunshine duration analysis.

The graphical output of the simulation allowed the selection of the best portion to perform the HFM measurements for each of the nine homogeneous stratigraphies—generally a portion of the façade with two to five rooms under direct sunshine for the shortest time.

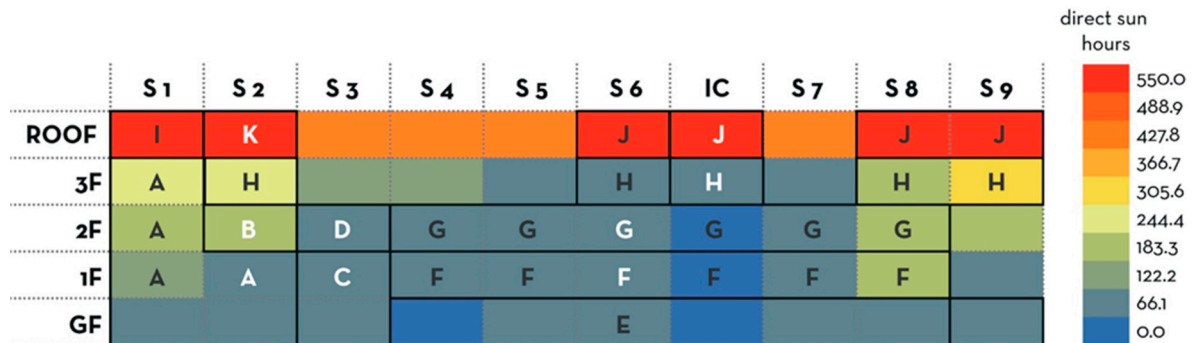
Figure 8. Sunshine hours matrix on the building façades.

Figure 8 shows the matrix with the sunshine hours on the building façades for January and February; the blue-grey areas indicate low irradiation. The letters define homogeneous envelope stratigraphies (see Figure 6), while the white letters indicate the areas selected for HFM analysis.

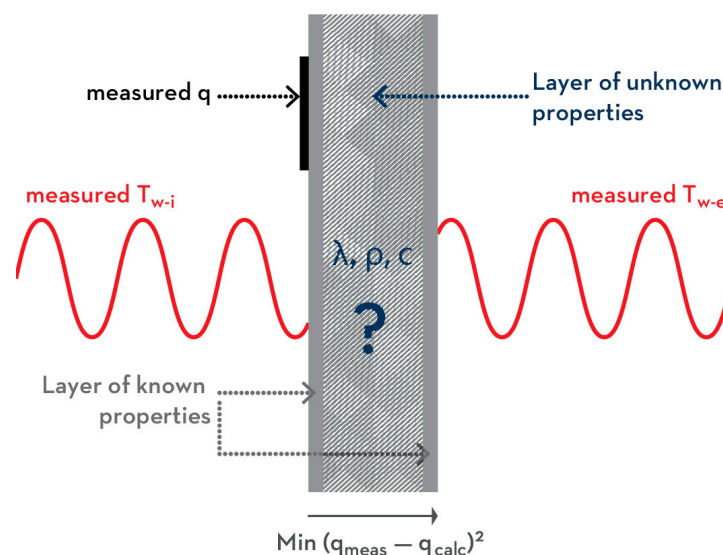
**Figure 9.** Conceptual scheme of the masonry package model.

An inverse method was also used to double-check and validate the measured results, and for the parametric identification of the thermophysical properties of the unknown materials of the layers of the investigated walls (namely, the equivalent thermal conductivity  $\lambda$  and the equivalent heat capacity  $\rho \cdot c_p$ ). This was done by comparing and minimising the difference between the results coming from the HFM data and those resulting from a numerical model of the masonry. Figure 9 shows a conceptual scheme of the masonry package model and a synthesis of the optimization process.

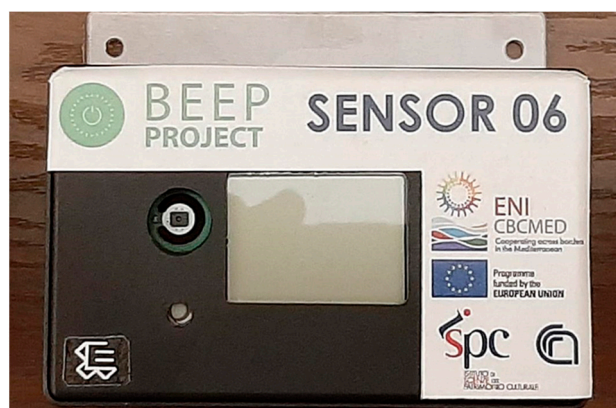
Figure 10. Smart Gadget Datalogger.

The indoor temperature and relative humidity measurements were carried out using the Bluetooth Smart Gadget Datalogger SHT31 (Sensirion AG, Staefa ZH, Switzerland), shown in Figure 10, a battery-powered data acquisition system that is capable of measuring

relative humidity and air temperature, is compact and lightweight, and is intended for indoor use (see Table 3 for the specifications).

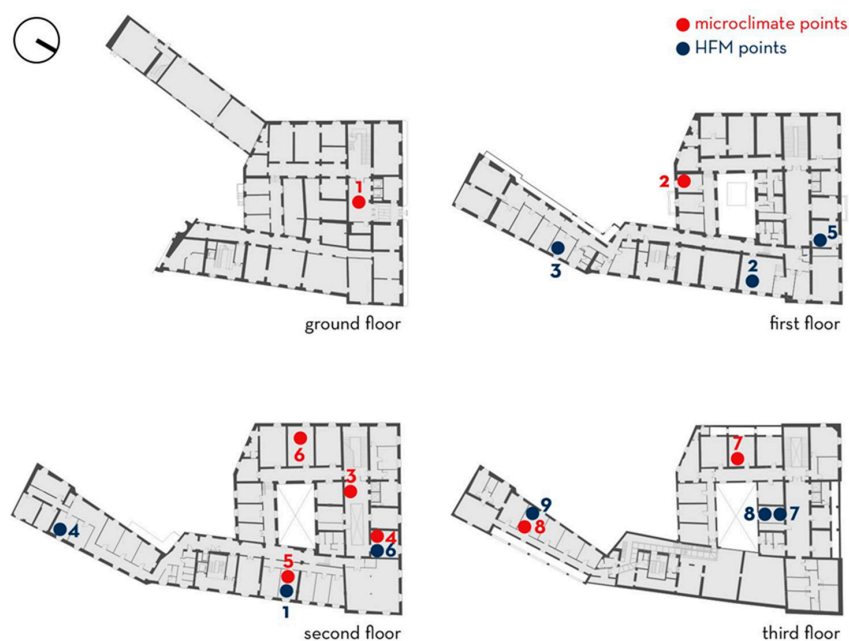
**Figure 11.** Locations and sensors code for indoor microclimate monitoring and HFM analysis divided by floor.

Figure 11 depicts the position of the sensors for HFM and monitoring in the different floors of the building. Figure 12 shows a picture of the sensor installation for HFM measurement in six of the nine rooms under investigation.

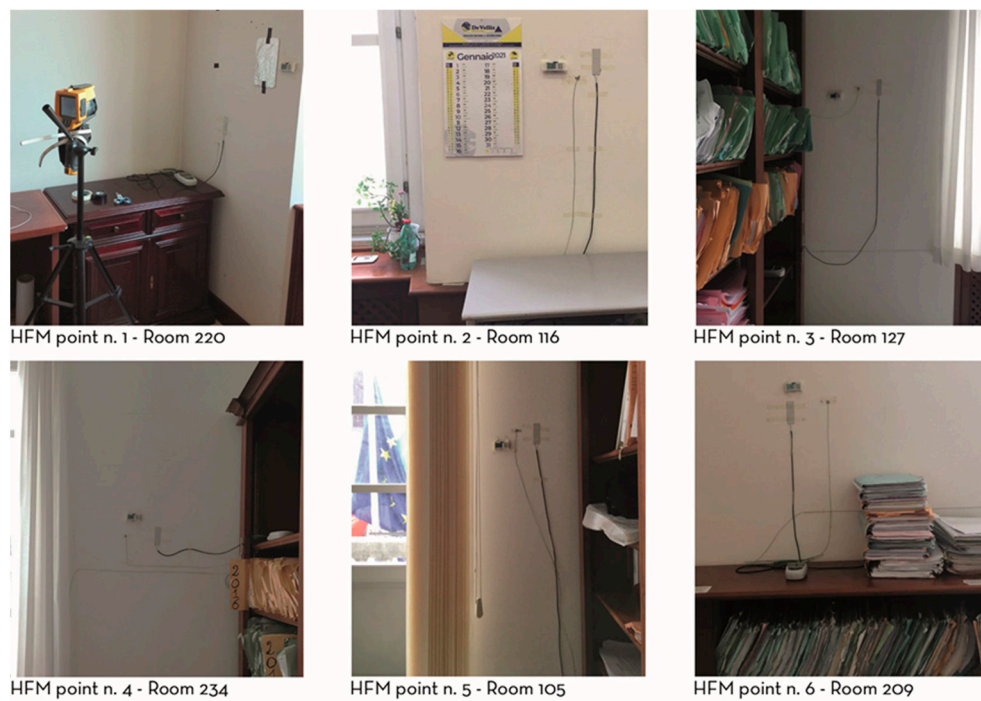
**Figure 12.** Example of installation of sensors for HFM measurements in 6 of the 9 rooms.

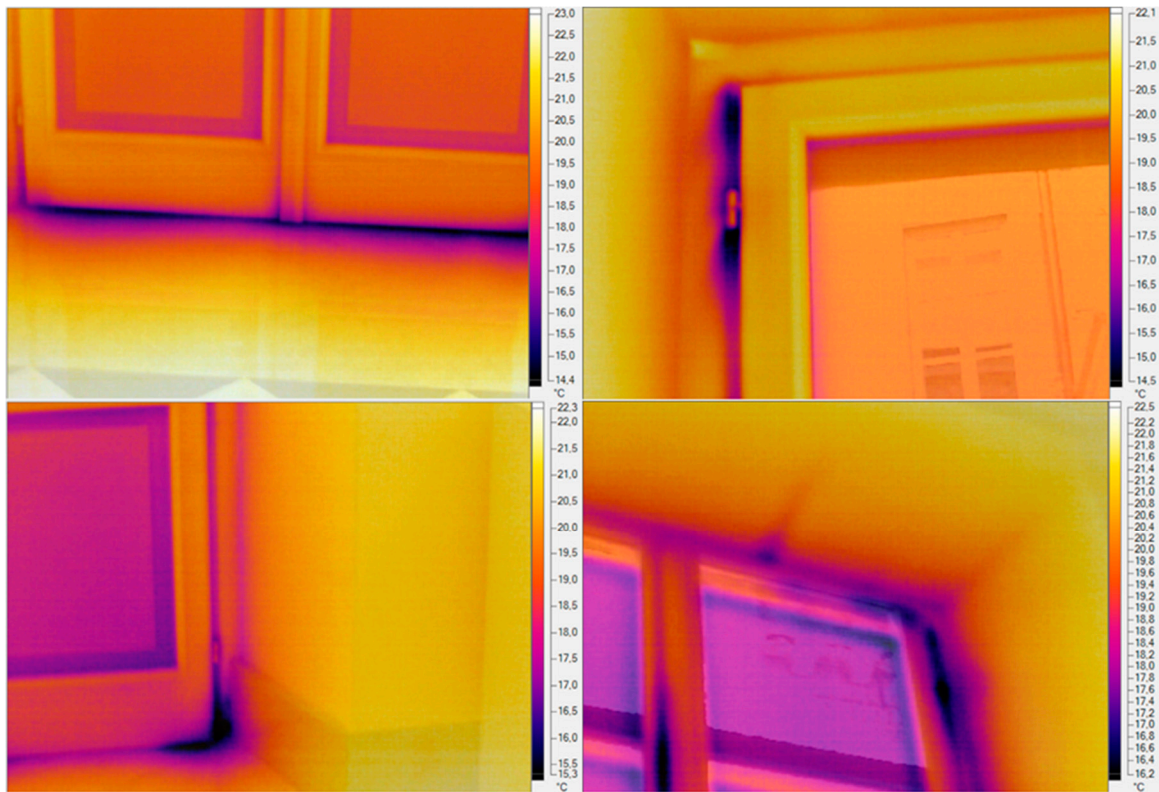
**Figure 13.** Example of installation errors on the windows.

Relative to the inside of the building, the qualitative survey allowed the team to identify window installation errors resulting in air infiltrations, as shown in Figure 13.

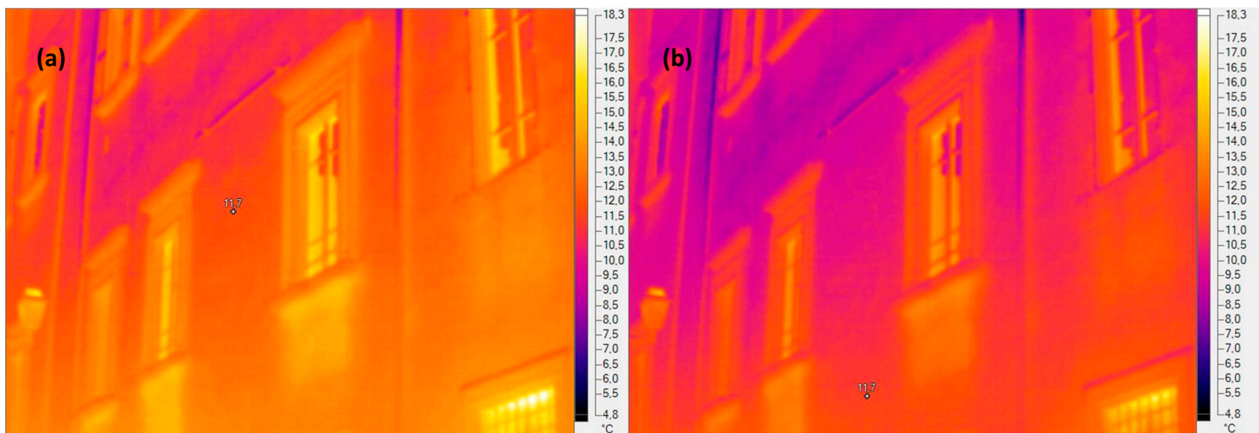
**Figure 14.** Vicolo del Divino Amore, Sector S1-1F/2F—ground floor (part), first floor, second floor (part): (a) temperature of the wall compensated at sky temperature, (b) temperature of the wall compensated at air temperature.

Applying the correct compensation, Figure 14 shows that the upper and lower parts of the wall have the same temperature, which means that the wall can be assumed to be uniform in construction.

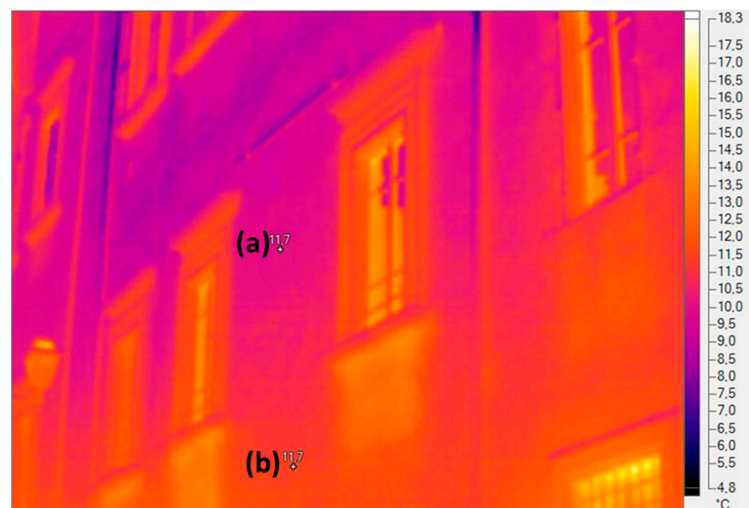
**Figure 15.** Vicolo del Divino Amore, Sector S1-1F/2F—ground floor (part), first floor, second floor (part): (a) background temperature at  $-30\text{ }^{\circ}\text{C}$  (clear sky temperature), (b) background temperature at  $11\text{ }^{\circ}\text{C}$  (air temperature).

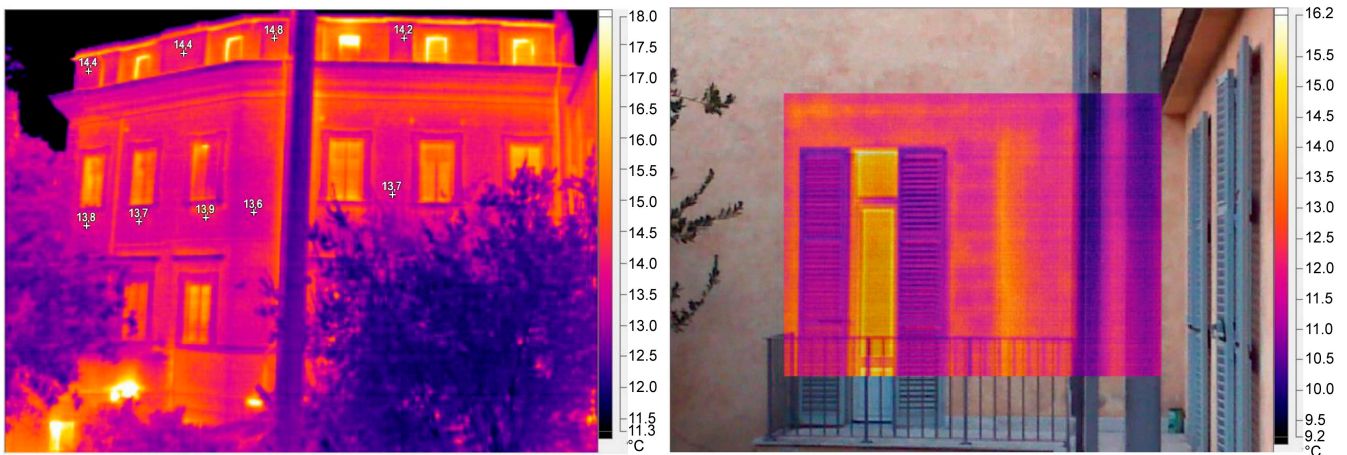
**Figure 16.** Example of thermographies used to analyse and discard the hypothesis of a distinction between Part-02, 03 and 04—Sector S9.

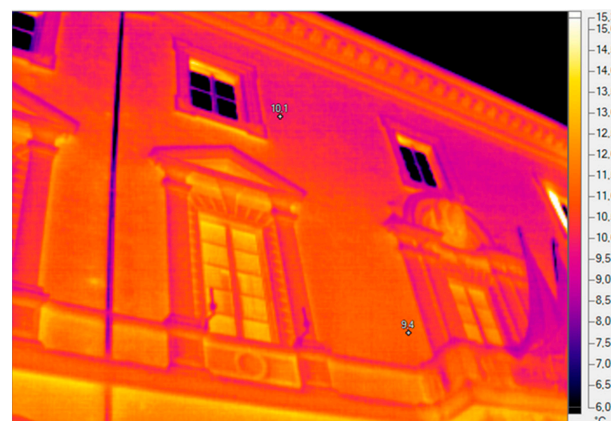
**Figure 17.** Marker at the measuring points of the heat flow meter of rooms 105 ( $T = 9.4$  °C) and 209 ( $T = 10.1$  °C)—Sector S6-2F/3F.

As an example, the differences in temperature, shown by the thermographic image corresponding to rooms 105 and 209, were tested with HFM to investigate if they could be ascribed to a reduction in the thickness of the same construction system or to two different wall construction types (see Table 4). Figure 17 shows the thermography results of points 5 and 6 of Figure 11.

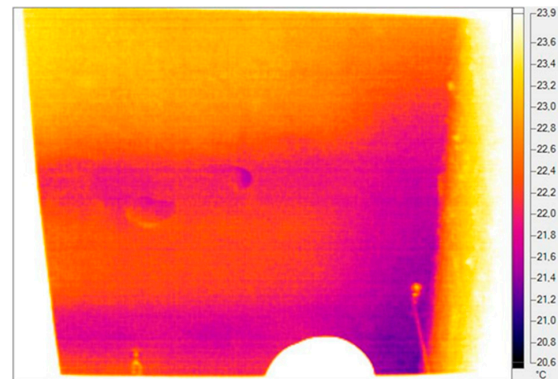
**Figure 18.** Third floor joist cold spots.

Regarding the inside part of the building, no remarkable criticisms were found. It is worth mentioning that the thermography allowed us to check for wall irregularities before deploying each HFM point, identifying, for example, the location of the joists of the roof in room 318 and room 344 in order to place the sensors correctly, as shown in Figure 18.

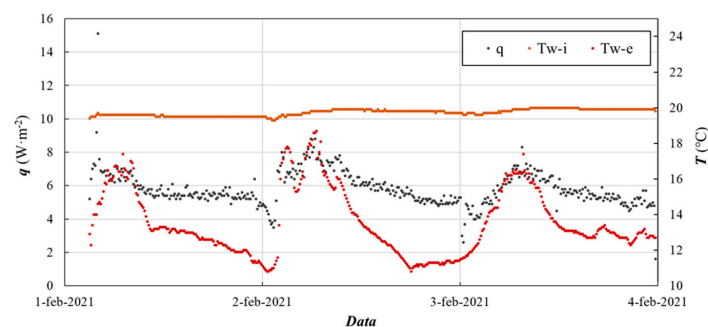
**Figure 19.** Trend of the temperature of the inner surface of the masonry ( $T_{w-i}$ ), the outer surface ( $T_{w-e}$ ) and the heat flow for room 220 (Meas. #1).

As an example, Figure 19 reports the trends of the internal and external wall temperatures, shown together with the heat flow measured in room 220 during the measurement campaign.

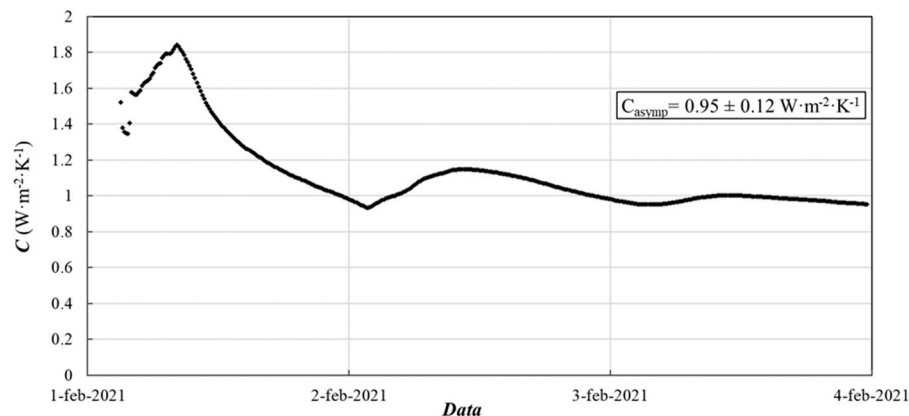
**Figure 20.** Trend of the progressive average of the conductance (C).

The application of the progressive average method resulted in the wall conductance being identified as an asymptotic value, characterised by the progressive average trend shown in Figure 20.

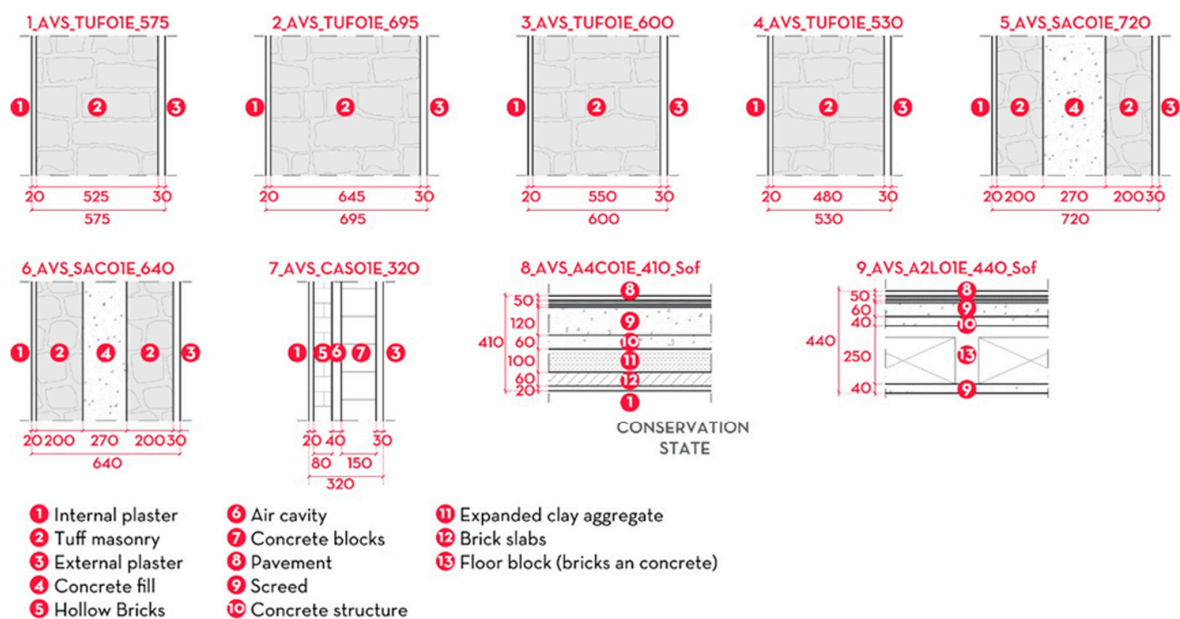
**Figure 21.** Specific technical sections representing the 9 identified wall types.

At the end of the investigation process, integrating the results of all the analyses carried out, the HFM analyses provided further support to the hypothesis of three main construction systems of the building with variable thicknesses (as shown in Figure 21), related to the three main parts identified: Part-01 is mainly load-bearing rubber masonry with a tuff wall layer and plaster on both sides, while Part-02-03-04 is tuff masonry with plaster on both sides, and Part-05 is hollow masonry and relates to recent interventions. Floors are confirmed to be steel beams with segmented hollow brick vaults for the inner floors, and the flat roofs are mostly arranged in an iron beam structure with hollow bricks, with lightened screed in the expanded clay (with few wooden structure exceptions). The HFM measurement number 9 was confirmed by a technical drawing retrieved after the analyses. For sloped roofs, both wooden and steel structure technologies are present.

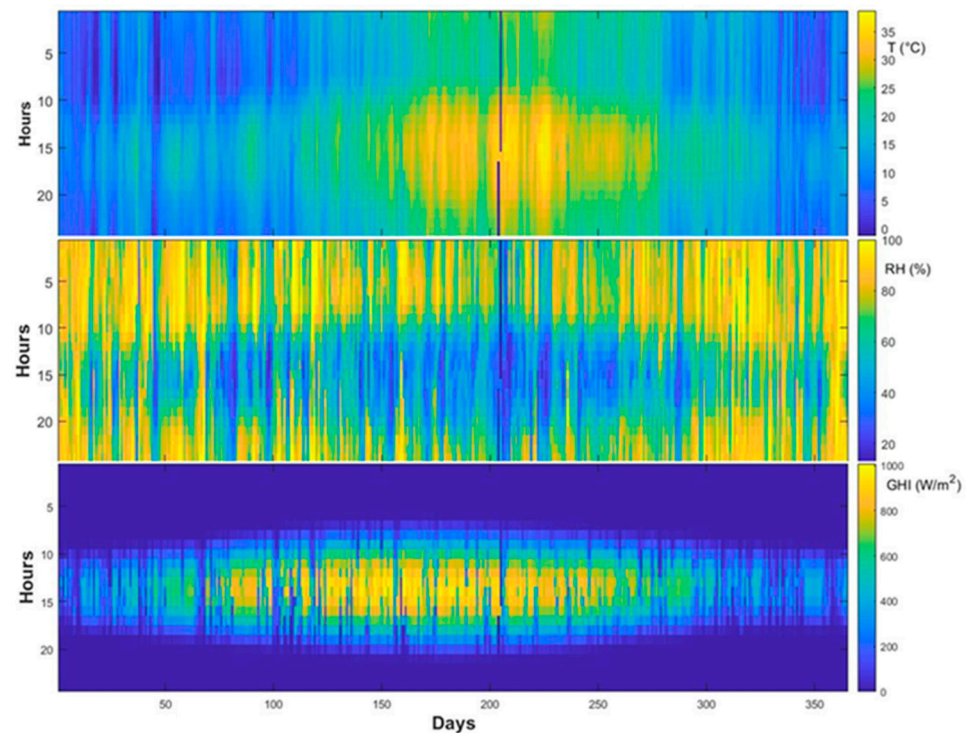
**Figure 22.** Temperature, Relative Humidity and Global Horizontal Irradiance for Tor Vergata area.

The measurement of internal microclimatic variables was integrated with meteorological data provided by the ESTER laboratory of the University of Rome Tor Vergata, which is not far from the site under study. In Figure 22, the carpet plots of the Temperature, Relative Humidity (RH) and Global Horizontal Irradiance (GHI) for the whole period are reported.

From the figure, it can be seen that 2021 was characterised by temperatures that were not too low in winter and mild in spring, while in summer they were quite high both during the day and at night. RH was quite high, especially during the night. Looking at the GHI, we can see that there was an interval of good weather in the central hours of the day for a period between the end of March and the first half of September.

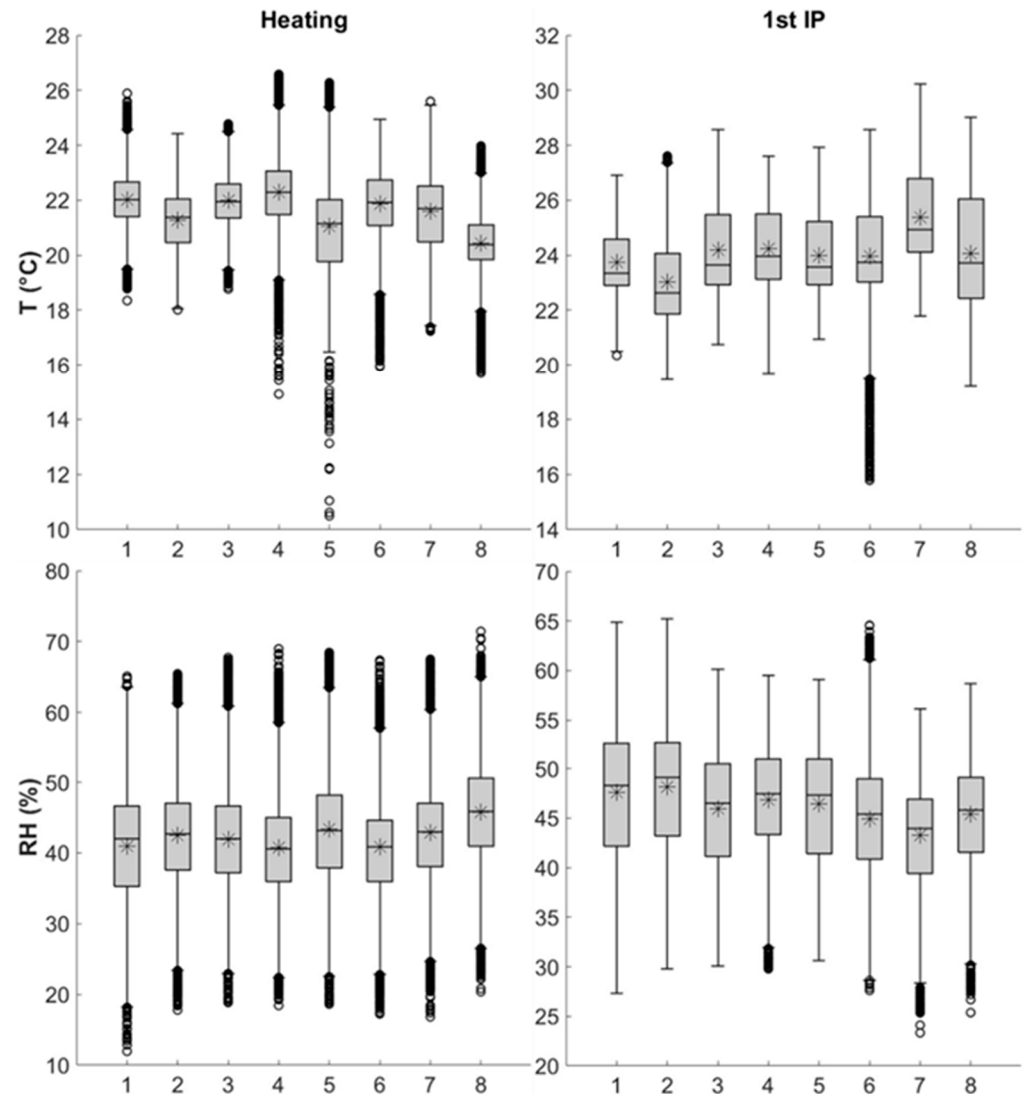
**Figure 23.** Carpet plot of temperature and relative humidity for the 8 rooms and external conditions, \* symbol is the average value while the circles are the outliers.

It can be observed that, during the winter period (heating), the median is in the middle of the box, both for the temperature and the relative humidity, indicating a normal distribution (see also the histograms in Figure 24). For all rooms, there are outliers both at high and low temperature. As far as temperature is concerned, we can notice that room sensors 3, 4, 5, 6 and 8 have many outliers at low temperature, which could be due to frequent window openings in the early morning, as can be observed from the temporal series of the data. Room sensor 1 (office reception), instead, has an almost identical number

of outliers at low and high temperatures, due to the high attendance of the room (opening and closing of the entrance door), the simultaneous presence of a few people, and the presence of one additional split to support the existing system.

The temperature variability (50% of the data contained in the box) is limited between 1 and 1.5 °C for all rooms (including night-time and weekends), except for room sensor 5, in room 105, which is usually unoccupied, with the fan coil usually turned off.

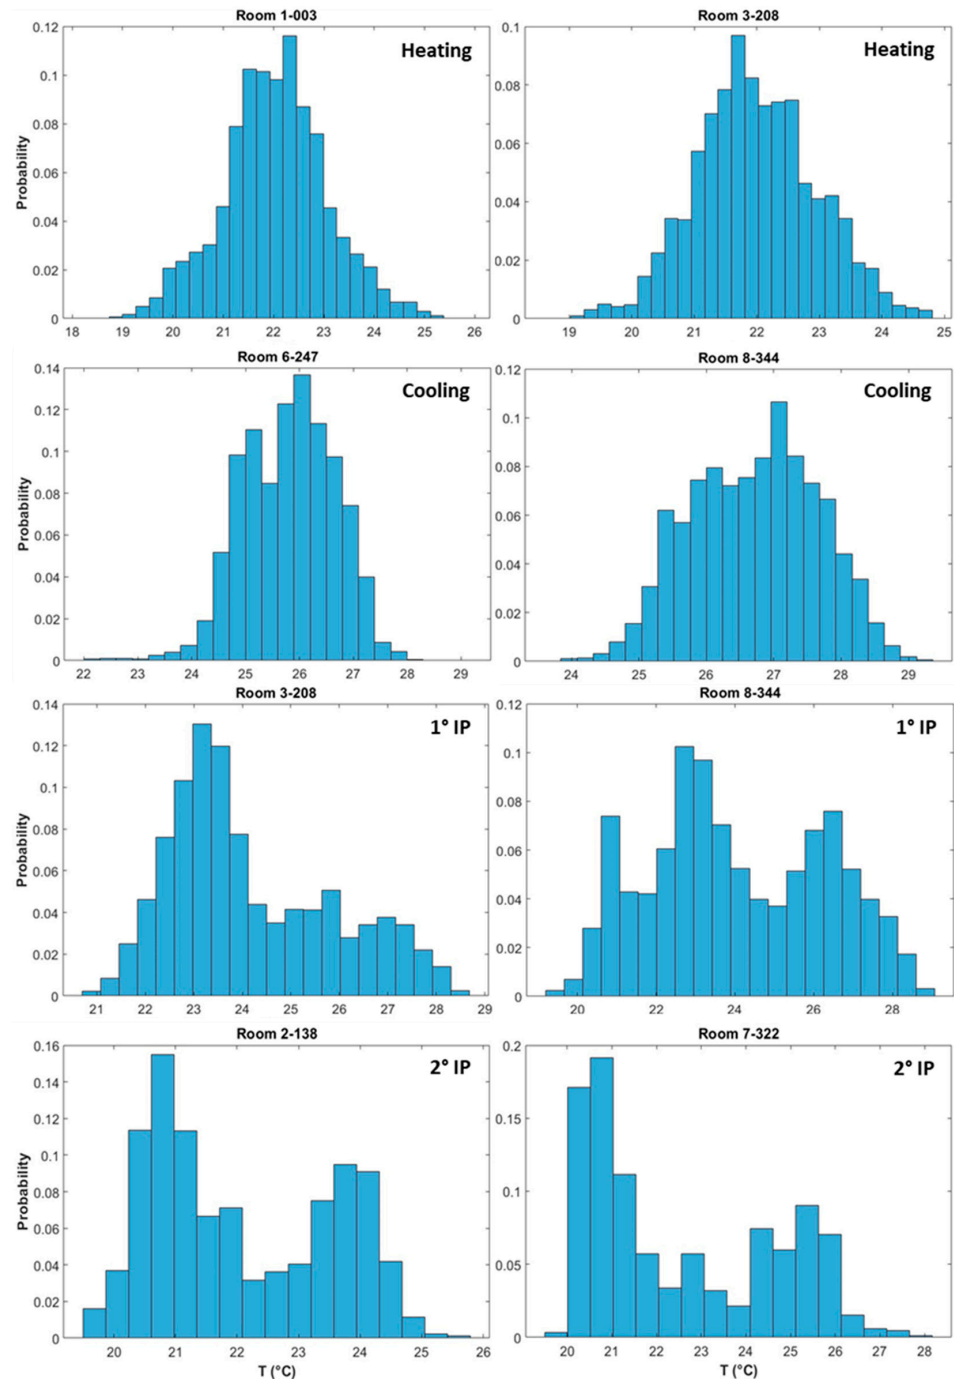
**Figure 24.** Temperature histograms of selected rooms.

We can identify two different trends. For the first IP, the second peak of the bimodal distribution is much lower than the first, or is almost absent; this may mean that the heat gain due to the presence of people or outdoor conditions is negligible, as the windows

are often open. On the contrary, in the second intermediate period, both peaks are clearly distinguishable; in this case, the lower frequency of the opening of windows does not compensate for the heat gain.

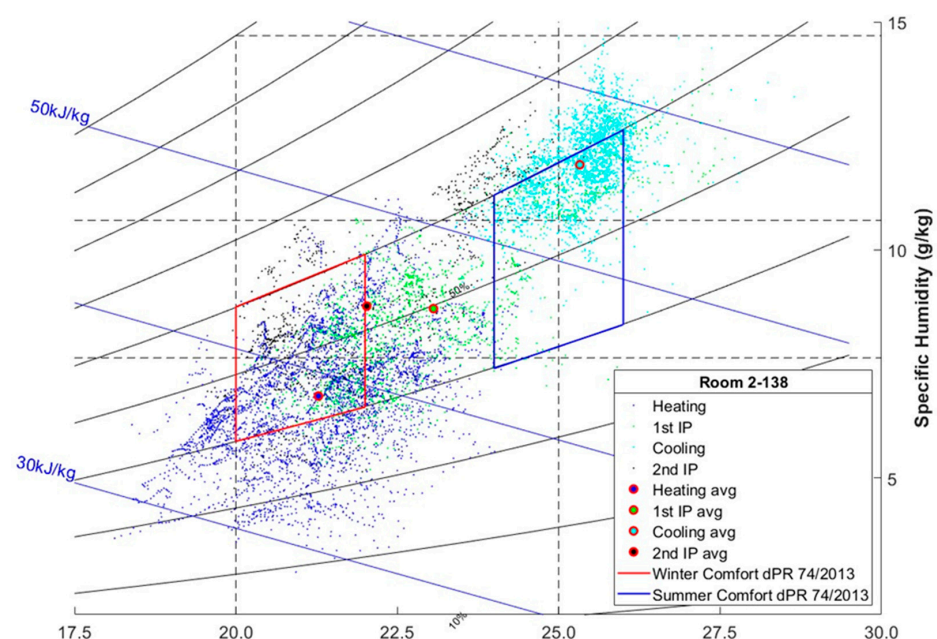
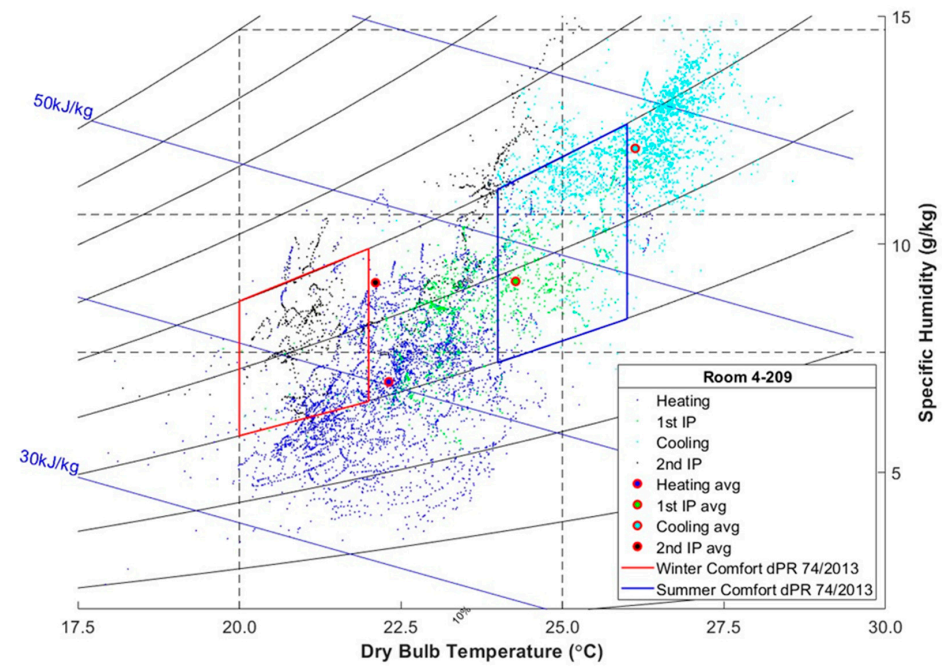
Figure 25. Room 138 and 209 psychrometric chart.

The data (hourly average) of temperature and relative humidity are reported on a psychrometric chart, together with the seasonal average. The comfort zones (according to Italian regulation [130]) are also represented on the psychrometric chart for both the winter period ( $20 \leq T \leq 22$  °C and  $40 \leq RH \leq 60\%$ ) and the summer period ( $24 \leq T \leq 26$  °C and  $40 \leq RH \leq 60\%$ ).

Room 138's seasonal average is in the comfort zone, but is much shifted towards the lower limit in winter and the higher end in summer, indicating the presence of many points of discomfort. For all the other rooms, such as room 209 in Figure 25, it can be noted that in summer (Cooling) and winter (Heating), they are hardly ever in comfort conditions; this is better highlighted by the seasonal average, which falls outside the comfort limits. Finally, it should be noted that, for the heating period, the data appear highly dispersed, denoting a high variability in the microclimate, while in the cooling period, the data appear more concentrated with less variability. This is mainly due to the absence of relative humidity controls in the thermal system.

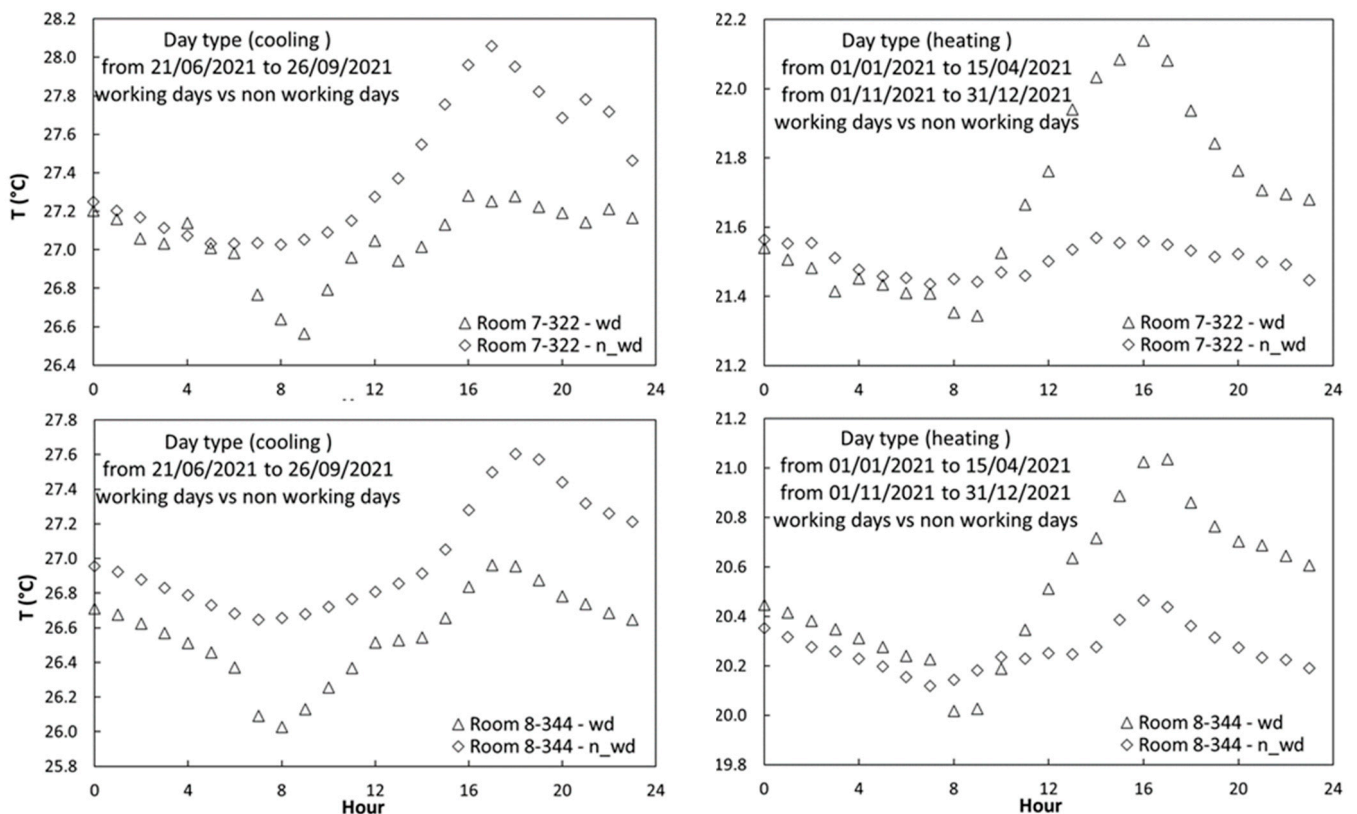
Figure 26. Day type of rooms 322 and 344.

Comparing WD with NWD (when the thermal plant should be off for at least 36 h), both for the HDT and the CDT, between midnight and 8:00 am, we can notice the same temperature trend. From the data described above, and especially from the construction techniques used for rooms 322 and 344 (light hollow-brick masonry) and exposure (third floor, with three out of six sides exposed to the outside environment), we can conclude that thermal inertia cannot be solely responsible for such a small temperature difference between WD and NWD. So, we can deduce that the system (which, due to a series of unrepaired breakdowns, is currently serviced by an underpowered generator) is in operation 24 h a day, as also confirmed by energy bills and subsequent simulative analyses.

Under this assumption, considering the WD of the HDT, we can notice the contribution of the presence of employees to the heating of the room, which results in a temperature peak around 4:00–5:00 p.m. due to heat accumulation.
