Towards IoT monitoring of street-side monuments: the Florentine *Dietrofront* as a case study

Fabio Tarani, Rachele Manganelli del F and Cristiano Riminesi

CNR-ISPC (National Research Council, Institute of Heritage Science)
via Madonna del Piano 10, I-50019 Sesto Fiorentino, Italy

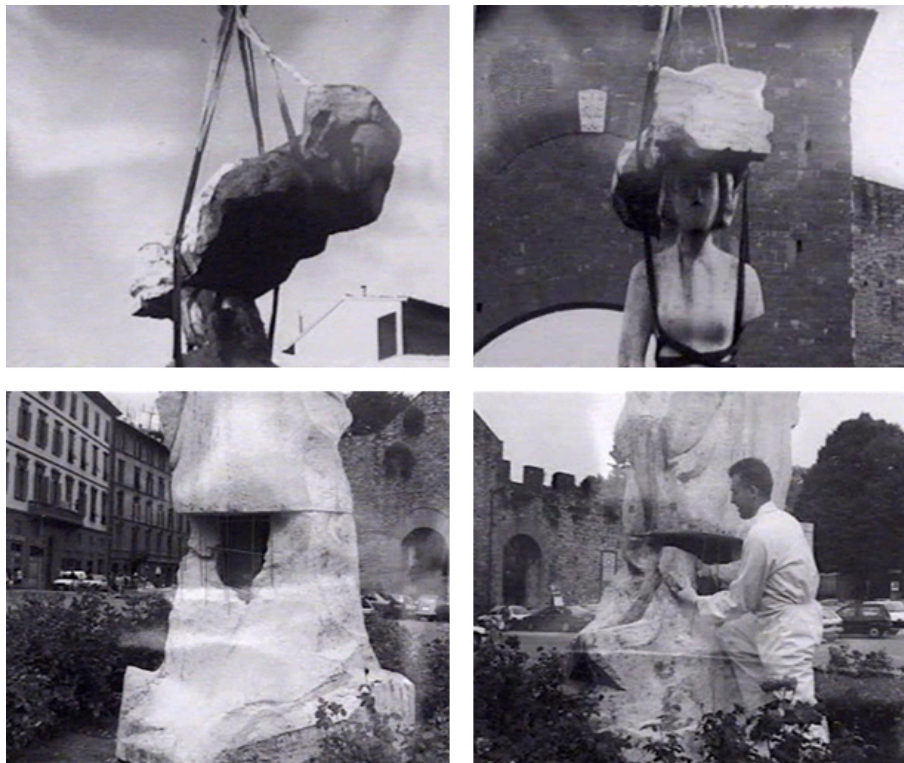
Figure 3. Phases of the 2000 major restoration

treated with biocide and damaged structural links were reinforced with stainless steel pivots and epoxy resin (Figure 3).

The local data infrastructure needs to be operated within a few hundred metres from the sensors to ensure proper coverage. Thanks to the collaboration of the city administration, an indoor space has been found inside the mediaeval city gate standing next to the roundabout (visible in Figure 3). Again, the lack of power grid connection has led to the design of a micro-PV
