Non-destructive diagnosis at the Brancacci Chapel, Church of Santa Maria del Carmine (Florence)

Abstract – The Basilica of Santa Maria del Carmine in Florence, in the Oltrarno area, was built in 1268 (pre-Renaissance low medieval context), consecrated in 1422. Due to a devastating fire in 1771 of the interior of the original church, very little remained, between the parts that managed to save including the Corsini and Brancacci chapels. The architect Giuseppe Ruggeri was responsible for the reconstruction of the church, which was completed in 1782 (with the exception of the gabled façade which remained unfinished, as it can still be seen today (in fact it has bricks and exposed stone elements). Geophysical investigations were undertaken into the Brancacci chapel in order to have information on the wall structure that contains the wall paintings by Masaccio, Masolino and Filippino Lippi, to understand the stratigraphy of the mortars and formulate some hypotheses on the causes of their detachment.. The results are interesting.

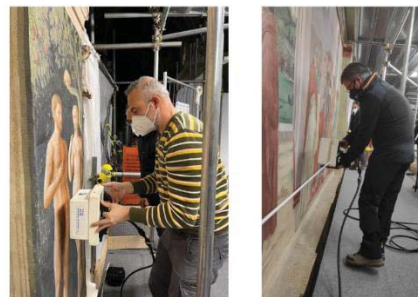
Fig. 3. The GPR data acquisition

The GPR system is generally composed of a control unit, a transmitting and receiving antenna, and a computer. The central unit produces short electromagnetic pulses (from about 1 to 60 ns) [1] that are radiated to the ground through the transmitting antenna and then recorded back to the receiving antenna. The data acquisition was performed using the impulse GPR system Ris Hi-mod (IDS) equipped with a monostatic shielded antenna of 900 MHz and 2000 MHz nominal frequency. The choice of these frequencies is related to the fact that it is known that smaller objects can be detected by higher frequency signals whereas big objects require low frequencies. Moreover, the higher the frequency of the antenna used, the higher the vertical resolution and the lower the investigation depth. The choice allows obtaining a good compromise between resolution and depth of investigation. In order to protect the frescoes from any damage that might be caused when passing the antenna (Fig. 3), GPR data were acquired keeping the antenna about 1cm away from the wall. An orthogonal grid with 0.1 m spacing was designed, acquiring scans in both X (horizontal) and Y (vertical) directions. Close parallel profiles allowed the assembling of a 3D GPR volume, which was then sliced into GPR time slices and GPR iso amplitude surface.

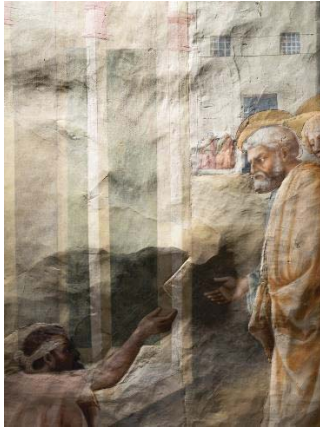
Fig. 5. Raking light image of the scene of the Miracle

dimensional reflection profiles (standard radar sections). A way to obtain visually useful maps for understanding the plan distribution of reflection amplitudes within specific time intervals is the creation of horizontal time slices. The area related to these reflections is located where the painting surface present a huge deformation respect of its vertical profile. Fig. 5 highlights the deformation of the masonry that correspond with the detected anomalies.
