A System of Monitoring and Warning in a Complex Landslide in Northeastern Italy

M. G. ANGELI, P. GASPARETTO
R. M. MENOTTI, A. PASUTO, S. SILVANO

A Huge Slope Movement at Séchilienne, Isère, France

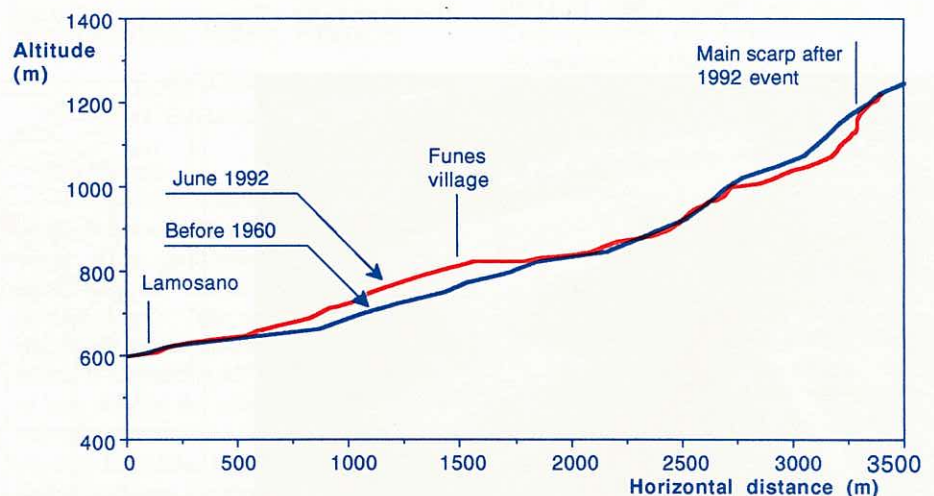
Fig. 2 Surface profiles along the Tessina Stream showing pre- and post-failure.

These events caused the filling of the Tessina valley with thicknesses of material ranging from 30 to 50 m, seriously endangering the village of Funés, which is situated on a steep ridge originally quite high above the river bed, but now nearly on a level with the mud flow (Fig. 2).

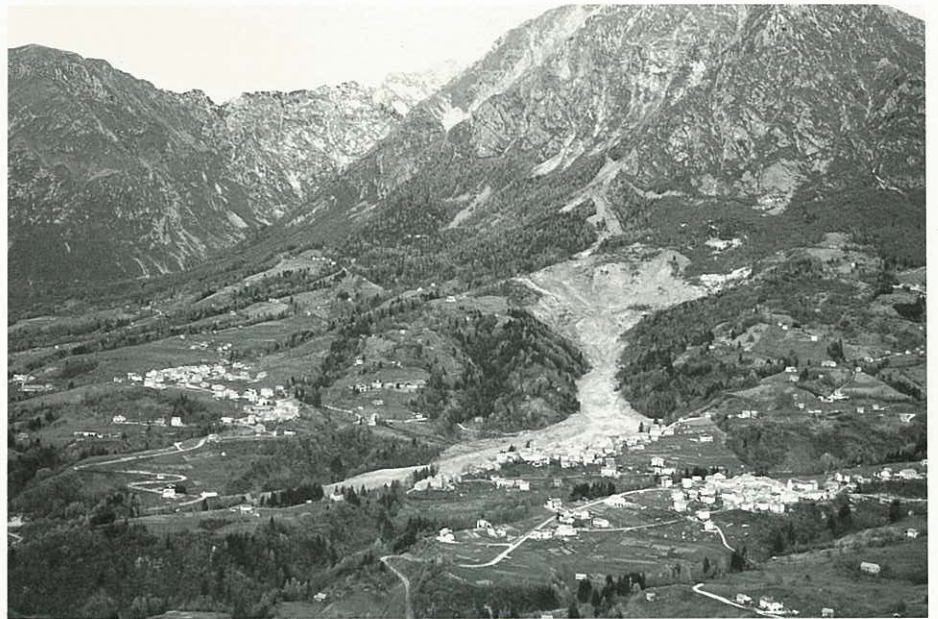
Fig.3 Aerial view of the Mt. Teverone and the Tessina Landslide.

In April 1992, a period of quite heavy rainfall (160 mm in 15 days), followed the annual snow-melt period. Under these circumstances, on 17 April 1992 an area of about 40,000 m², collapsed on the left-hand slope of the Tessina Stream, involving a volume of approximately 1 million m³ of material (Figs. 3 and 4). During the months before, signs of intense fracturing (which became worse just a few days before the main event) appeared in this sector.

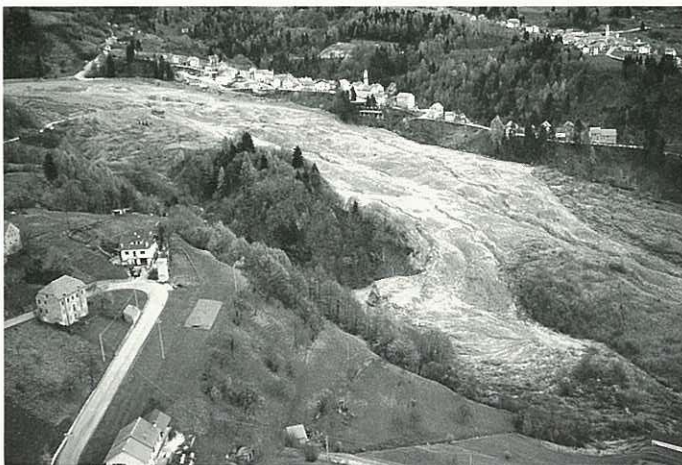
Fig. 4 Aerial view of the mud flow in the proximity of the village of Funes.
