# A present risk from past activities: sinkhole occurrence above underground quarries

**Abstract** Sinkholes are extremely common in Apulia, a low-relief carbonate region of southern Italy that is highly predisposed to this hazard due to the widespread presence of soluble rocks. In addition to the natural setting favoring their development, sinkholes may also be induced by anthropogenic activities and in particular by extensive systems of underground quarries. Many types of rocks have been historically quarried in Apulia, from the Cretaceous limestones to the Quaternary calcarenites, and used in different epochs as building and ornamental materials. In several areas, the rocks with the best petrographic characters are located at depths ranging from a few to some tens of meters. This, combined with the need to save pieces of land for agriculture, caused opening of many quarries underground and development of complex networks of subterranean galleries, especially at the turn between the nineteenth and twentieth centuries. Later on, many quarries were progressively abandoned, partly because of appearance of the first signs of instability, both underground and at the ground surface. W

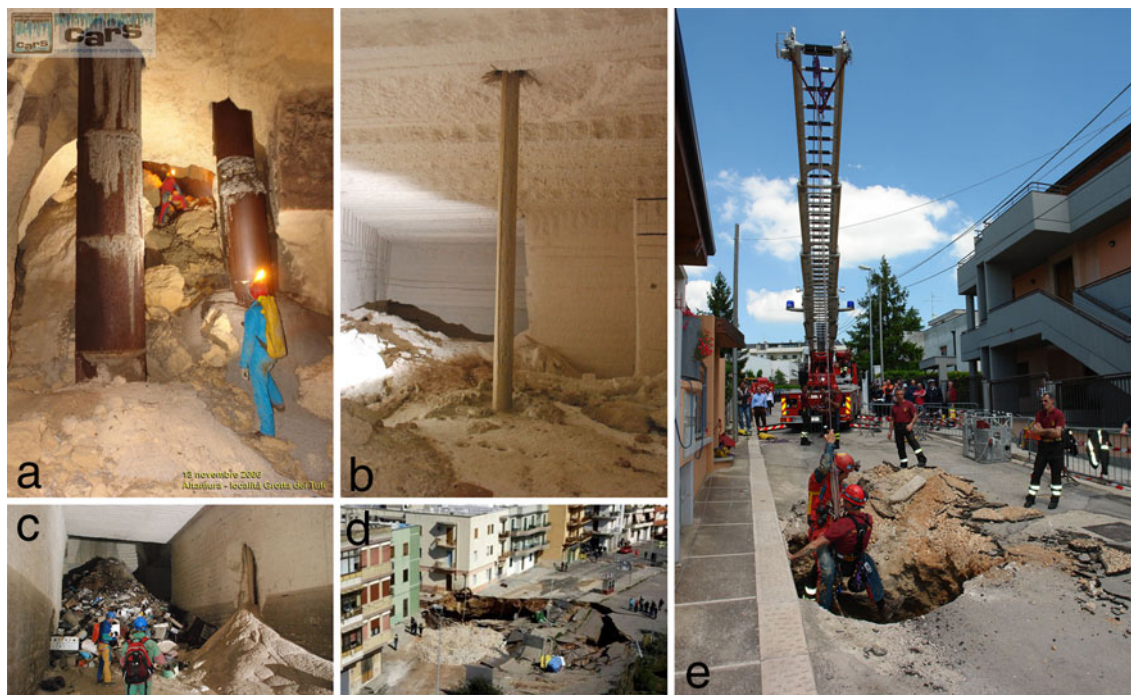
**Fig. 3** Infrastructure at risk because of the occurrence of sinkholes related to underground quarries: **a** and **b** foundation piles within underground quarry at Altamura (photo courtesy of CARS) and Cutrofiano; **c** solid wastes in underground quarry at Cutrofiano;

**d** buildings threatened by the sinkhole at Gallipoli (case no. 27 in Table 1); **e** covers entering the sinkhole near buildings of recent construction at Altamura (photo courtesy of CARS)

Gallipoli is not the only case in Apulia. The town of Altamura, in the central part of the region, is presently expanding the urban area in a sector located north-east of the historical part of town. There, several houses were built since the 1990s, but it was only on March 2006 (case no. 21 in Table 1) when a sinkhole opened in Via Barcellona (Fig. 2a) that the presence of a wide network of underground quarries below the area came to light. This was the first event that made the presence of a wide system of underground quarries in the calcarenite, below the clays cropping out at the surface, clear. The quarries soon appeared to be very irregular, with regard both to height and development of the areas of extraction. This made it even more complex to gain a detailed knowledge of the subterranean environment below the newly built area and required the direct involvement of cavers who carried out long and difficult explorations, coming out with topographic surveys of a network consisting of several kilometers of underground passages. These surveys have become the first step on which to build a GIS to collect and manage all the data about the underground environment at Altamura. Based upon this newly acquired knowledge, the underground quarries are being filled by grouting in order to allow new construction in the area. However, it has to be noted that in many cases, the presence of the quarry had to be known (even not “officially”) by geologists and engineers, as demonstrated by the foundation piles of several buildings observed within the quarry (Fig. 3).

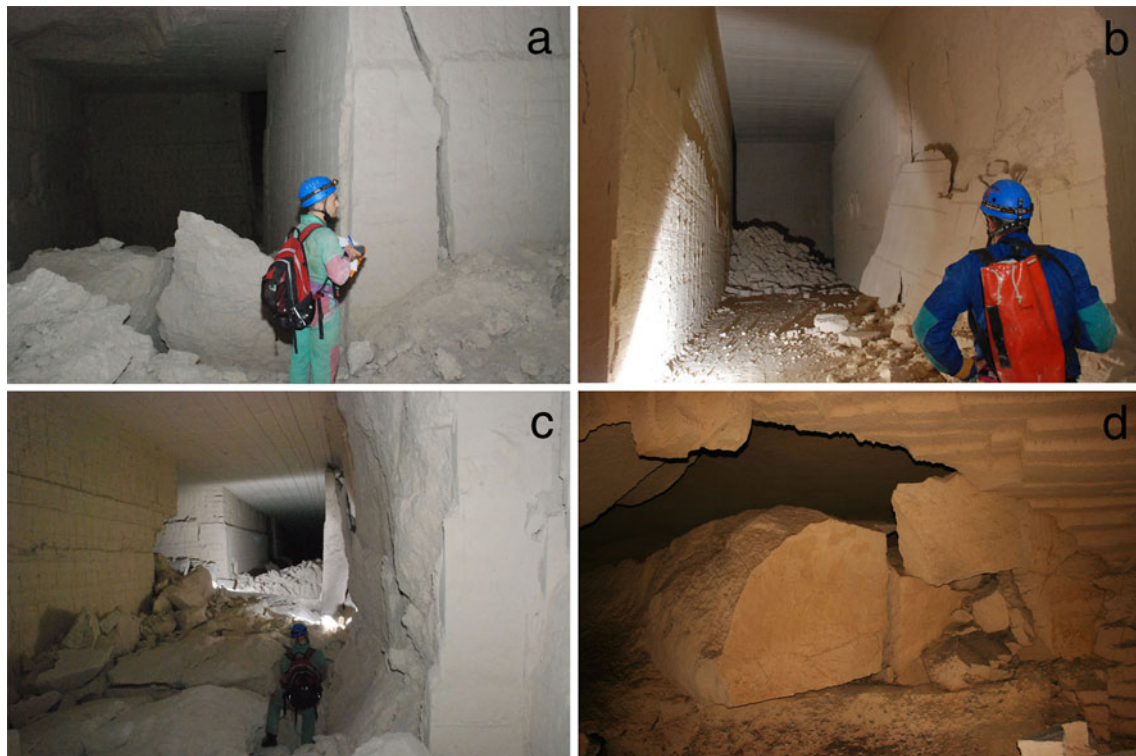
**Fig. 4** Failures in underground quarries, potentially leading to upward stoping of instability and development of a sinkhole at the ground surface. **a** Open cracks in the pillars and falls from the vault

(Cutrofiano); **b** wall deformations and failures (Cutrofiano); **c** diffuse failures from the walls (Cutrofiano); **d** large failures affecting the entire wall (Gallipoli)

phenomena (Fig. 4). In addition to those already occurred, as detachment from the vault or slab failures coming out of the walls, also several incipient signs of instability have been identified: bulging in the walls, wedge failures, deformations and opening of cracks. These are generally premonitory signs of instability, as observed in many sites worldwide, and can be used to understand the mechanical behavior of the rock mass and the degradation processes occurring within the caves (Szwedzicki 2001; Parise and Lollino 2011).

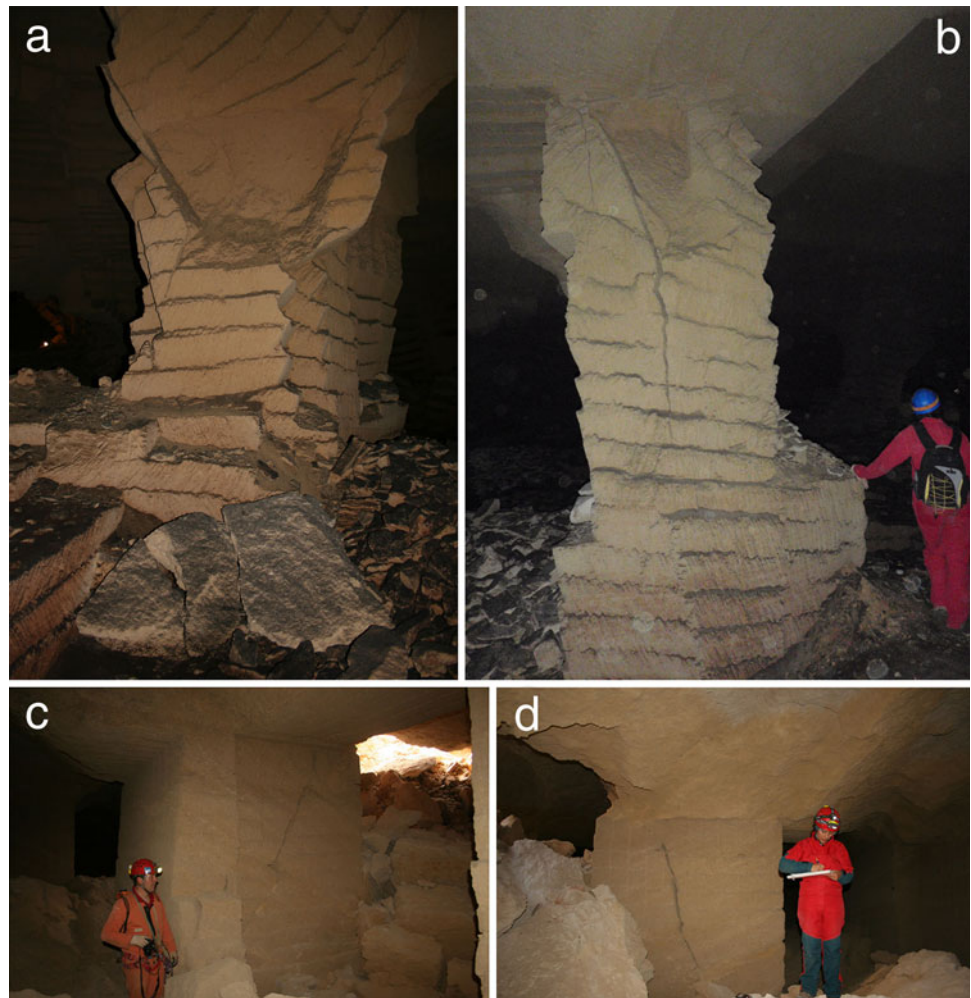
**Fig. 6** Examples of pillars with open cracks and deformations in underground quarries of Apulia: **a, b** detachment (**a**) and open cracks (**b**) in pillars at Gallipoli; **c, d** open and crossed cracks in pillars at Barletta

allowed discriminating the instability into falls from the vault and from the walls; further, the pillars were carefully analyzed, to evaluate their stability (Fig. 6). The structural survey resulted in showing the high degree of hazard present in the whole underground quarry, pointing out to the likely possibility of further collapses in the area.
