Geostructure of Coroglio tuff cliff, Naples (Italy) derived from terrestrial laser scanner data

We present a long-range terrestrial laser scanner application for the geostructural mapping of Coroglio cliff, a tuff rock face exposed along the coastal zone of Campi Flegrei, Napoli. The procedure includes several phases (geomorphological analysis, structural field survey, laser scanner data acquisition and data processing, 3-D model development and analysis, geostructural classification of discontinuity orientation data and 2-D vertical cartographic production). Field data were processed with specific software dedicated to geostructural and geometric analysis. Spatial data were managed with a geographical information system and have been used for the construction of 2-D and 3-D geometric models of the rock cliff surface and geostructural interpretation. The main product of this study is a vertical geostructural map of the Coroglio cliff at 1:500 scale that illustrates the spatial distribution and orientation of the major families of structural discontinuities detected along the exposed surface of the cliff. The cartographic product includes base information useful to identify the mai

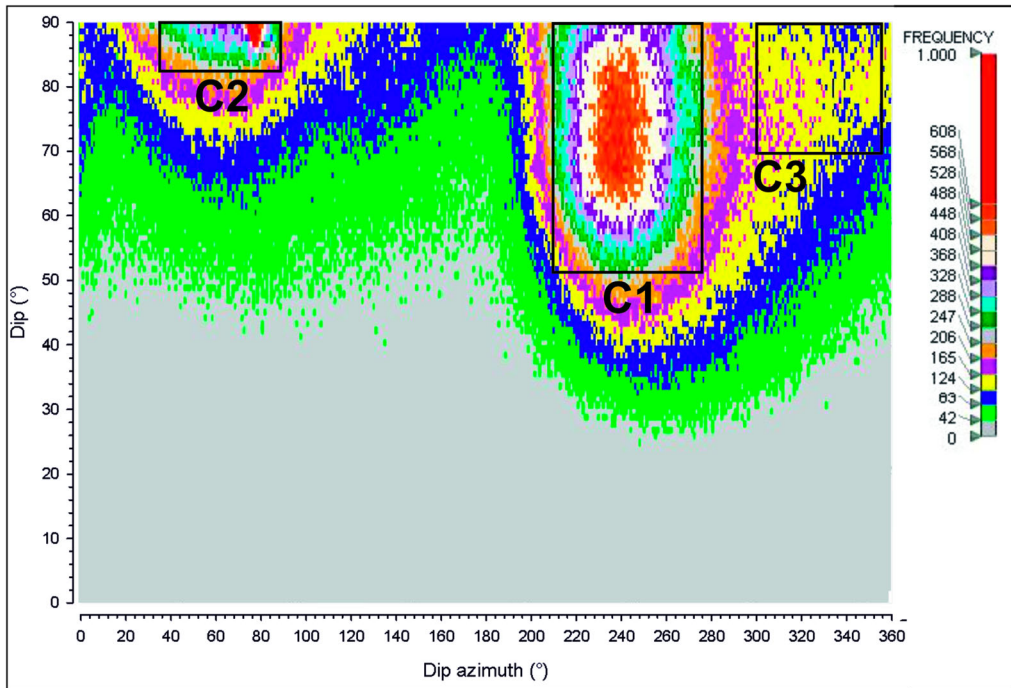
Figure 5. Data concentration plot of mesh orientation data with identified clusters.

The identification of the orientation clusters of mesh polygons was carried out through a concentration analysis of joint distribution frequency of dip and dip direction variables, performed on data of all the polygons (ca. 2.95 millions) forming the triangular mesh of the 3-D model. Statistical analysis shows a non-uniform, mainly bimodal, data distribution ([Figure 5](#)) and identifies three clusters of facet orientation in the 3-D mesh, namely C1 (dip direction 210–275°; dip 55–90°), C2 (dip direction 40–90°; dip 80–90°) and C3 (dip direction 300–355°; dip 70–90°).

The two main clusters C1 and C2 represent discontinuity sets mostly subparallel or slightly oblique to the average orientation of the cliff (85/248°). Cluster C3 includes nearly vertical structural sets that are sub-orthogonal to oblique to the cliff face. Due to its orientation, which implies limited morphologic expression on the rock face, this cluster displays relatively poor statistical relevance in the 3-D model mesh derived from TLS data. However, cluster C3, and its conjugate discontinuities, have been recognized by our structural fieldwork ([Figure 4](#)) and had been already detected by previous structural mapping of the area ([Froldi, 2000](#)).

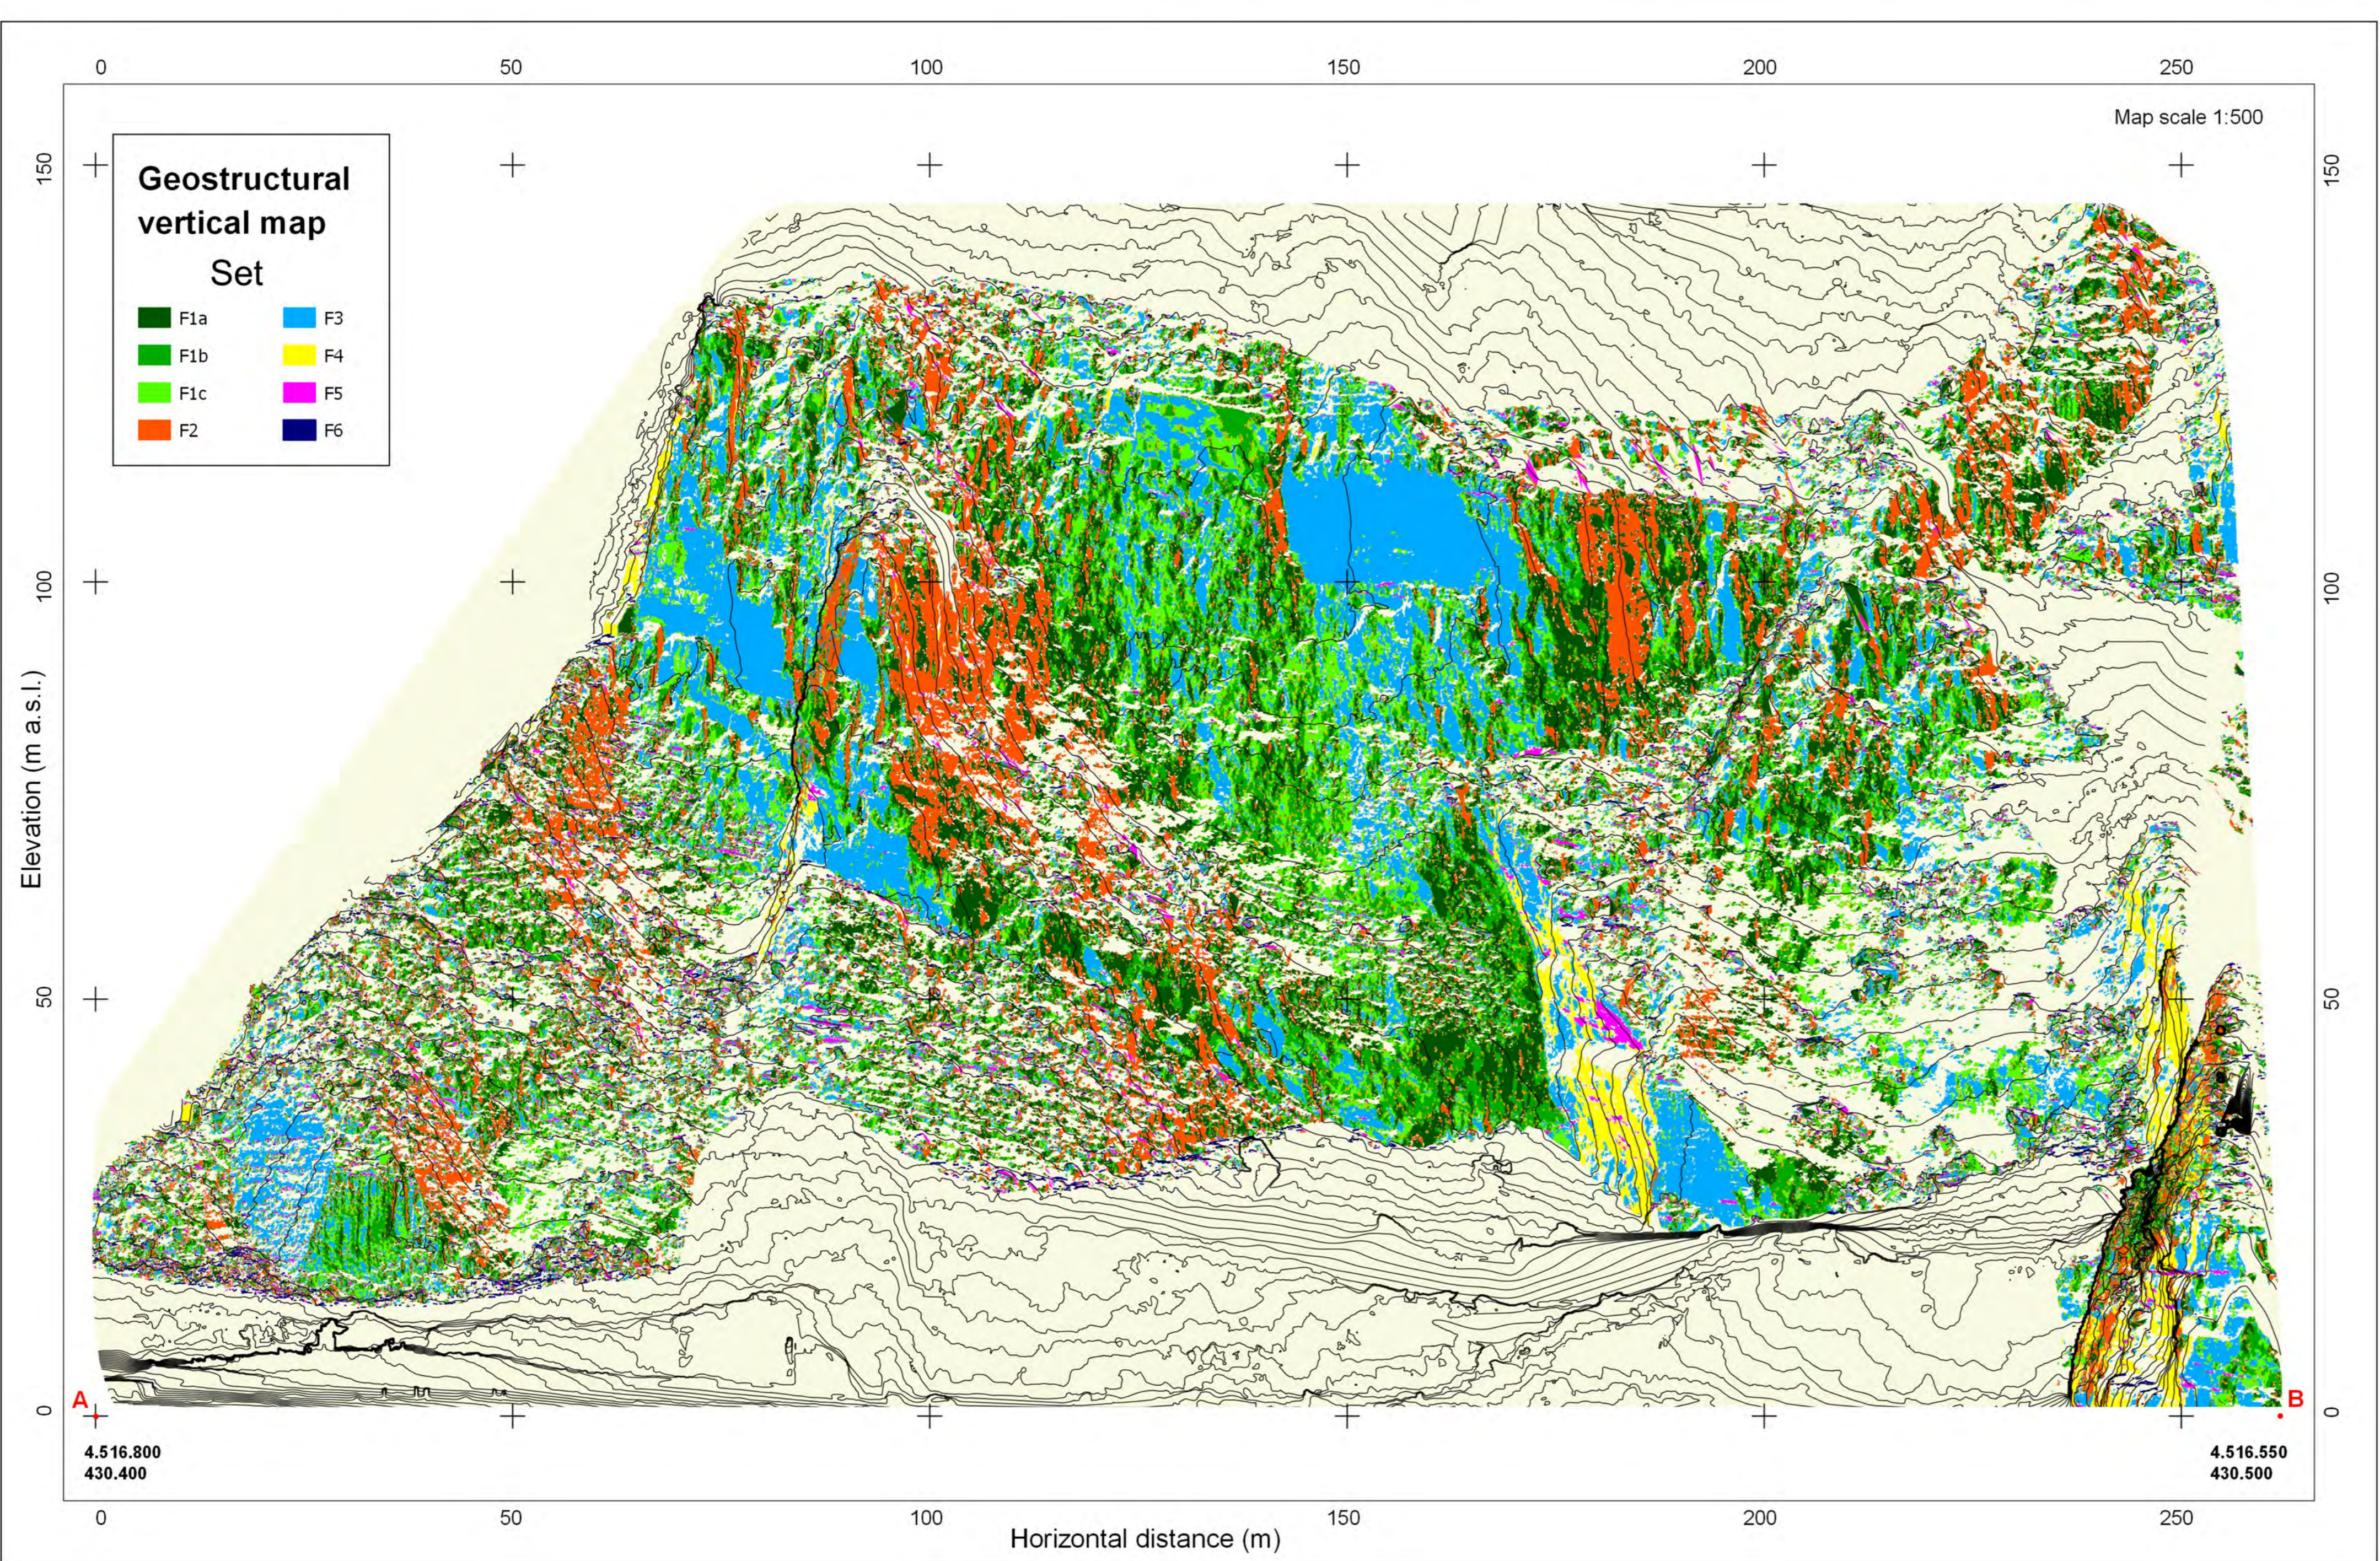
The main result is a geostructural vertical map of the cliff at 1:500 scale (central figure in the map) reporting the spatial distribution and the orientation of six discontinuity sets (F1 to F6) detected along the exposed surface of the slope. In order to allow a better view, the single joint set (with F1 set divided in 3 sub-sets) are showed in the lateral figures in the map at a 1:1000 scale.

In order to construct the 2-D cartography, the spatial model and geostructural data were rotated to a vertical projection plane oriented 158°N , which is the average direction of the cliff. Following this approach, we have produced a geostructural map of the discontinuity sets that may control the potential failure mechanisms recognized on the cliff.
