Geostructure of Coroglio tuff cliff, Naples (Italy) derived from terrestrial laser scanner data

We present a long-range terrestrial laser scanner application for the geostructural mapping of Coroglio cliff, a tuff rock face exposed along the coastal zone of Campi Flegrei, Napoli. The procedure includes several phases (geomorphological analysis, structural field survey, laser scanner data acquisition and data processing, 3-D model development and analysis, geostructural classification of discontinuity orientation data and 2-D vertical cartographic production). Field data were processed with specific software dedicated to geostructural and geometric analysis. Spatial data were managed with a geographical information system and have been used for the construction of 2-D and 3-D geometric models of the rock cliff surface and geostructural interpretation. The main product of this study is a vertical geostructural map of the Coroglio cliff at 1:500 scale that illustrates the spatial distribution and orientation of the major families of structural discontinuities detected along the exposed surface of the cliff. The cartographic product includes base information useful to identify the mai

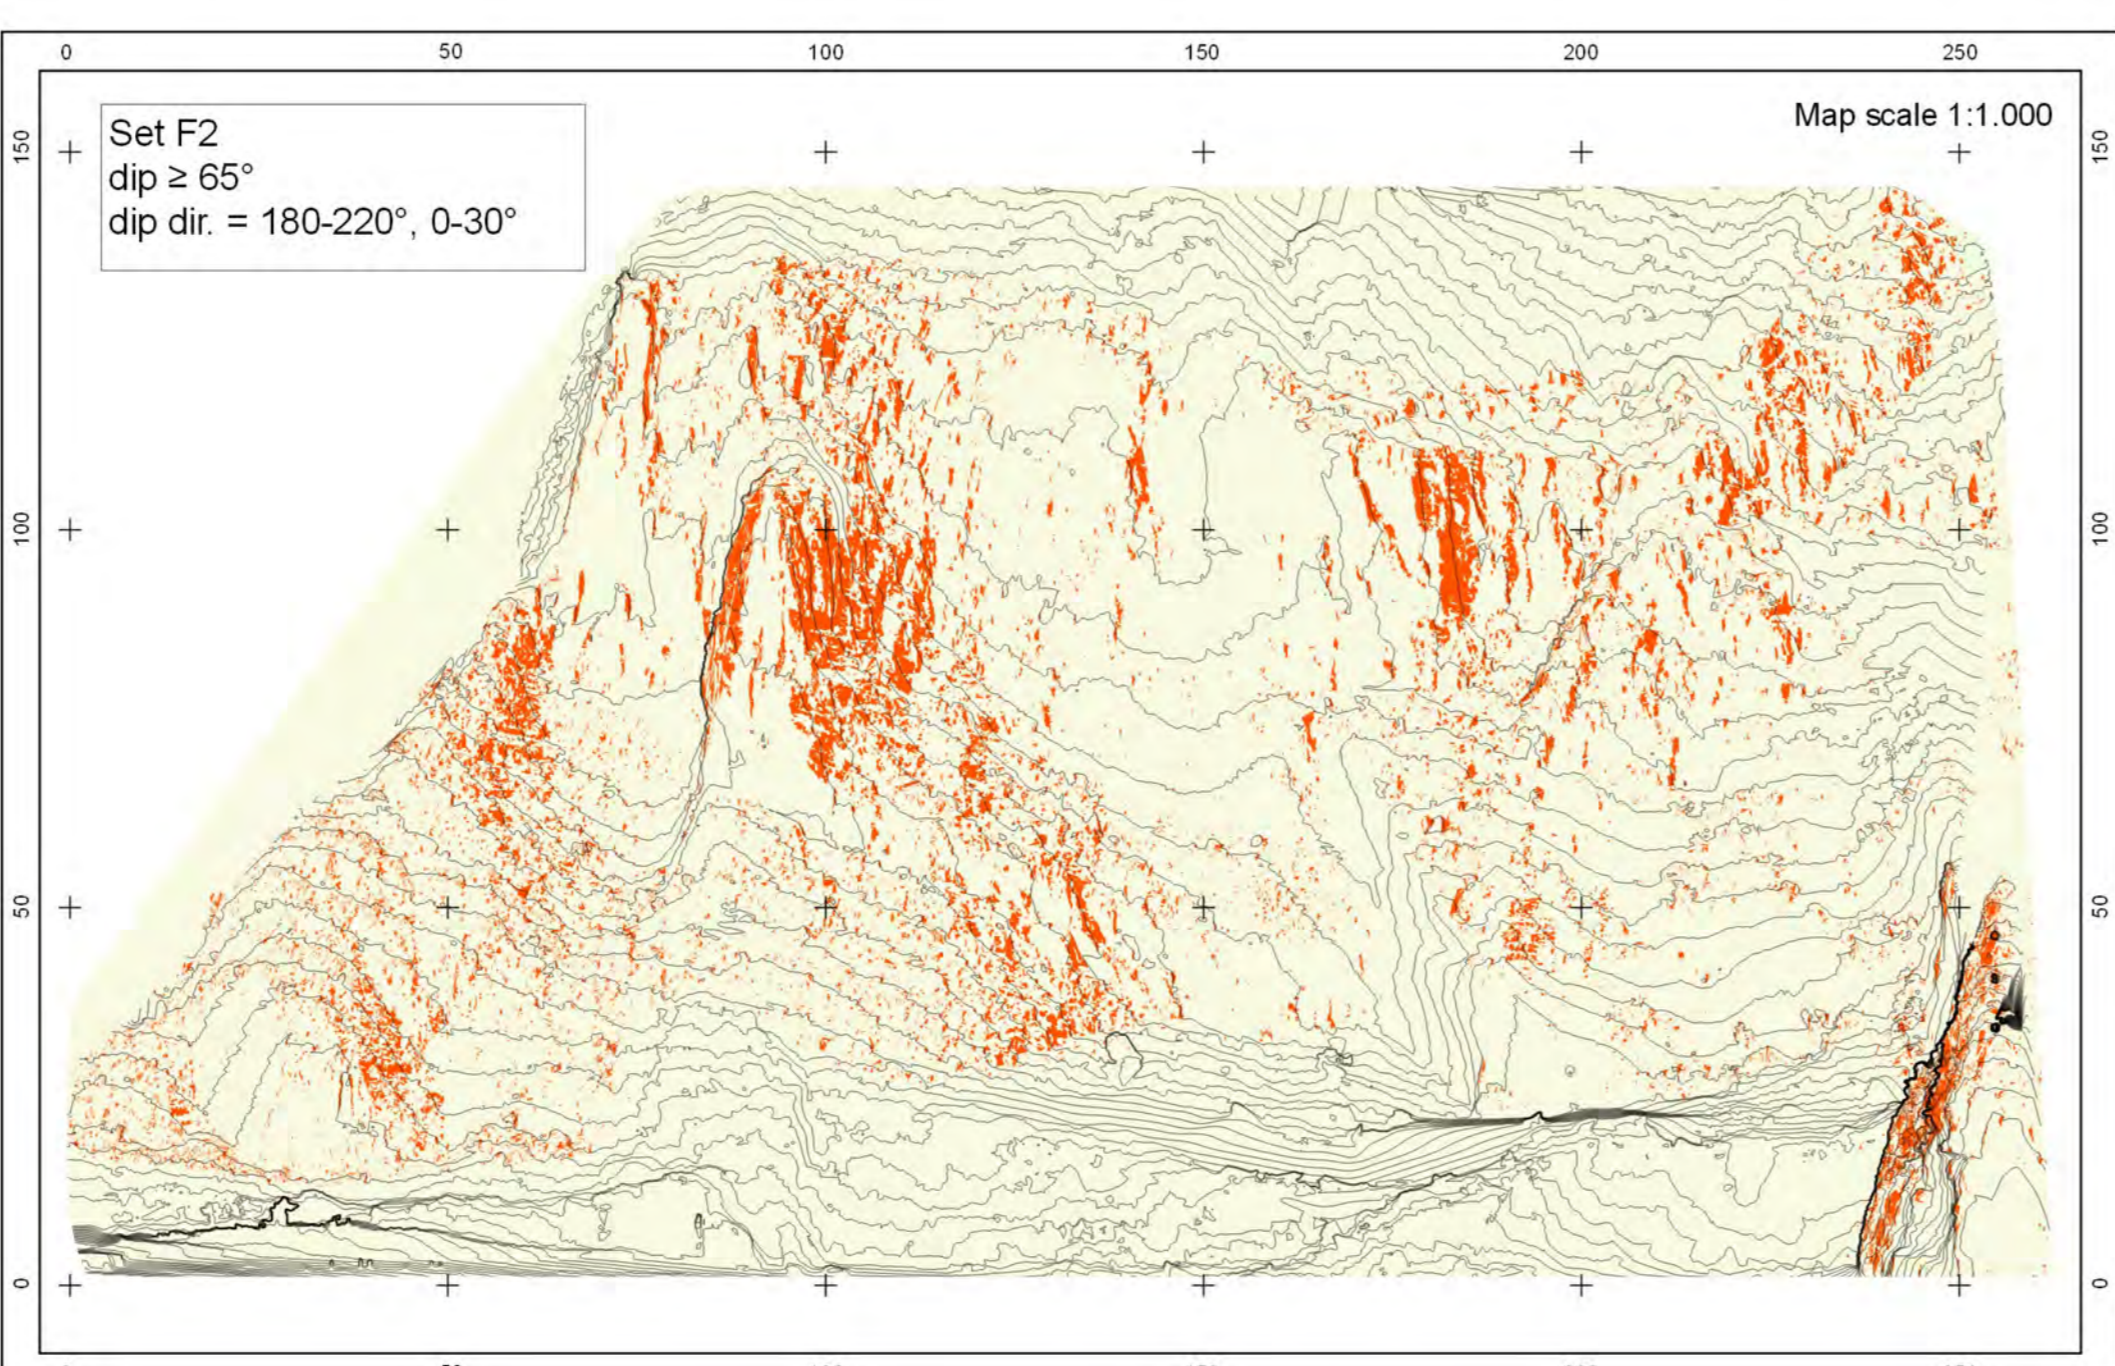
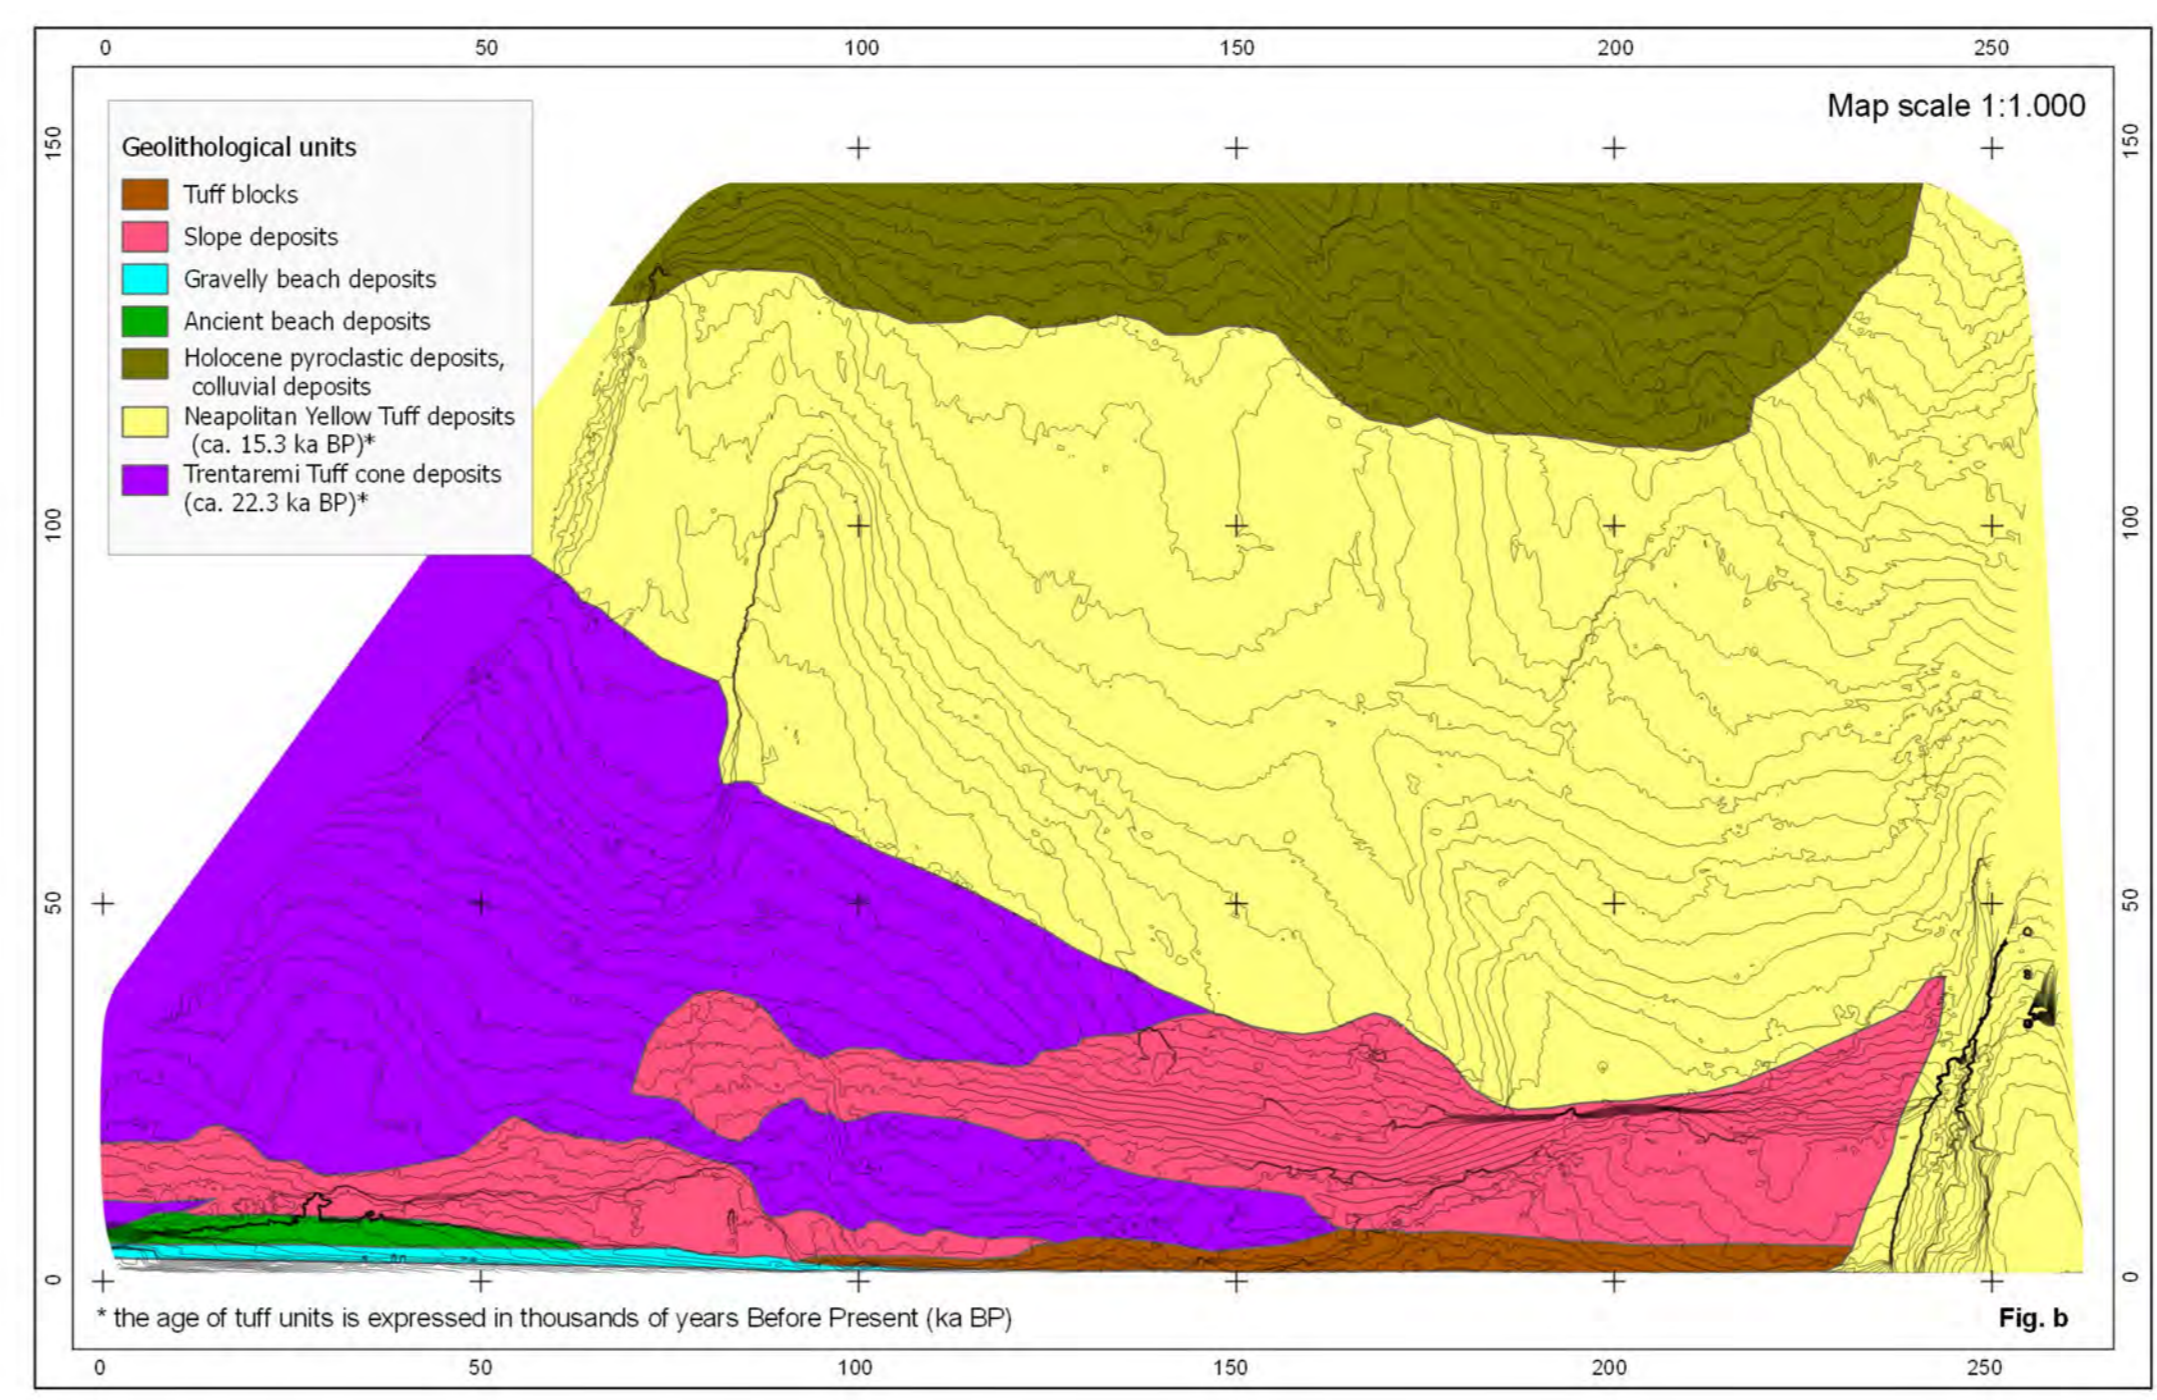
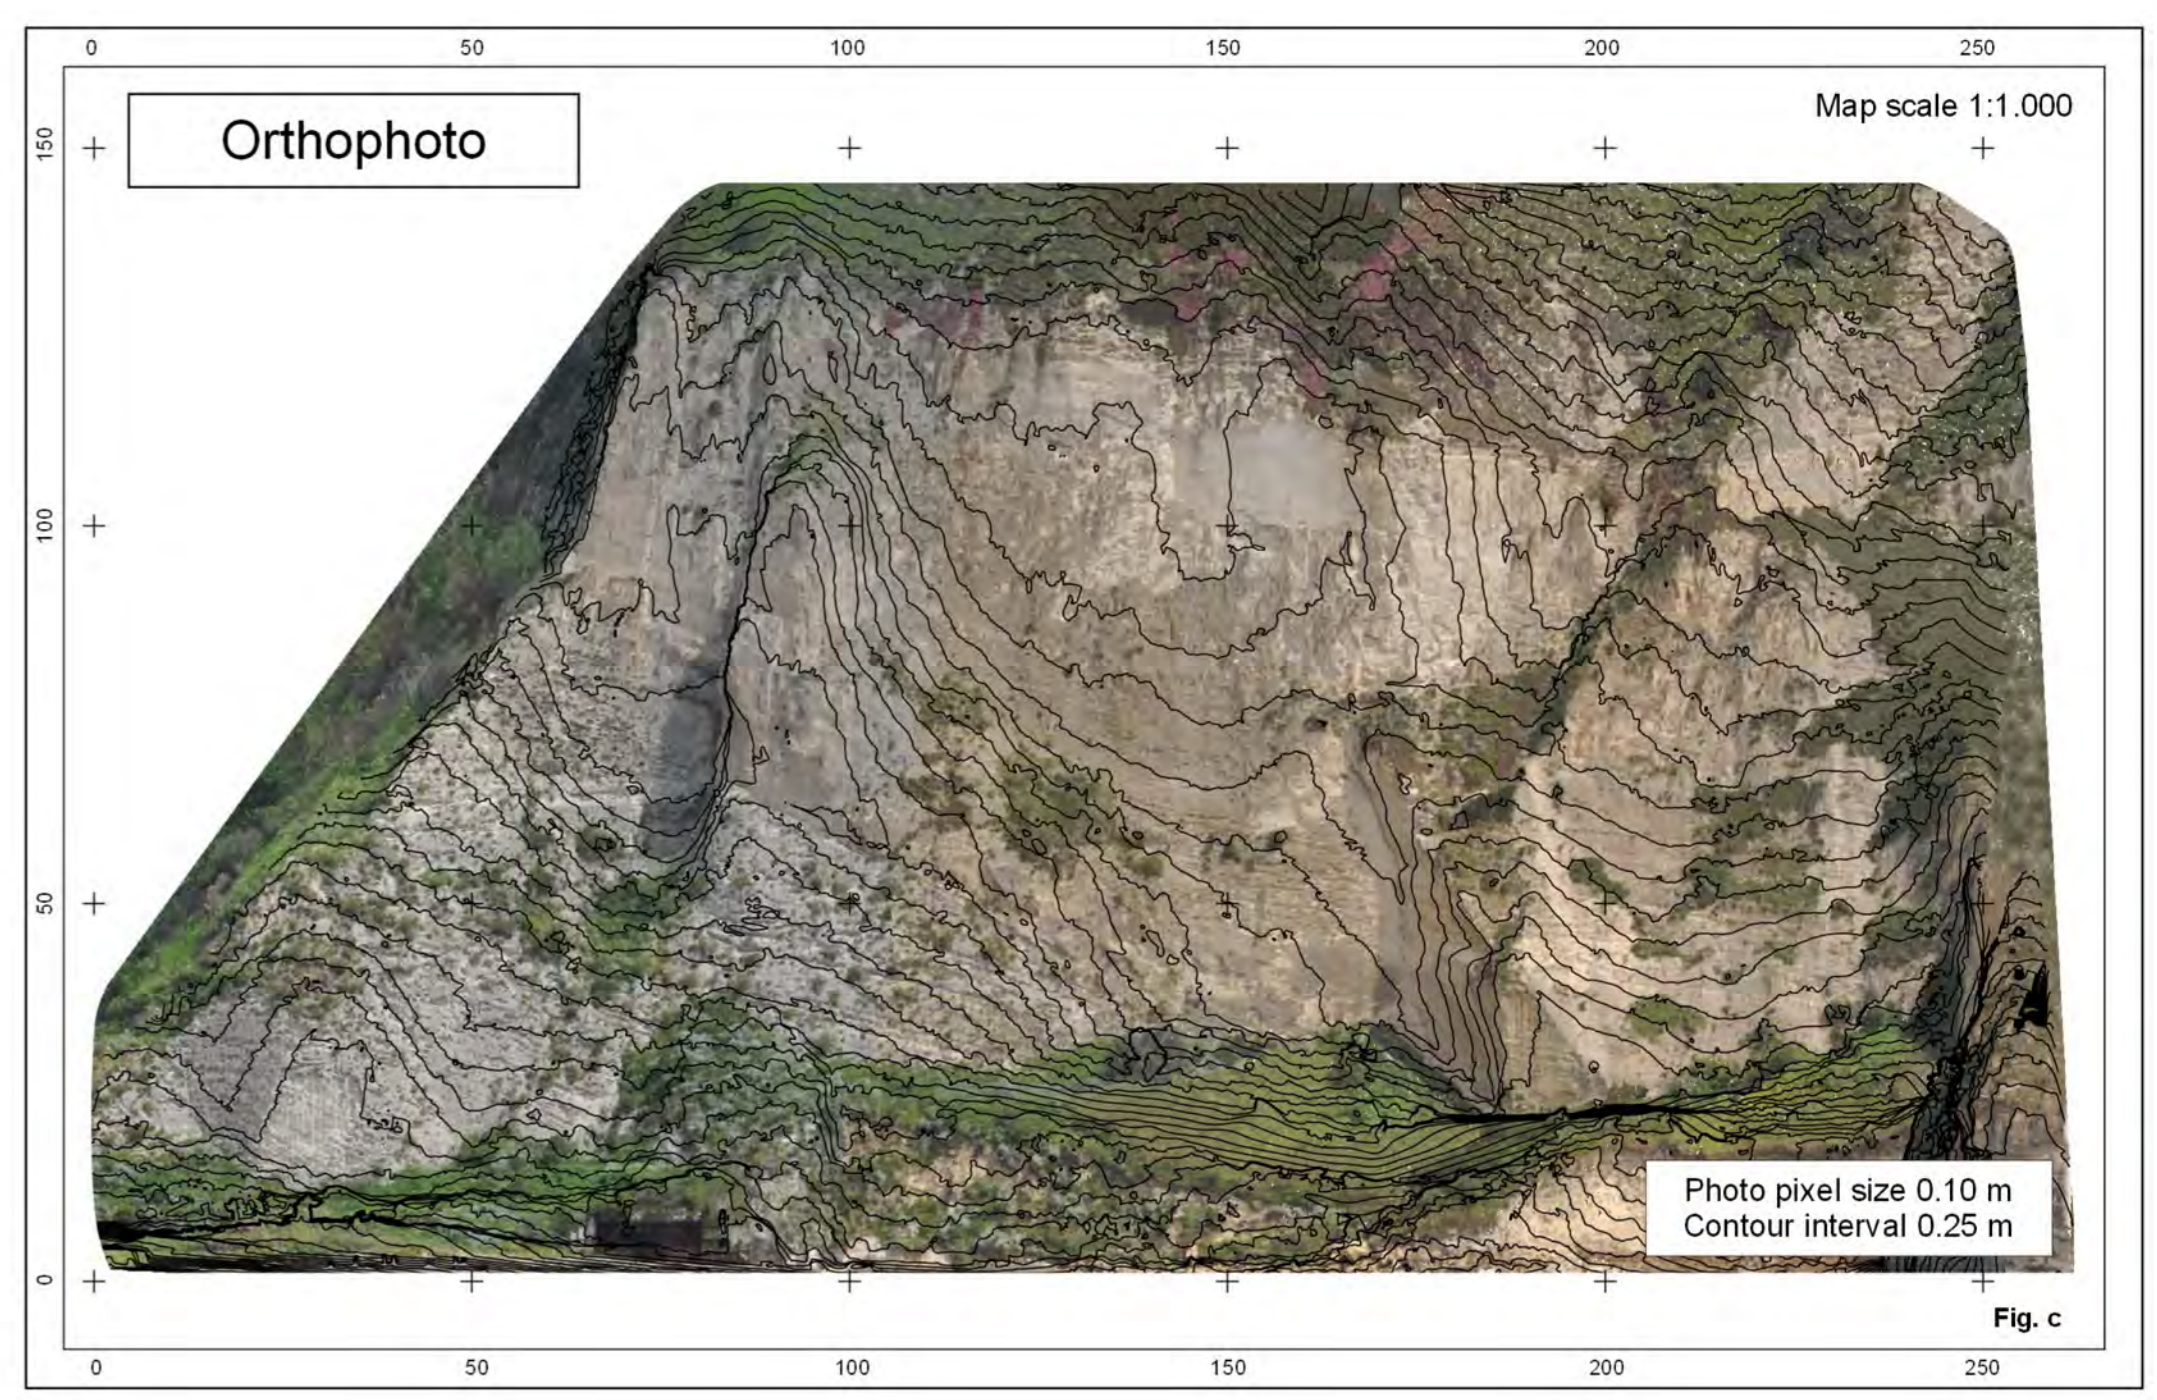
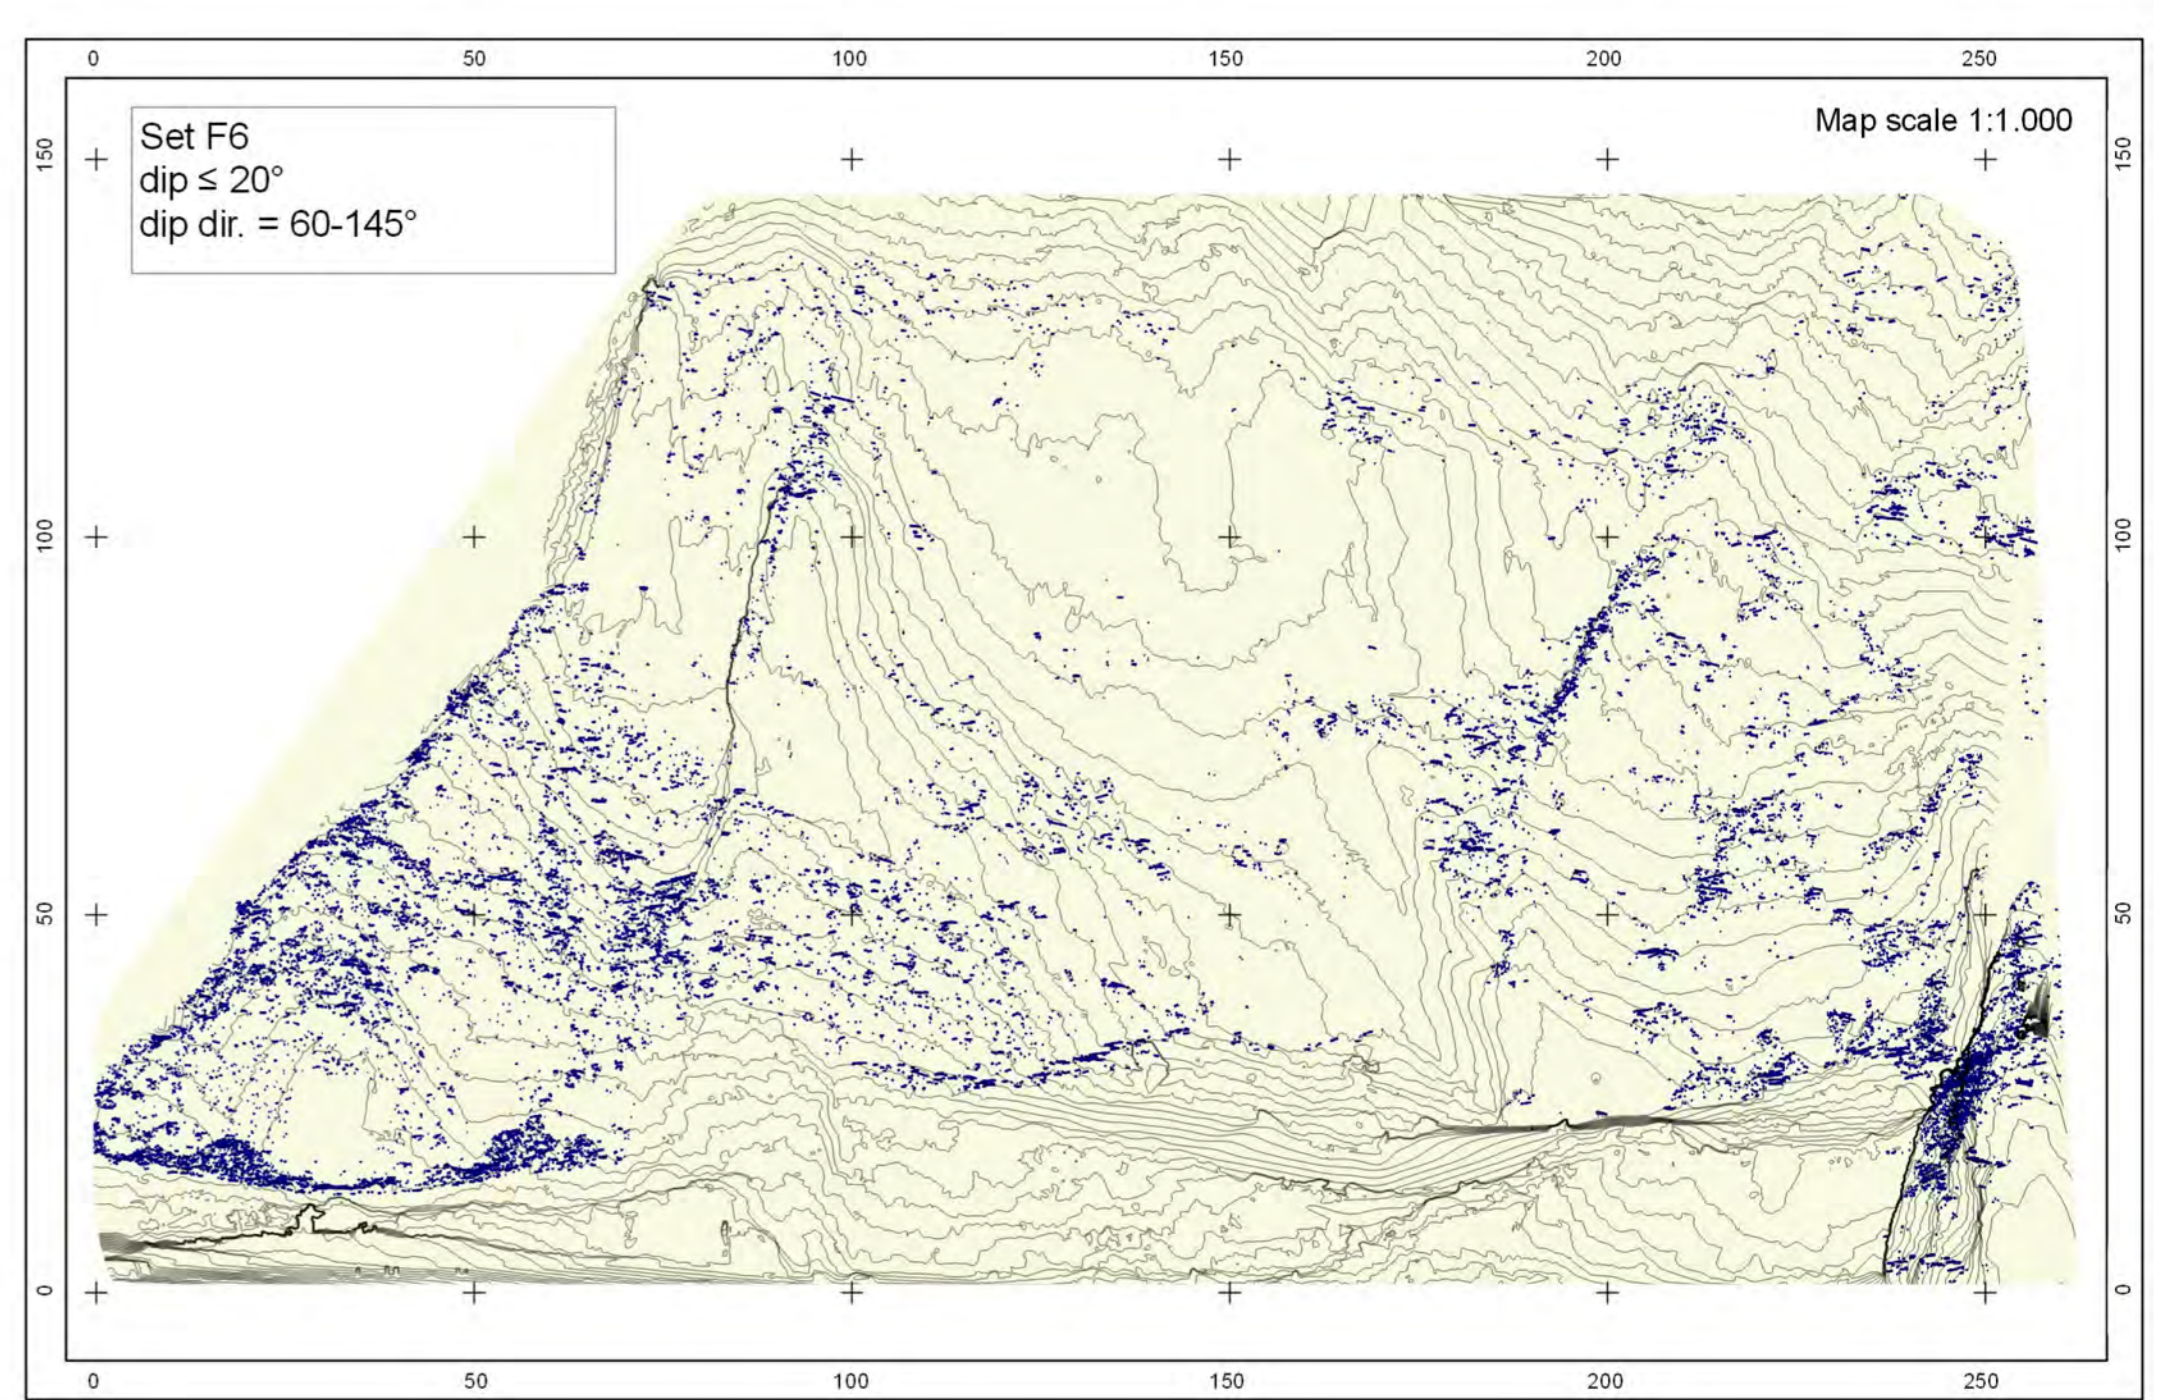
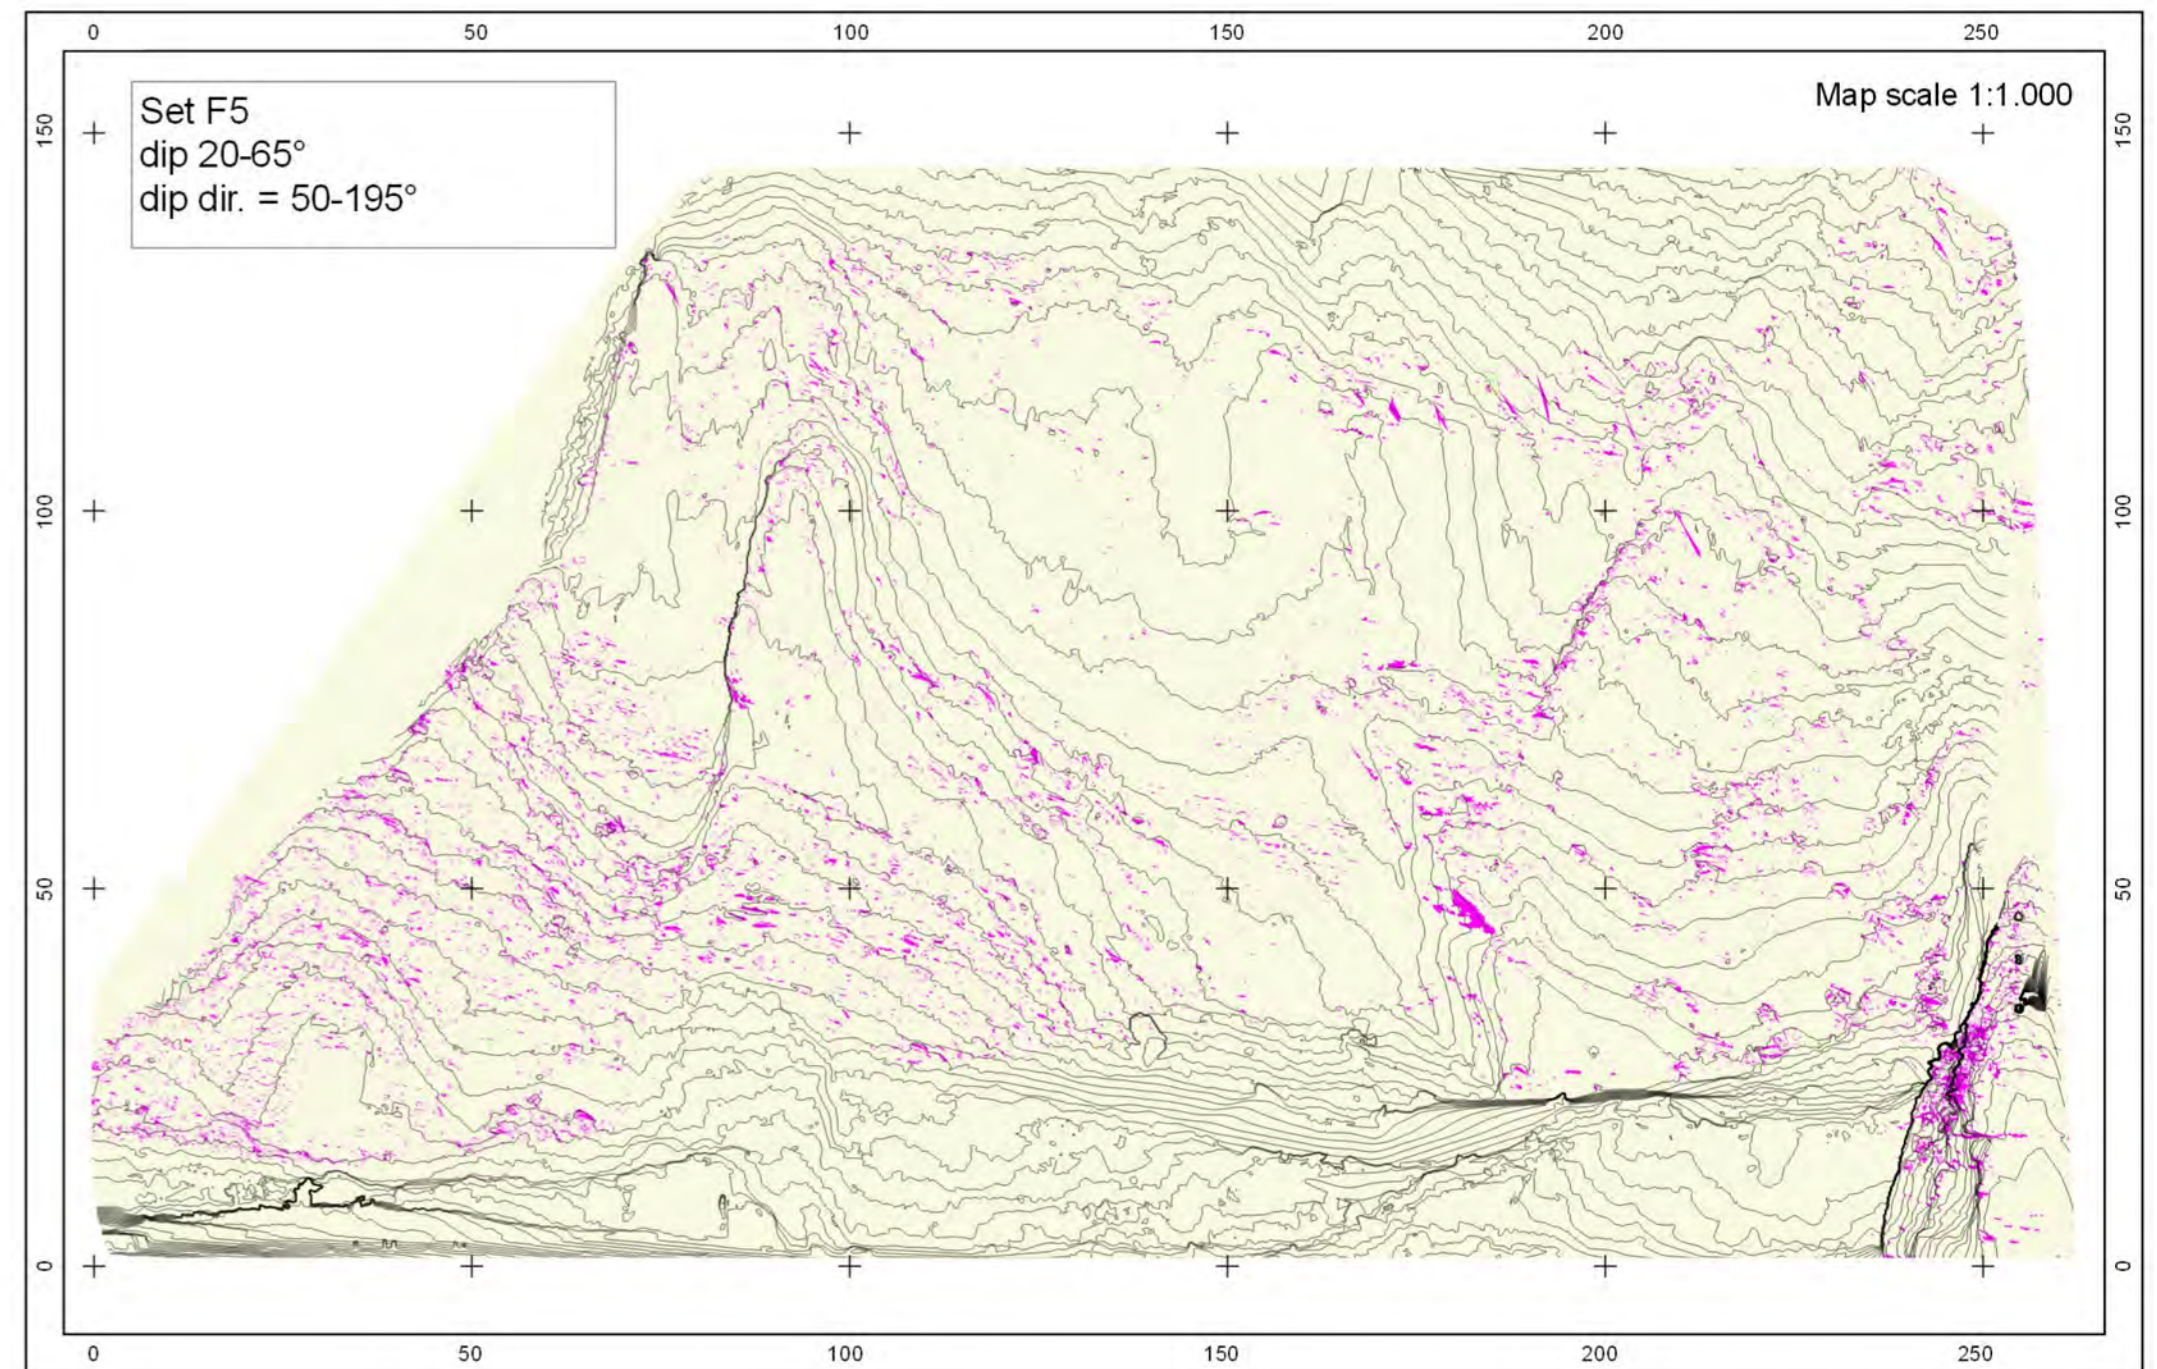
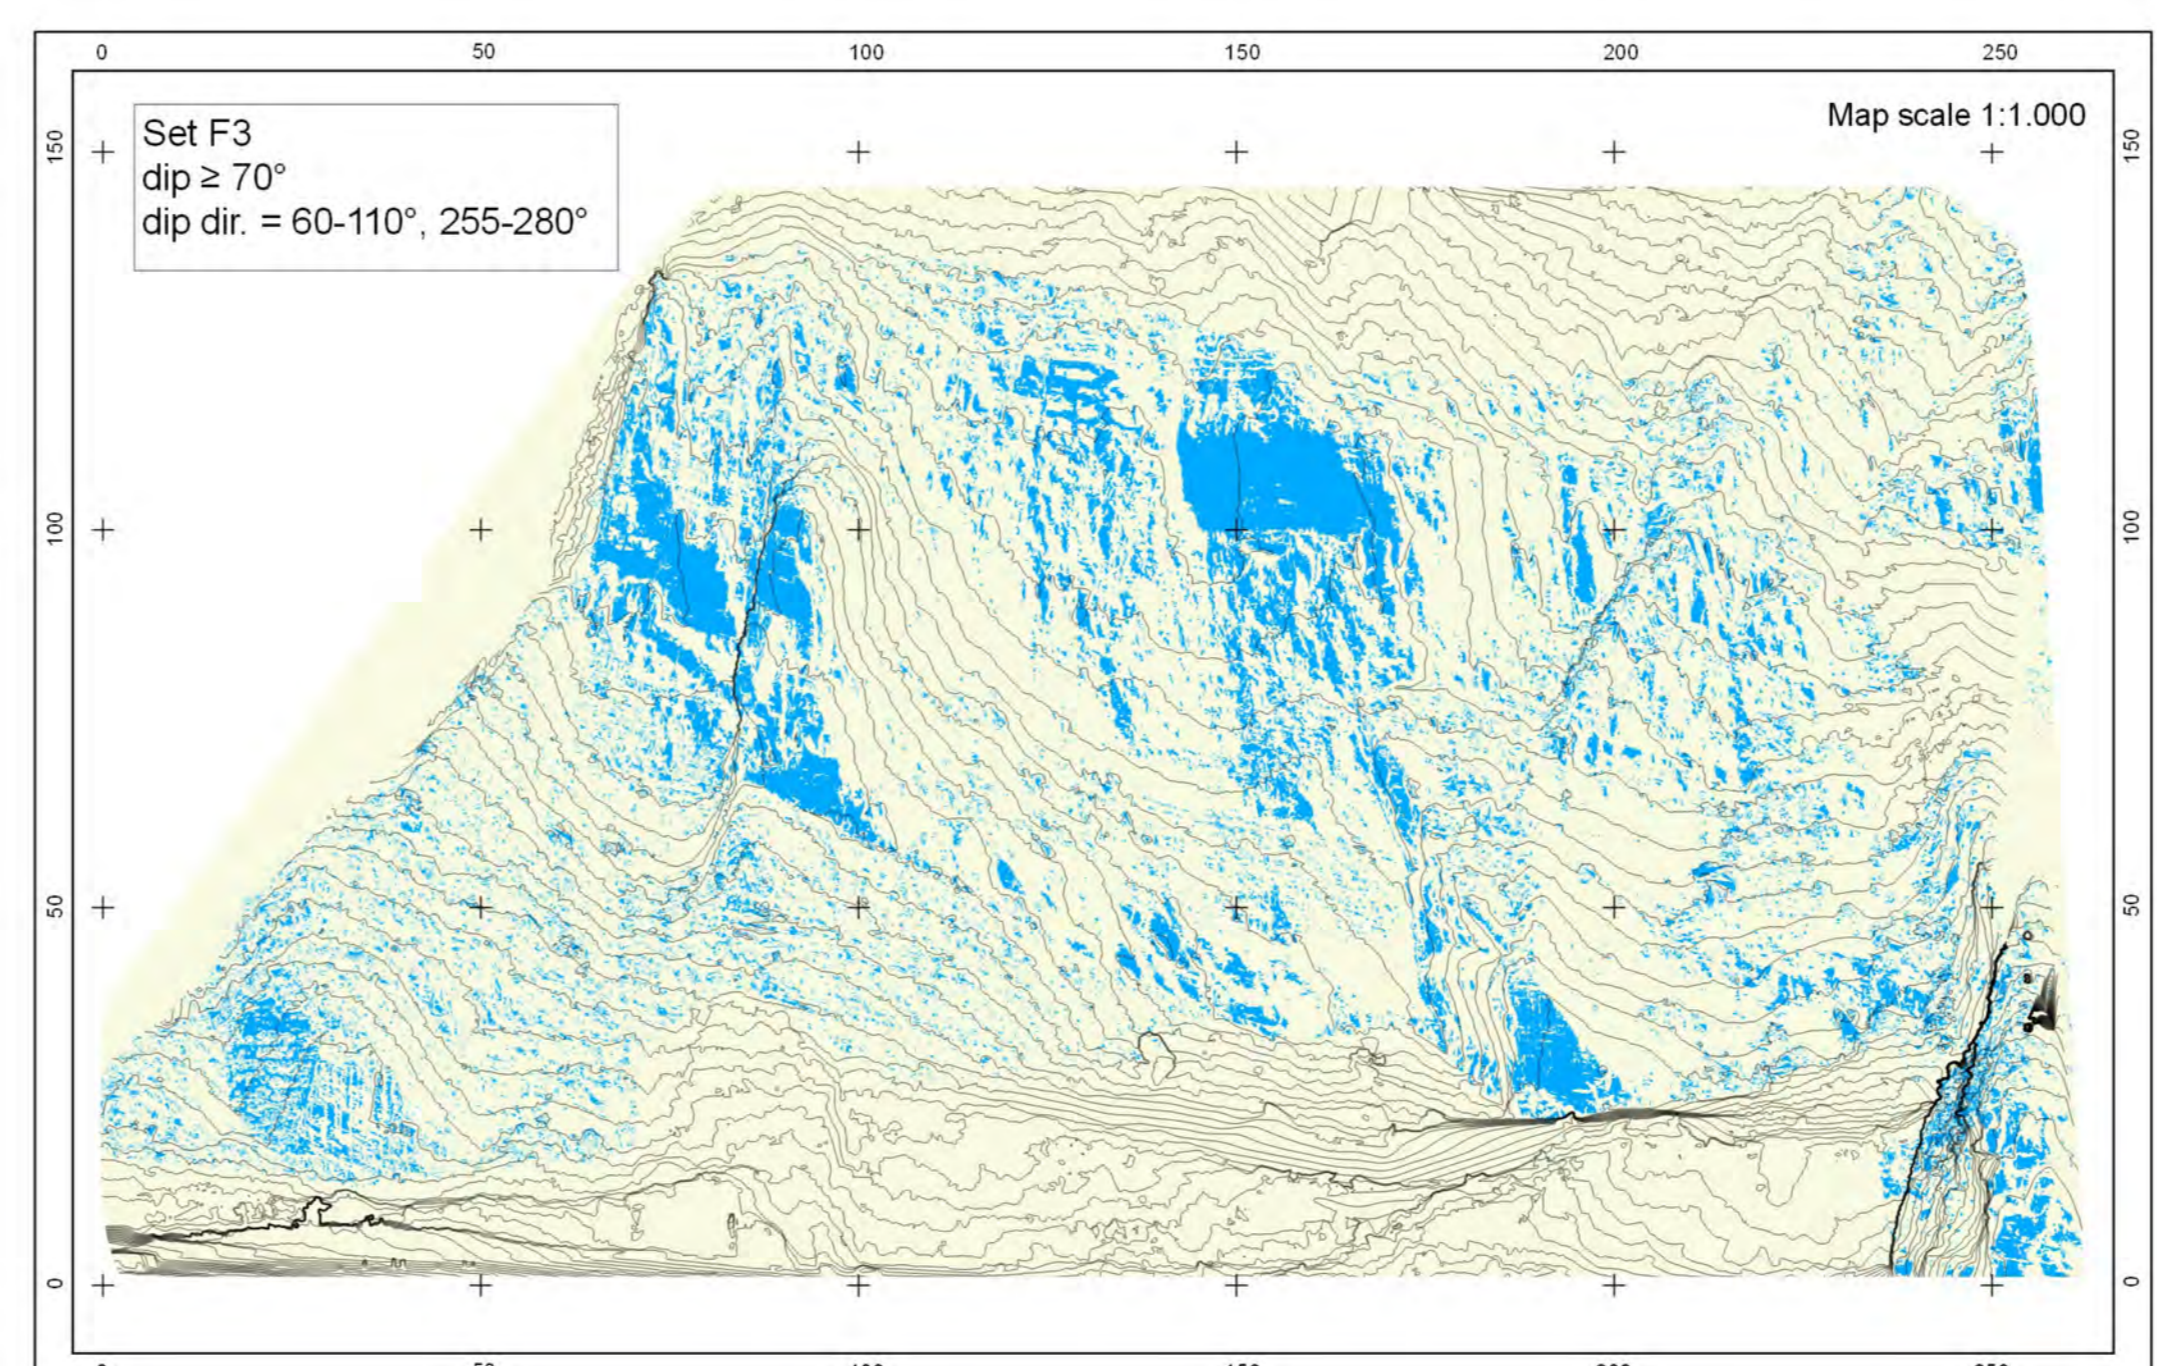
The main result is a geostructural vertical map of the cliff at 1:500 scale (central figure in the map) reporting the spatial distribution and the orientation of six discontinuity sets (F1 to F6) detected along the exposed surface of the slope. In order to allow a better view, the single joint set (with F1 set divided in 3 sub-sets) are showed in the lateral figures in the map at a 1:1000 scale.

The geological, geomorphological and geostructural field survey allowed the recognition of various geolithological units cropping out along the cliff (Fig. b) and the characterization of the main sets of fractures determining the possible failure mechanisms of unstable tuff blocks. The elaboration procedure includes several phases of work with the use of different specific softwares in Geographical Information Systems, such as: i) Laser Scanner (mod. RIEGL VZ1000®) data acquisition and data processing, ii) 3D model development and analysis, iii) discontinuity orientation classification, iv) 2D vertical cartography and orthophoto elaboration (Fig. c).

The study is aimed at identifying the joint sets controlling the main failure mechanisms along the cliff. The map is the first step to define susceptibility zoning to block failures and is also preliminary to monitoring activities, including installation of a sensor network and multi-temporal TLS surveys.
