Loess geohazards research in China: Advances and challenges for mega engineering projects

5 C. Hsein Juang^{1*}, Tom Dijkstra², Janusz Wasowski³, and Xingmin Meng⁴

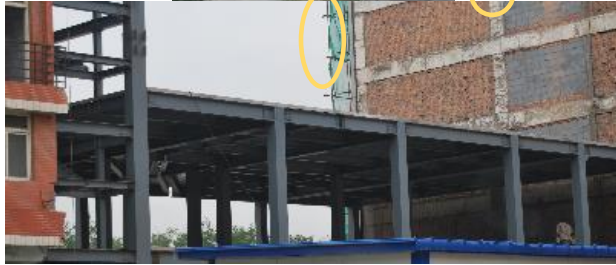
317 Figure 5. Damage to a University building in Xi'an where a ground fissure has caused relative
318 displacement along the connection between two buildings (left) and (right) construction of a
319 new building across an active fissure. To accommodate relative movement, the floor slabs are
320 separated by a small gap: an imaginative solution, but of questionable sustainability (gap in
321 floor slab is visible in yellow circles. (Photos: Dijkstra).

311 2007; 2016c). The consequences for urban development are severe with an increasing number
312 of buildings and connecting infrastructure, including metro-lines, at risk from
313 continuous displacements along these fissures (Peng et al., 2017a; see Figure 5).
