Article

The Mortars of Florence Riverbanks: Raw Materials and Technologies of *Lungarni* Historical Masonry

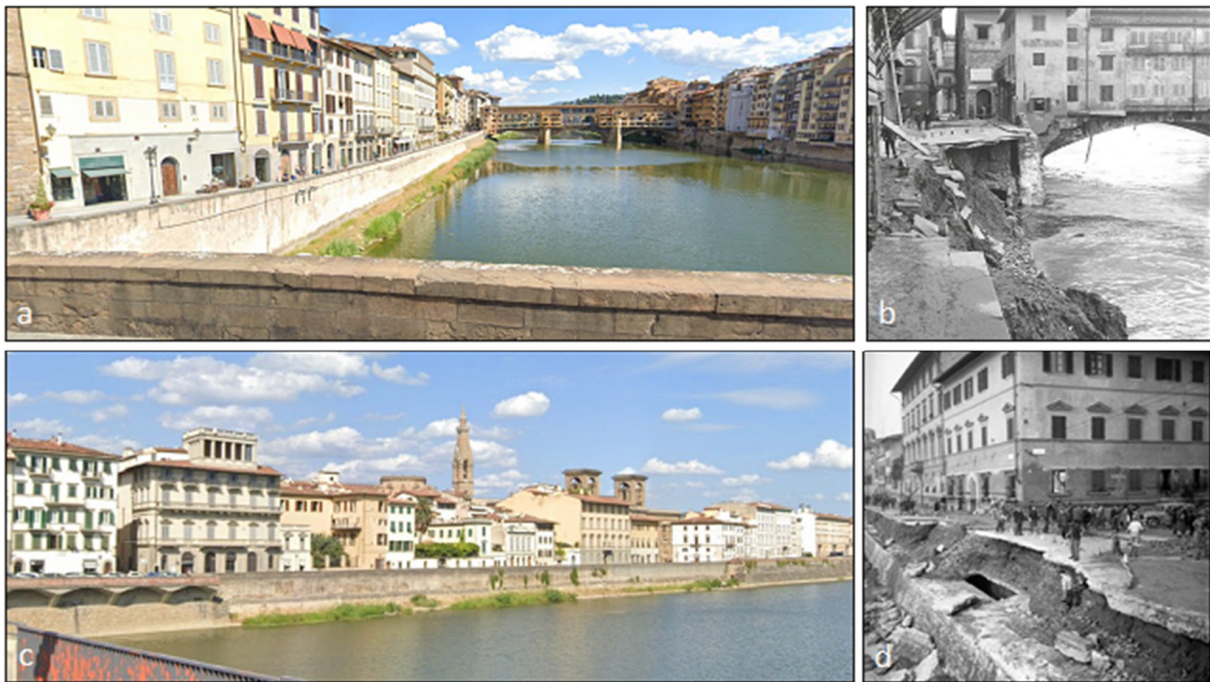
Figure 1. *Lungarno degli Acciaiuoli* riverbank: currently (a) and after flood of 1966 (Alinari archive), the embankment viewed from Ponte Vecchio of collapse of riverbank (b); *Lungarno delle Grazie* riverbank: currently (c) and after flood of 1966 (Alinari archive) (d).

Lungarno degli Acciaiuoli and *Lungarno delle Grazie* are located on the hydrographical right side of the Arno River in Florence, between Ponte Vecchio and Ponte Santa Trinita and Ponte San Niccolò and Ponte alle Grazie, respectively (Figure 1).

The *Lungarno degli Acciaiuoli*, whose name comes from the magnificent Palace of the Acciaiuoli family, is mentioned in official documents for the first time in 1246. In 1823–1824 it was amplified, during the demolition of a wing of the Spini Palace. The “Operation Feuerzauber” or “Magic Fire” in 1944 during the Second World War, which destroyed all the bridges in and near Florence, except Ponte Vecchio, did not damage *Lungarno degli Acciaiuoli* although the riverbank was close to Ponte Vecchio (Figure 1a) [30–32].

The *Lungarno delle Grazie*, whose name comes from the Oratory of Santa Maria delle Grazie, was built most likely in the 13th century. The definition of the route of *Lungarno delle Grazie*, indeed, is closely linked to the construction of the homonymous bridge in 1236 (Figure 1c) [30–32]. Both riverbanks were severely damaged during the flood in Florence in 1966 and subsequently restored (Figure 1b,d).

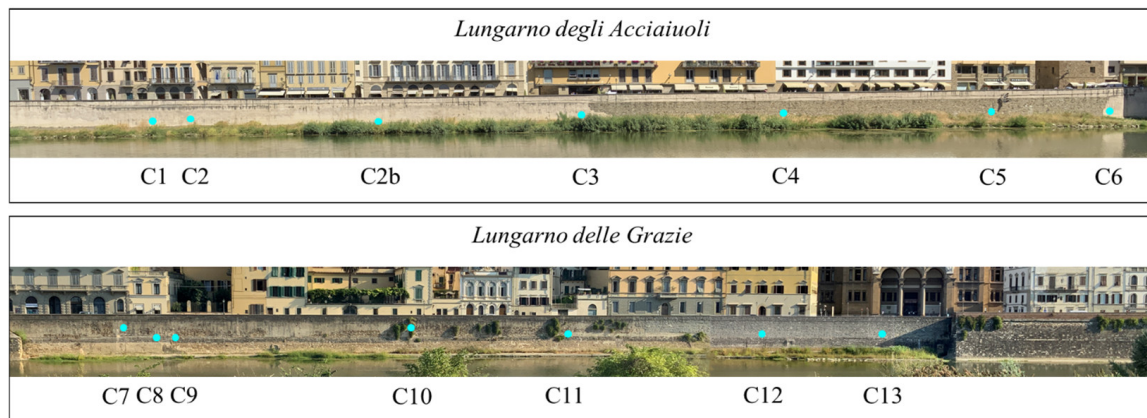
Figure 2. Position of core sampling: 14 masonry cores (light-blue dots) were extracted (7 core samples from *Lungarno degli Acciaiuoli* and 7 from *Lungarno delle Grazie*).

In Figure 2 the position of coring is reported. The core samples are composed by fine mortar and coarse aggregates. These materials were investigated through a preliminary macroscopic observation, and on some selected samples a complete mineralogical, petrographic, and physico-mechanical characterization was carried out.

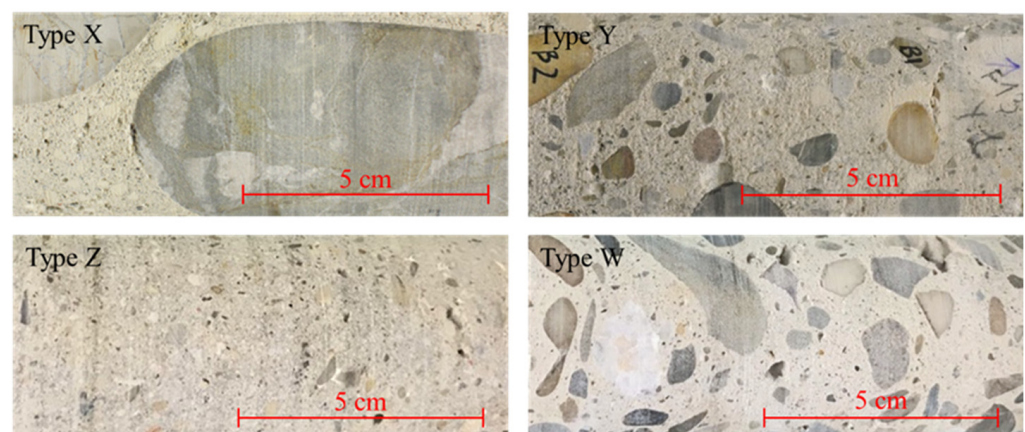
Figure 3. Macroscopic aspect of the four different macroscopic types of core samples.

A macroscopic description was performed on site using an endoscopic and optometric survey to identify macroscopic features of the masonry and in the laboratory using a Zeiss optical stereomicroscope up to 200 magnifications. The combination of the techniques allowed identification of 4 typologies of mortar, which are named X, Y, W, and Z. In Figure 3, the macroscopic aspect of these types are reported: historic mortar with decimeter-sized coarse aggregates (type X), historic mortar with centimeter-sized coarse aggregates (type Y), modern mortar with millimeter-sized coarse aggregates (type Z), and modern mortar with centimeter-sized coarse aggregates (type W). The term historic mortar is used to indicate a mixture of a traditional binder, fine aggregates, water, and possible additives used in riverbanks as filling of the nucleus of the masonry, while the term modern mortar is used to identify modern hydraulic binder and fine aggregates mixed with water and additives. The coarse aggregates are largely composed of stone fragments, such as *Pietraforte*, *Pietra Serena*, and *Pietra Alberese*. *Pietraforte* and *Pietra Serena* are the most used sandstones in Florentine architecture [33,34], while *Pietra Alberese* is a marly limestone that in Florence was mainly used for lime production [35].

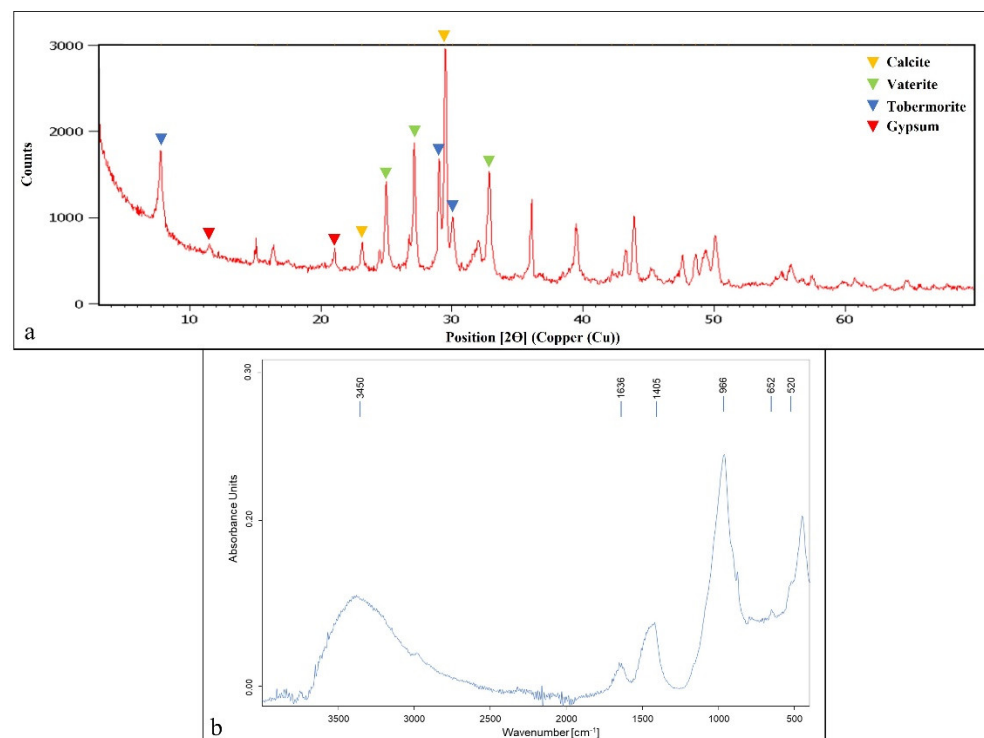
Figure 4. XRD pattern of sample C2-X lump. The most intense peaks for calcite, vaterite, tobermorite and gypsum are indicated (a). FTIR spectra of sample C2-X lump. The vibrational bands of tobermorite are highlighted (b).

In Figure 4a, a representative diffractometric pattern of a lump extracted from the core of the C2-X sample is shown; calcite, vaterite, tobermorite and gypsum were identified. Moreover, analyzing the lump via FTIR analyses concerning the wavenumber from 4000 to 400 cm^{-1} (Figure 4b), the XRD composition was confirmed; in fact, the presence of tobermorite is highlighted in the spectra.

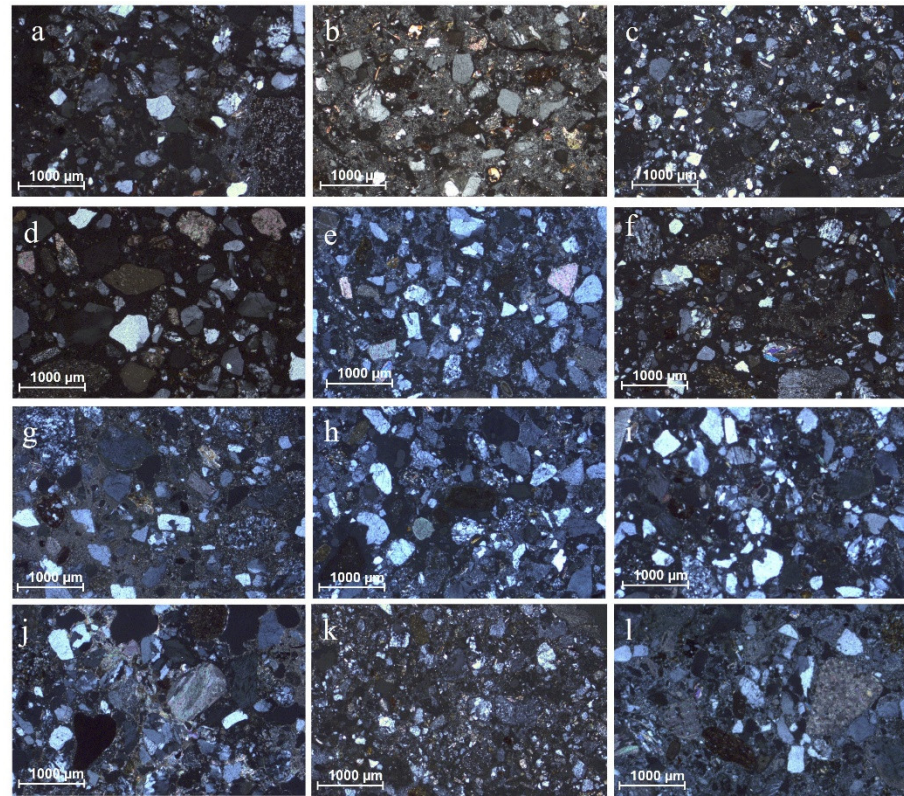
Figure 5. Thin section microphotographs (XPL) of some selected samples: C2-X (a), C2b-Y (b), C3-X (c), C5-Z (d), C5-W (e), C6-Y (f), C7-X (g), C7-Y (h), C10-X (i), C10-Y (j), C11-X (k), and C13-X (l).

The petrographic observation performed on *Lungarno degli Acciaiuoli* samples reveals a binder for samples C2-X, C2b-Y, C3-X, and C6-Y with heterogeneous structure and micritic/microsparitic texture (Figure 5a–c,f). Some areas with low birefringence color were also identified.

Lumps are present as remnants both of not well mixed binder and of overburnt limestone fragments in samples C2-X, C2b-Y, and C3-X. The aggregate is very abundant, not well selected, with a heterogeneous grain size distribution, and composed of quartz (mono and polycrystalline), plagioclases, K feldspar, calcite, arenaceous rock fragments, siltstones, and marly limestone fragments.

The sample C5-Z was obtained mixing a hydraulic binder with abundant aggregate (B/A 1/3) and has a very heterogenous composition (Figure 5d). Remains of unhydrated clinker grains have been identified. Quartz (mono and polycrystalline), plagioclases, K feldspar, arenaceous and carbonate rock fragments, siltstones, and magmatic and metamorphic rock fragments were identified under an optical microscope. The grain size distribution varies in the range of 1–2 mm for rock fragments and 100–800 μm for monocrystals. The shape is sub angular/sub rounded. A low macroporosity, due to microcracks and pores of irregular and rounded shape, was observed.

The C6-Y sample also contains few fragments of magmatic rocks (Figure 5f). The rock fragments have a pluri-millimetric size, while the monocrystalline portion ranges from 100 to 500 μm , shaped from sub-angular to sub-rounded. The macroporosity is of medium/high amount due to microcracks and pores of irregular and rounded shape.

The samples C7-X and C7-Y, belonging to *Lungarno delle Grazie*, were realized with a natural hydraulic binder, in which numerous lumps referred to not well mixed binder and remnants of overburnt marly limestone, identified as the local Alberese limestone, were observed. However, they show some differences: the binder of the C7-X portion has a micritic texture, while the binder of C7-Y varies from micritic/microsparitic to opaque for

the presence of areas with low birefringence color (Figure 5g,h). In the first portion the aggregate has a heterogeneous grain size distribution in the range 1–2 mm to 300 μm ; in the second one a homogeneous grain size distribution was observed (grain size 800–100 μm).

For samples C10-X and C10-Y and C11-X and C13-X a binder realized with natural hydraulic lime with a heterogeneous structure and micritic/microsparitic texture and with an area with low birefringence color was observed (Figure 5i–l). Some differences have been registered in grain size distribution and composition also for the same mortar type.

The presence, in some examined samples, of lumps showing Alberese limestone (Figure 5a,b,g,i,l) suggests the use of this stone to produce lime. It is in fact known as the Alberese limestone which has been widely used for the production of lime in the Florentine territory [35,38,41,53]. These stones have a variable amount of clay minerals (from 7 to 26%) and the binder produced by burning the stone with a higher amount of clay minerals develops, after setting, calcite, hydrated calcium silicates, amorphous carbonate, and vaterite able to confer to the mortar good performance and durability.

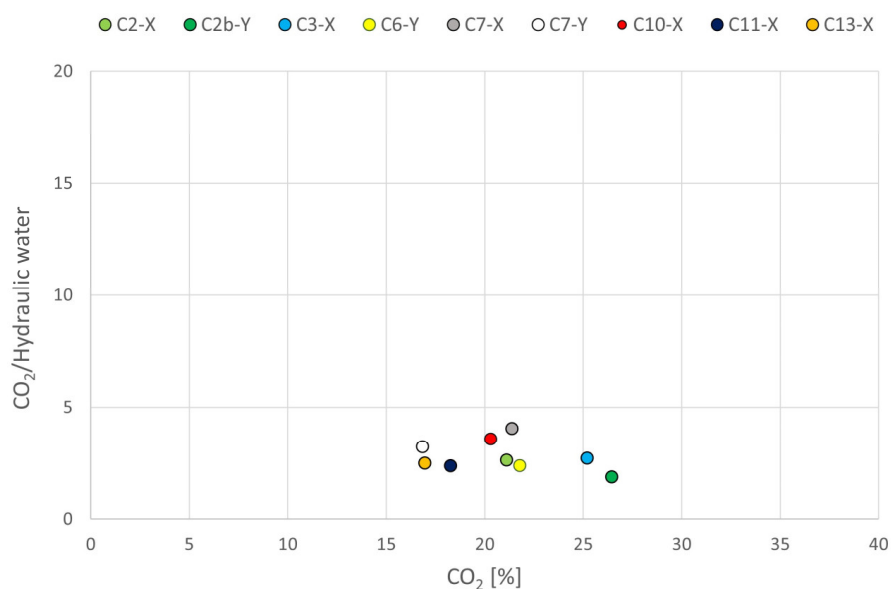
Figure 6. Diagram of $\text{CO}_2/\text{H}_2\text{O}$ vs. CO_2 measured on the enriched binders.

Figure 6 shows a plot of the $\text{CO}_2/\text{H}_2\text{O}$ ratio versus $\text{CO}_2\%$; TGA results show that the samples fall in the typical cluster of hydraulic mortars and are characterized by a rather homogeneous hydraulicity.

All samples present hydraulic water over 7.00%, indicating more condensed and higher strength mortars (in Figure 6 such values are highlighted via TGA results that are concentrated in the lower area of the plot). While the samples C7-X and C7-Y and C10-X, considering that they have a lower hydraulic water value (equal to 5.00%), are slightly

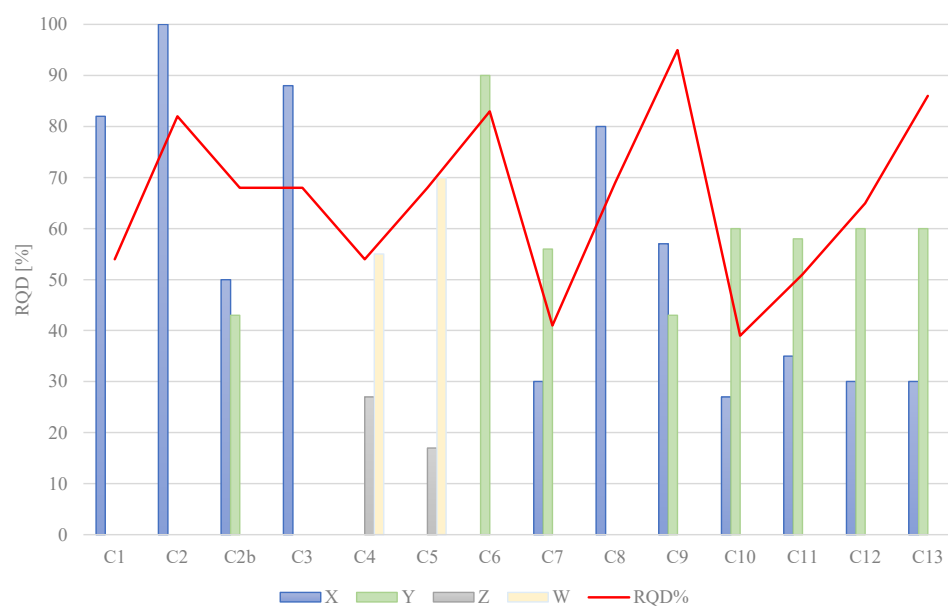
Figure 7. RQD index of core samples, correlated with types of masonry (X, Y, Z, and W).

A first mechanical consideration concerns the relationship between the type of mortar and the RQD values. Although a clear correlation between the types of masonry and the RQD cannot be identified, the core samples made of a single type have good and mean RQD values (Figure 7), while the core samples constituted by two types of masonry have lower values, except for C9 and C13, which appear to be the most cohesive. Only C7 and C10 show poor characteristics: these cores come from a portion of the riverbank wall higher than the others and they are characterized by the same binder composition and hydraulic behavior.

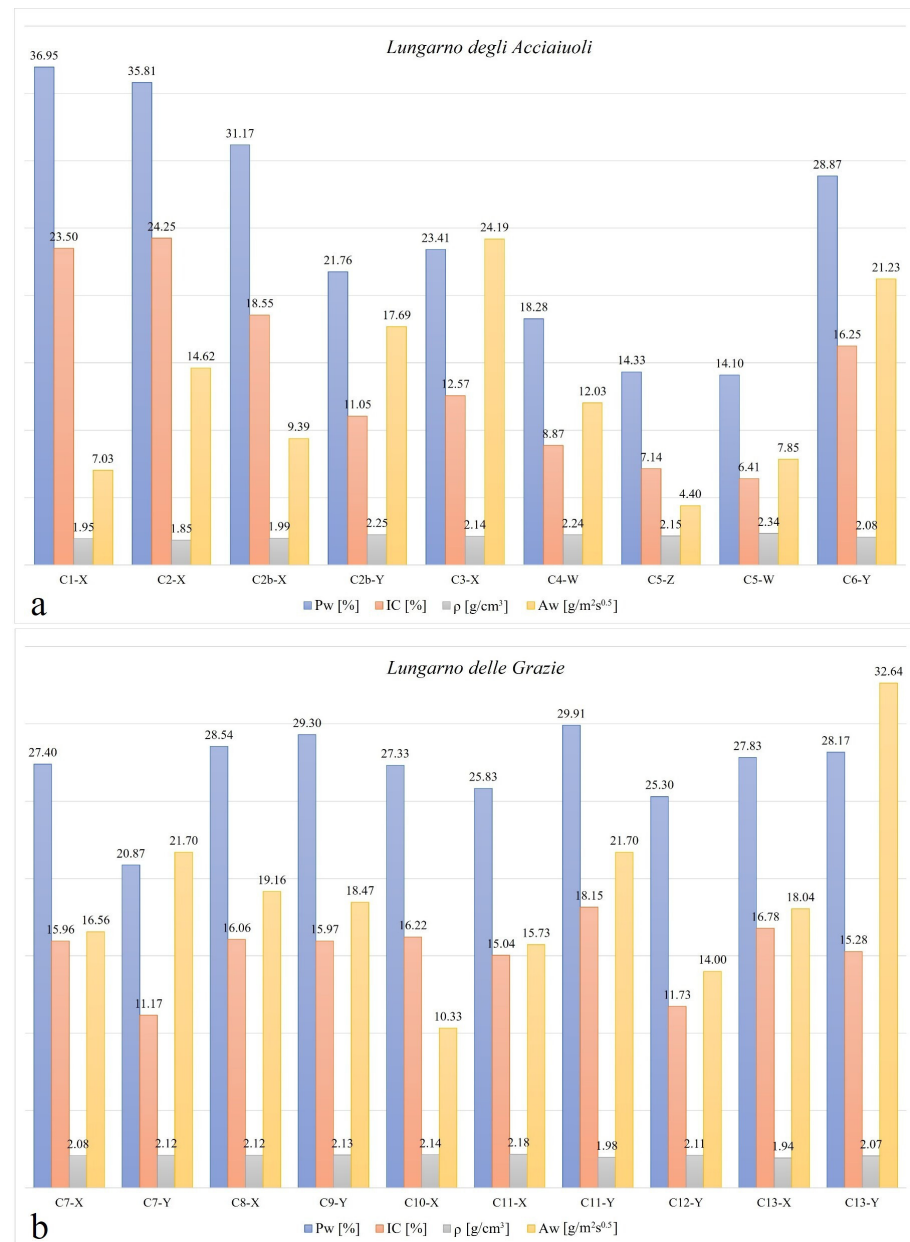
Figure 8. Results of physical analyses of test samples of *Lungarno degli Acciaioli* (a) and *Lungarno delle Grazie* (b). The values reported are effective porosity (Pw%, or porosity accessible to the water), total imbibition coefficient (IC%), density (ρ), and capillary water absorption coefficient (Aw).

Figure 8 shows the values of effective porosity (Pw%, porosity accessible to water), of the total imbibition coefficient (IC%) and of the density (ρ). The samples were grouped by type of masonry, selected on the basis of macroscopic observation. The effective porosity of *Lungarno degli Acciaiuoli* samples ranges from the minimum value of 14.10% (C5-W) to the maximum value of 36.95% (C1-X), while in *Lungarno delle Grazie* samples this value ranges from 20.87% (C7-Y) to 29.91% (C11-Y). The IC% has a similar trend varying from 6.41% to 24.25% (*Lungarno degli Acciaiuoli*) and from 11.17% to 18.15% (*Lungarno delle Grazie*). The density is slightly variable, from 1.94 g/cm³ to 2.34 g/cm³, with typical values of mortars [12]. The values of Pw, IC, and ρ , obtained from cores belonging to *Lungarno degli*

Acciaioli, are more variable, while the values of *Lungarno delle Grazie* cores are similar for all the samples.

In *Lungarno degli Acciaioli* the X type, defined as “mortar with decimetric-sized coarse aggregates”, show Pw values that vary from a minimum of 23.41% to 36.95% and are much greater than the Z and W type samples. In these specimens the effective porosity values vary between 14.10% and 18.28%. IC values have a similar trend of porosity: X and Y type samples have higher IC, while the W and Z type samples show lower values.

In the samples of the *Lungarno delle Grazie*, for the X type the Pw value varies from 25.83% to 28.54%. These values are similar to those of the Y type. The same behavior is observed for the IC values.

The results of the capillary water absorption test (Figure 8) show that all the specimens have absorption coefficients typical of mortars [18,56]. In general, all the samples show a very rapid imbibition in the initial stages of the test, since the largest porosities are immediately saturated by contact. The A_w values of *Lungarno degli Acciaiuoli* samples range from a minimum value of 4.40% (C5-Z) to the maximum value of 24.19% (C3-X), while for *Lungarno delle Grazie* this value ranges from 10.33% (C10-X) to 32.64% (C13-Y). A clear distinction can be observed between the values obtained from the specimens of Z and W samples compared to those of X and Y. The masonry type X has on average slightly lower capillary absorption coefficient values than the Y type, with an average of $13.86 \text{ g/m}^2\text{s}^{0.5}$ and $19.13 \text{ g/m}^2\text{s}^{0.5}$, respectively. In the average values, C3-X and C13-Y samples are not included, due to abnormal capillary absorption values. For the sample C3-X, this is due to the presence of a creep that clearly separates it into two portions, so representing an easy access route to water; while for the sample C13-Y, the mortar texture appears to be characterized by a detachment of single grains, due to sample preparation.

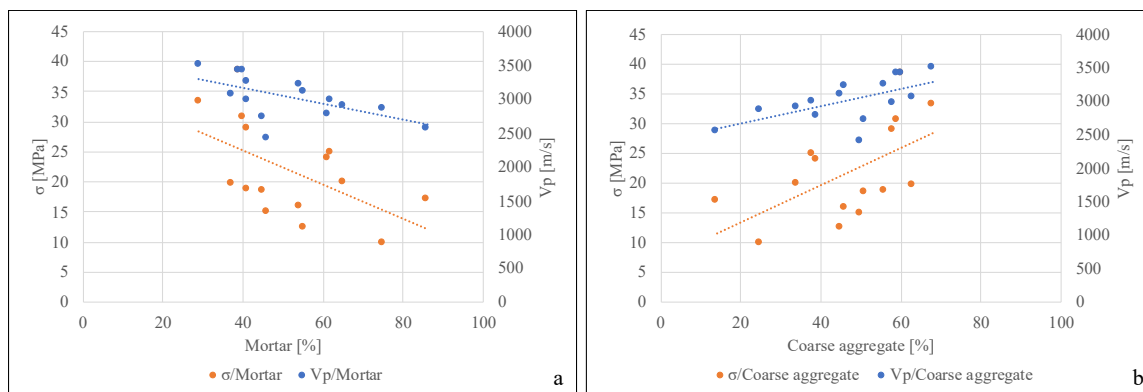
Figure 9. Diagram of correlation between σ , V_p , and % of fine portion of core samples (a); σ , V_p , and % of coarse aggregate (b).

If the mechanical parameters of the samples are compared with the percentages of fine mortar and coarse aggregates, the following correlations are obtained: the quantity of mortar and the mechanical parameters are inversely proportional (Figure 9a), while the quantity of coarse aggregate and the mechanical parameters are directly correlated (Figure 9b). For example, the sample C2b-X shows high values of V_p and σ ; indeed, it is composed of 68% of coarse aggregate and only 29% of mortar. On the contrary, the C13-Y sample, consisting of 25% of coarse aggregate and 75% of mortar, shows lower V_p and σ values. The amount of voids is always less than 5%, so they do not significantly affect the results of the mechanical tests.
