PAST AND PRESENT OF THE EARTHEN ARCHITECTURES IN CHINA AND ITALY

EDITED BY
LOREDANA LUVIDI, FABIO FRATINI
SILVIA RESCIC AND JINFENG ZHANG

This series of volumes comprises research outputs that have been achieved due to the financial contribution of the National Research Council of Italy (CNR) and the the Chinese Academy of Cultural Heritage (CACH) within the context of a Bilateral Agreement of Scientific and Technological Cooperation between these two Institutions.

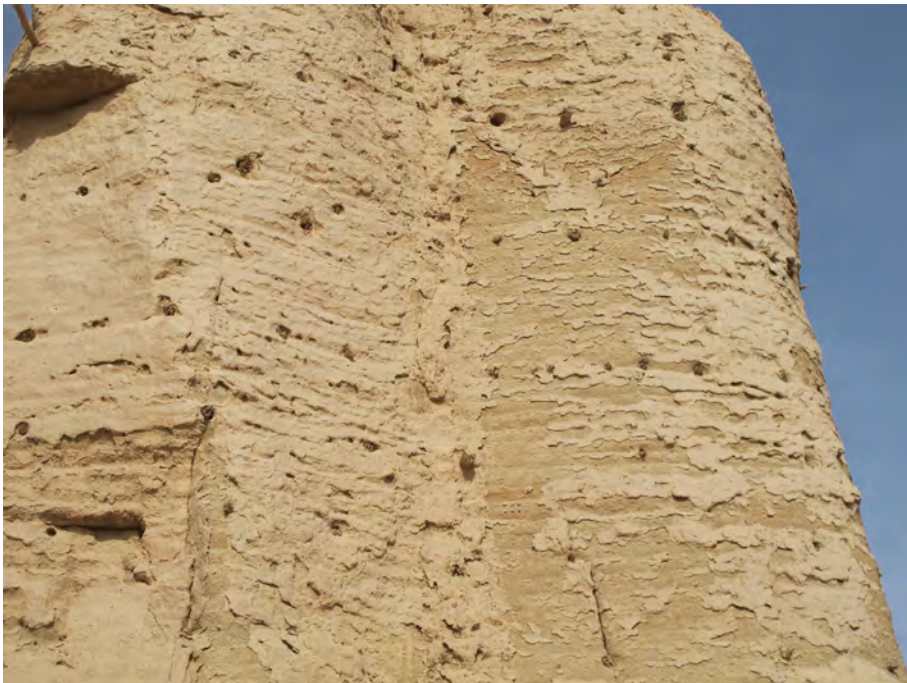
Spalling is a process in which the surface of an earthen site suffers pressure from external or internal forces, which results in a layer of crust peeling off in sheets or small blocks. The external or internal forces that lead to this phenomenology can be rain, wind, temperature or crack. The first two factors are very common in earthen sites in arid areas of northwest China.

Fig. 2 Spalling decay effect on a wall

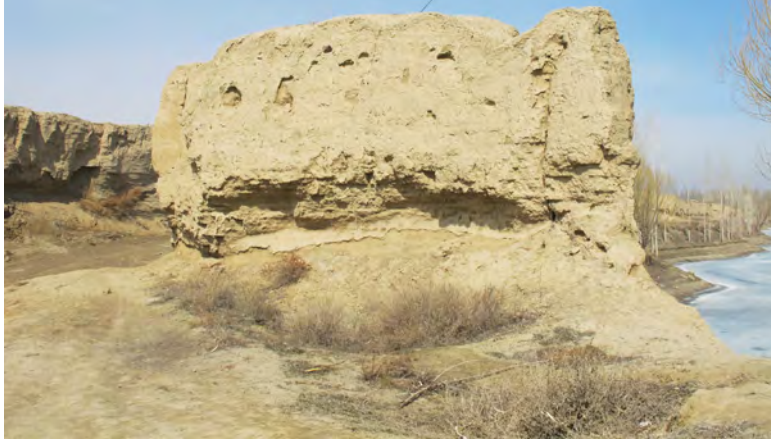
Erosion refers to the loss of earth to a certain depth, under the action of wind, rain, water and salt crystallization. It is a typical decay in the arid regions of northwest China.

Fig. 3 Erosion deterioration

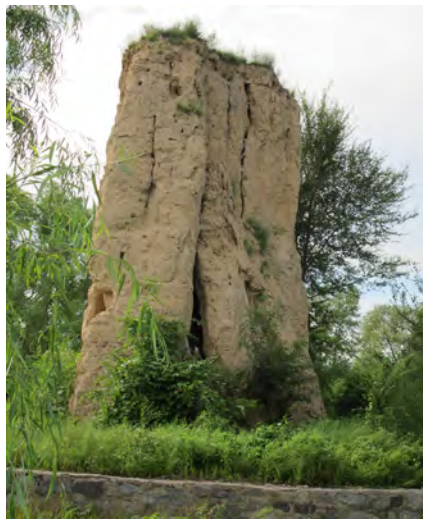
Fissures can develop due to different causes such as unloading fissures, structural joints, deformation fissures and manufacturing fissures. They often started the process of collapse.

Fig. 4 Fissure deterioration

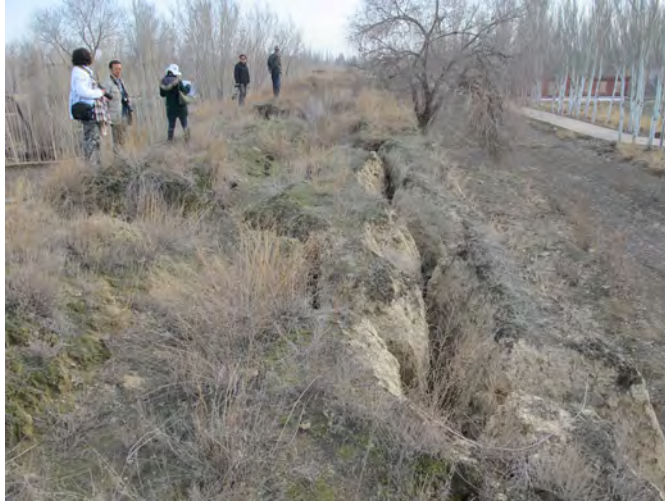
Gully are formed through surface runoff generated by rainfall especially in the proximity of reliefs (Zhao et al., 2003). Fissure gullies and runoff gullies can be recognised.

Fig. 5 Gully deterioration

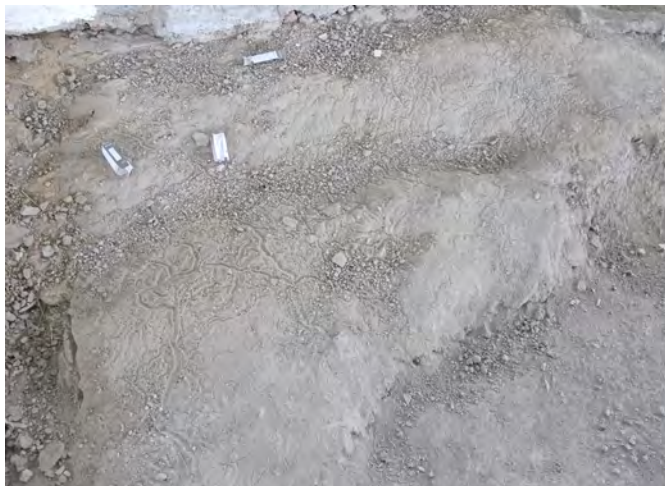
Pulverization is caused by periodic changes in the temperature and humidity, freezing and thawing or salt crystallizations.

Fig. 6 Pulverization decay effect

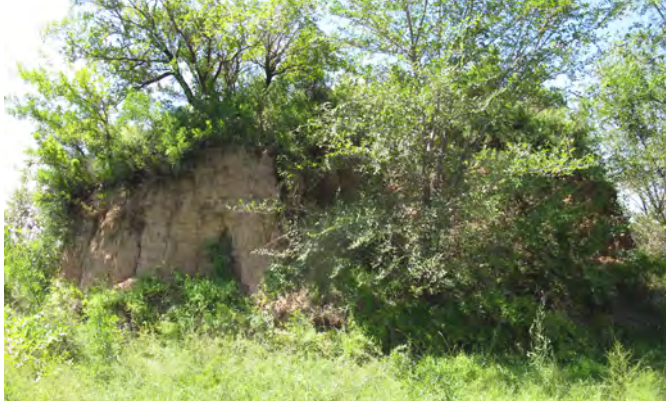
Biological damage is caused by the actions of animals or plants present around earthen sites.

Fig. 7 Biological damage caused by plant growth on earth sites

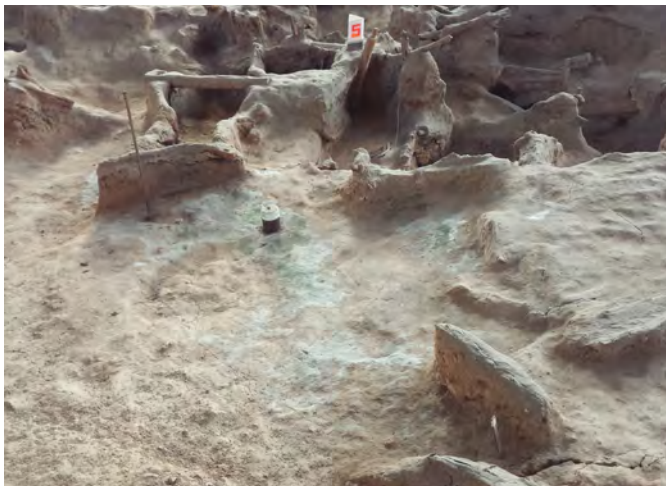
The decay due to microorganisms can cause serious damage to earthen sites. Some bacteria and molds can produce organic acids that directly decompose organic and inorganic matter in the earth causing powdering and flaking. In addition, some molds can secrete pigments which can adhere to the surface of cultural relics, and affect the appearance of earthen sites.

Fig. 8 Deterioration due to the growth of microorganisms: color variations, powdering and flaking

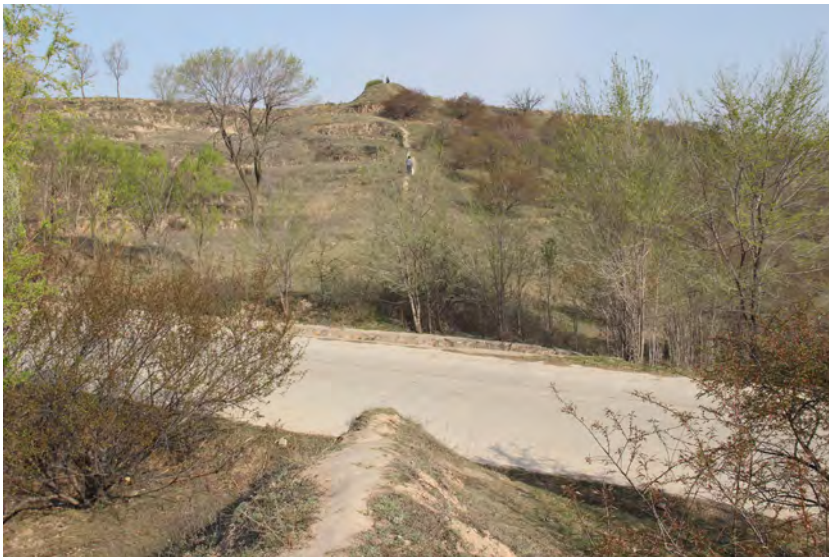
Modern destruction refers to the destruction of earthen sites caused by modern human activities. The forms and contents of modern destruction are complex and varied, such as industrial construction, agricultural farming, soil collection, houses building, roads building and water carriage system construction.

Fig. 9 An example of modern destruction, the Great Wall cut into two sections by a road

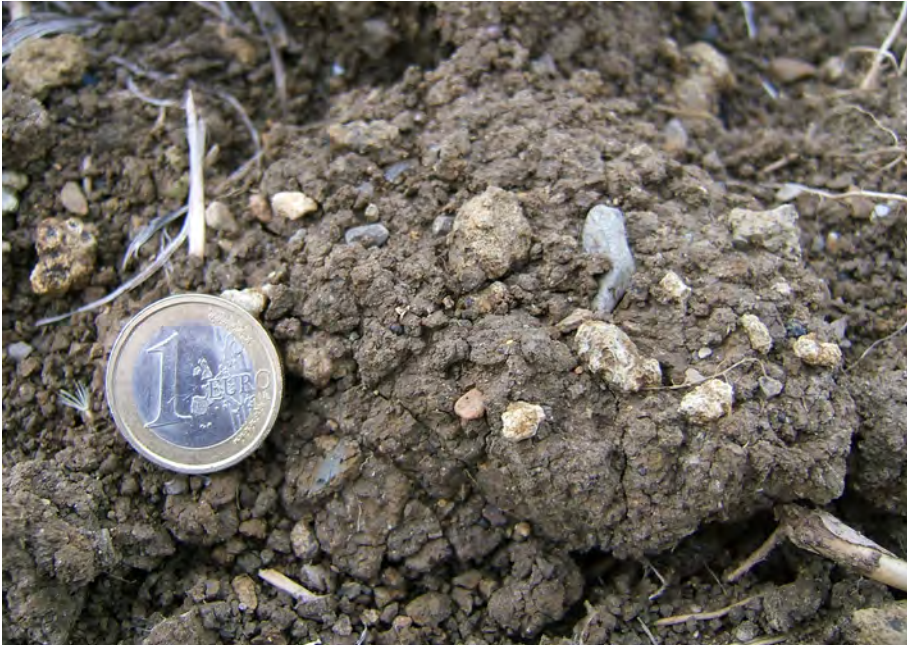
The mineral component of an earth consists of a fine-grained fraction mainly composed of *clay minerals* belonging to the Phyllosilicates class (which dimension is below $4\ \mu\text{m}$) and a coarse-grained fraction (silt, sand and gravel fractions) composed of quartz, feldspars, carbonate, iron hydroxides and rock fragments (Fig. 1).

Fig. 1 Particular of an earth, it is possible to recognize the different grain fraction and the organic component

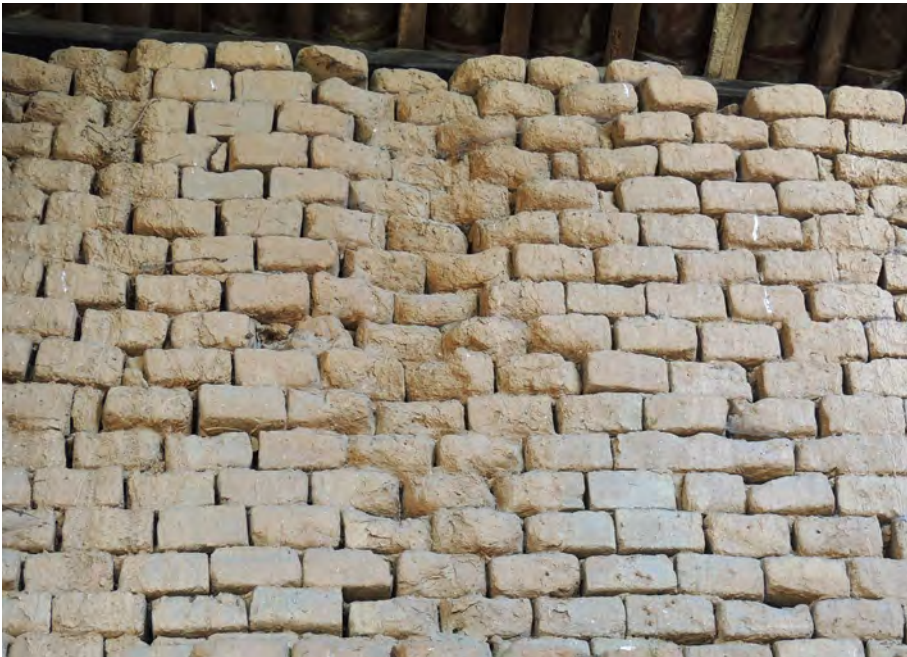
Fig. 4 Rain erosion of an adobe masonry in Piedmont (Italy) due to lack of maintenance of the roof

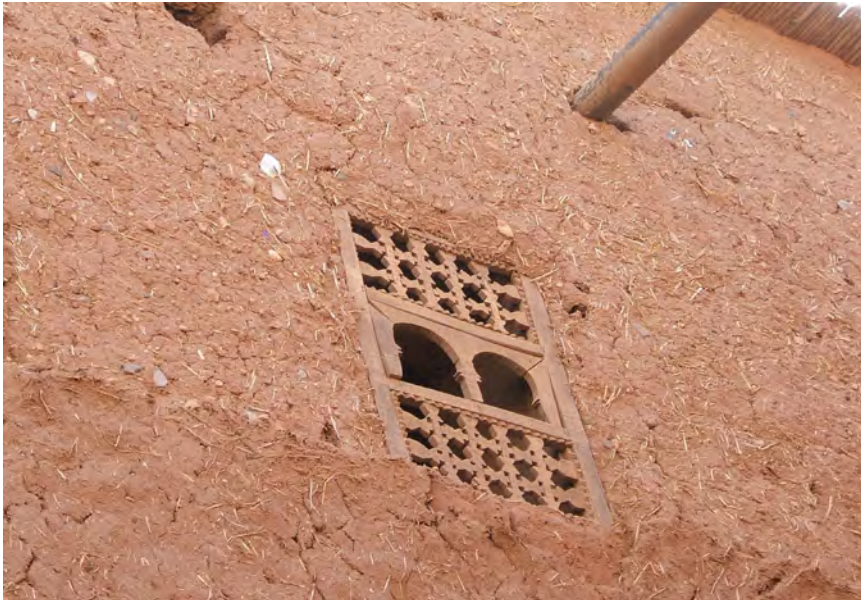
Fig. 6 Earthen plaster added with vegetable fibers to avoid shrinkage fractures (Morocco)

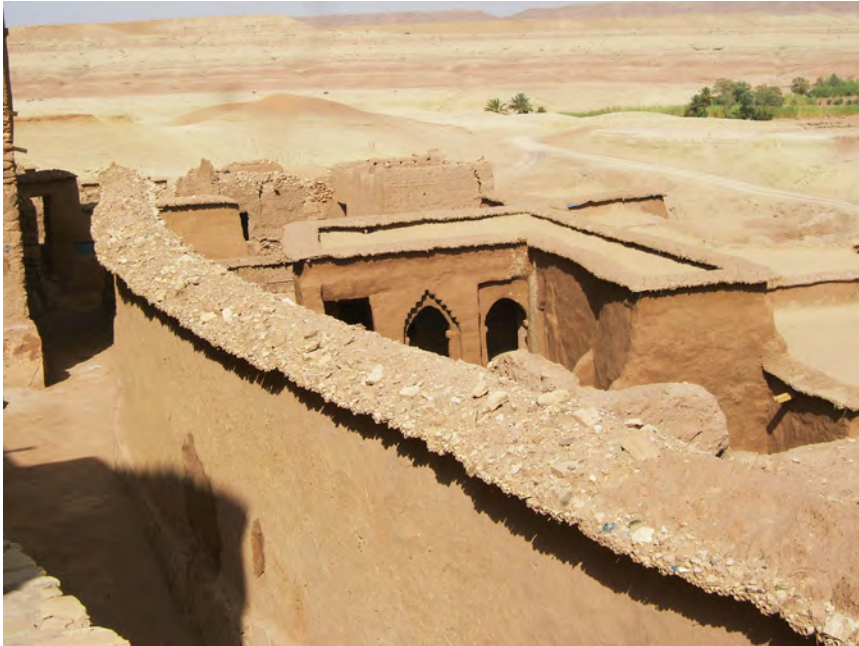
Fig. 9 Protection of the ridge of the walls to avoid water infiltration (Morocco)

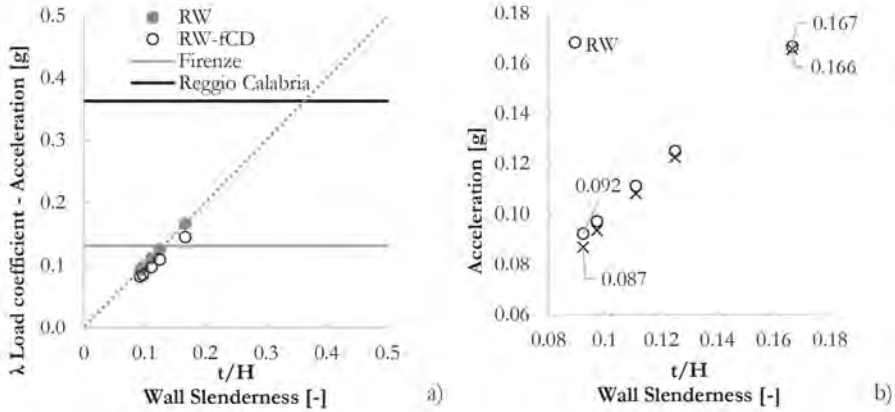
For a configuration of the slab on the 4 x 4 m masonry cell where main beams rest on the overturning wall, Fig. 3b shows the values of the activation acceleration of the mechanisms, RW-P2, compared to those of the overturning rigid wall, RW. Looking at Fig. 3b it can be noted that the superimposed slab force P2 affects slender walls more than stockier. Owing to superimposed loads, the value of the activation acceleration decreases, with respect to that of the simple rigid wall, by 5.4% and 0.6% respectively for the slenderest and stockiest profiles.

Fig. 3 a) Load coefficient values, coincident with the activation acceleration, for the overturning rigid wall (RW) and assuming a limited compressive strength $f_{cd}=0.56\text{MPa}$ (RW- f_{cd}) superposed to the expected peak ground accelerations in Firenze and Reggio Calabria (Italy). b) Activation acceleration values of an overturning rigid wall (RW) and for the same wall bearing an over load P2=28KN (RW-P2)

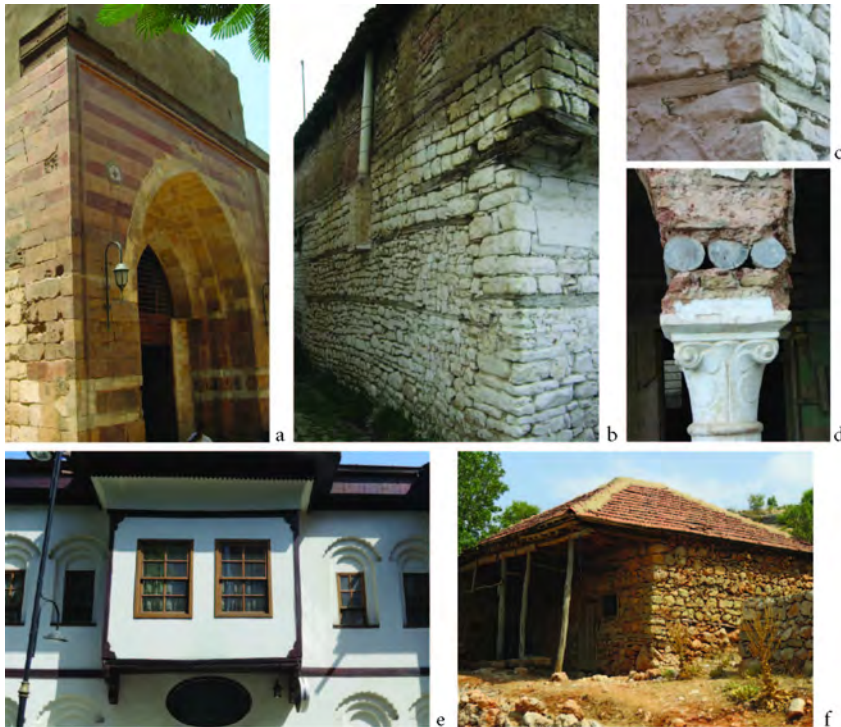
Fig. 4 Examples of anti-seismic and traditional retrofitting techniques making use of timber: a) Bayt es-Suhaymi palace, Cairo, Egypt, XVII century; b) and c) The Kalà of Elbasan, Albania, XV century; d) detail of a capitol of the Dey Palace, Algiers, Algeria, XVI century; e) and f) Malatya, Turkey

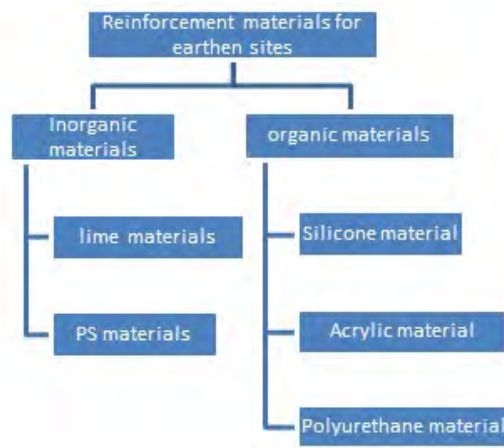
Fig. 4 Category of reinforcement materials for earthen sites conservation

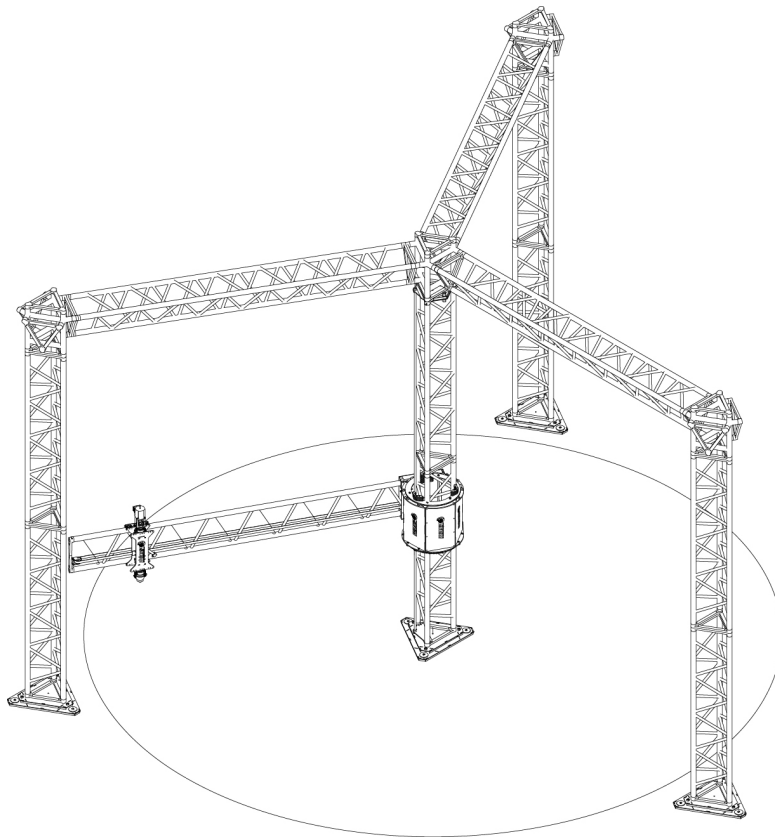
Fig. 2 Crane WASP, technical drawing by WASP, 2018

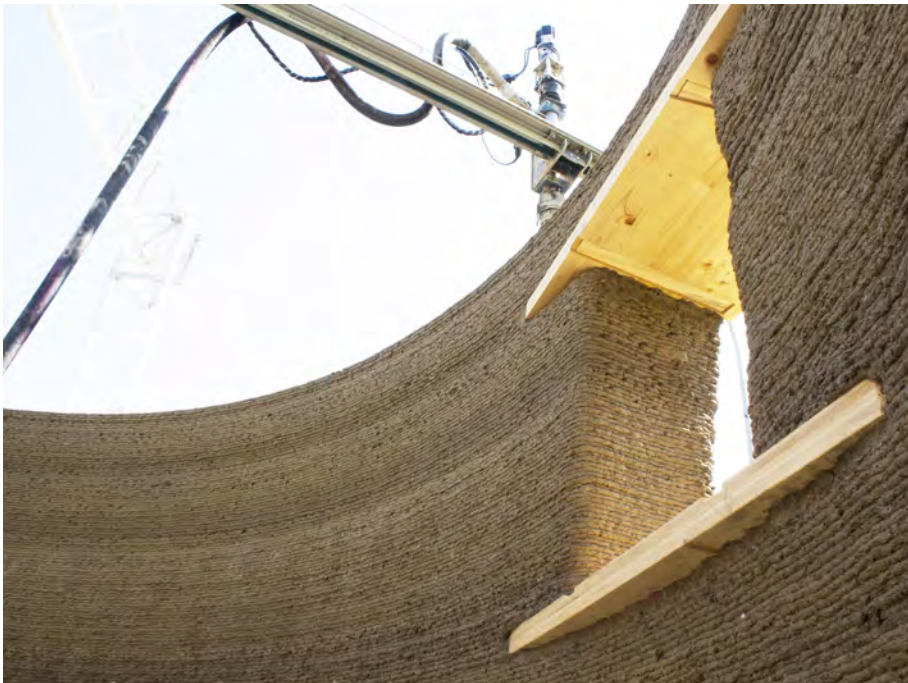
Fig. 4 Earthen mixture in 3D printing process, Gaia house, 2018

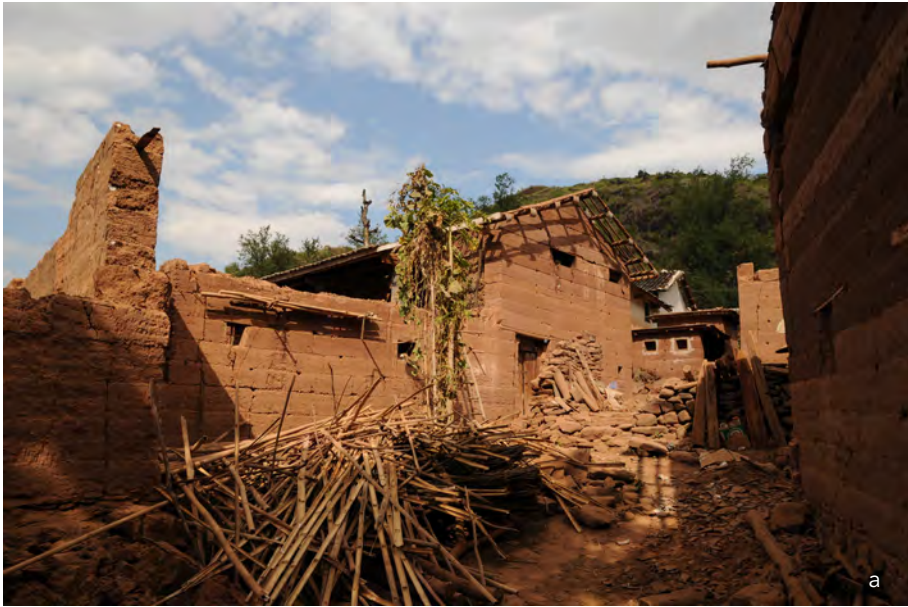
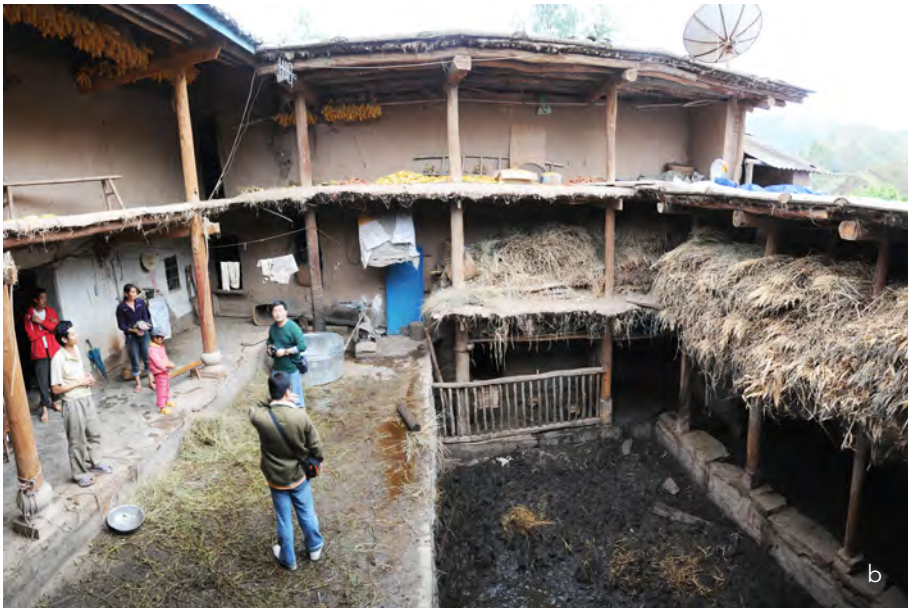
Fig. 6 a-b Local traditional rammed-earth courtyard dwellings and damaged houses after the earthquake

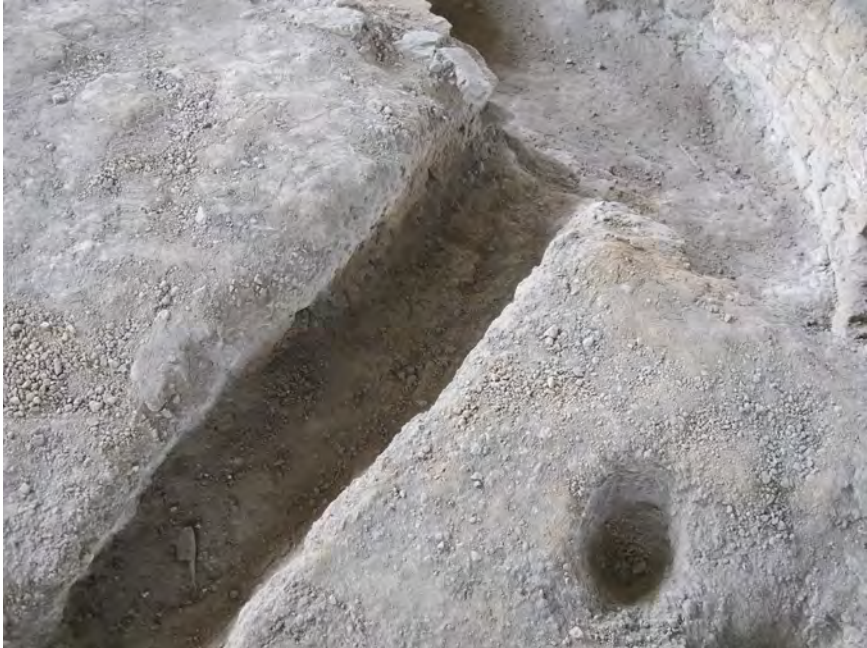
Fig. 2 Pulverization of the earth site: main phenomenon of surface decay

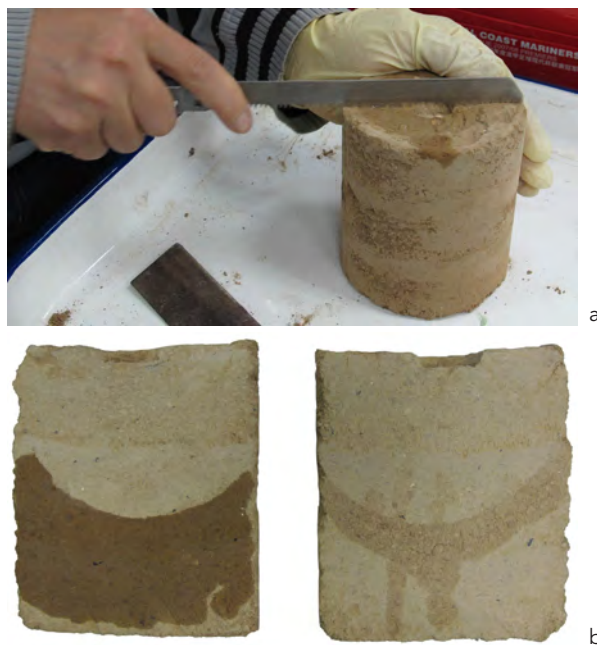
Fig. 3 Earthen samples ($\varnothing 100$ mm \times 120 mm) made for the measurements of the treatment depth: a) earthen samples cut into two halves; b) some water is put in one half the upper dry part means that is consolidated, the lower wet part is unconsolidated (left). The right image is after water evaporation.

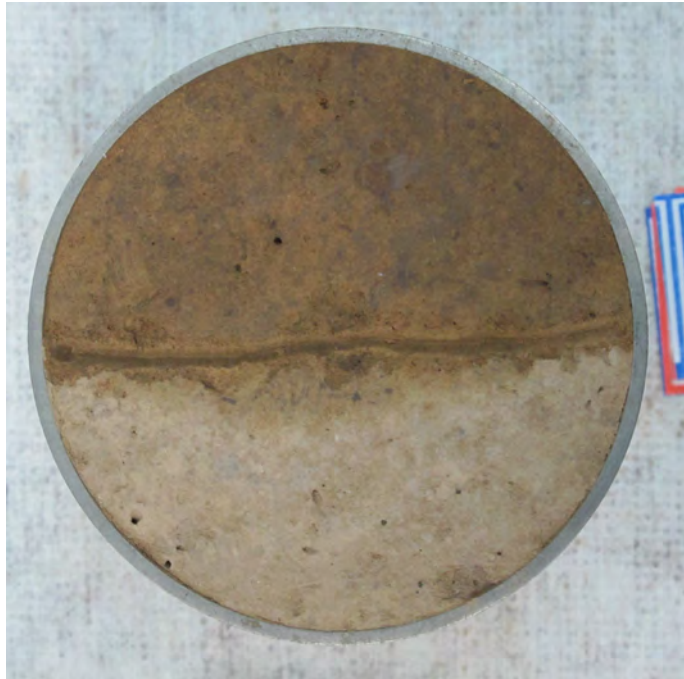
Fig. 5 Earthen samples are divided with a scored line and the consolidant is applied to one half. After curing of the consolidant, the colour difference between the two parts is evaluated to decide the gray scale rating

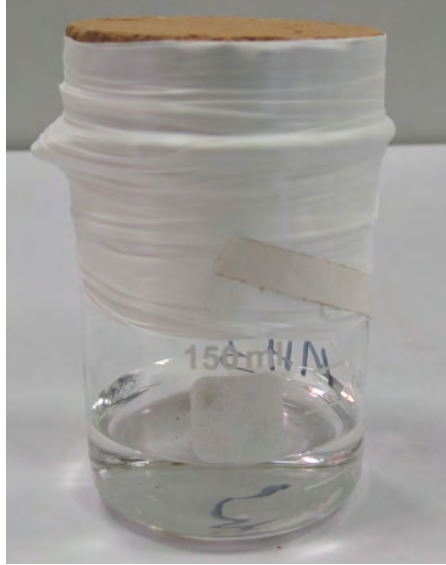
Fig. 6 Earthen samples were fixed on the top of cylindrical containers that are partially filled with water, sealed with a polytetrafluoroethylene tape, to evaluate the water vapour transmission

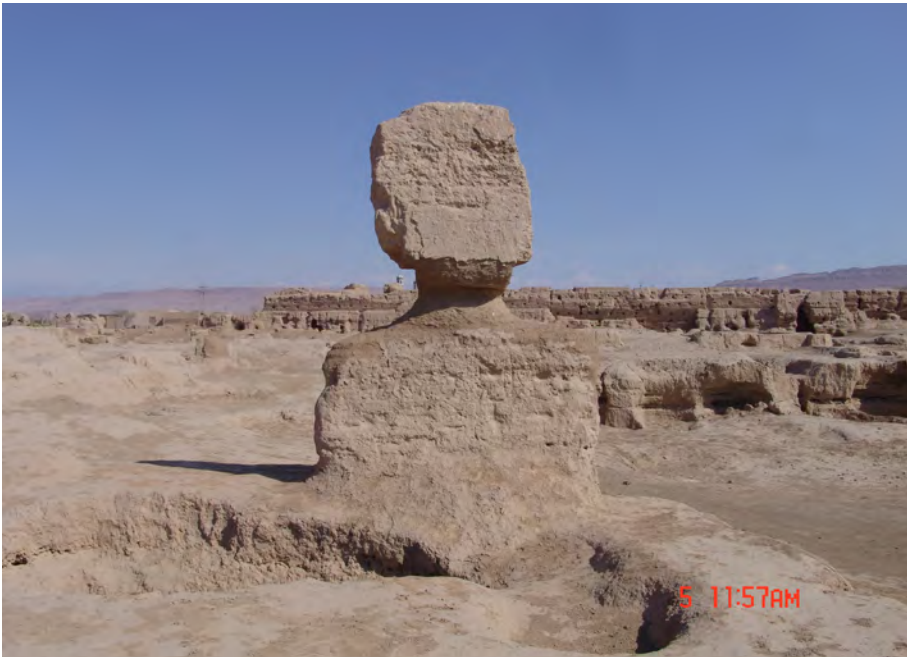
Fig. 3 Rammed earth wall eroded by winds

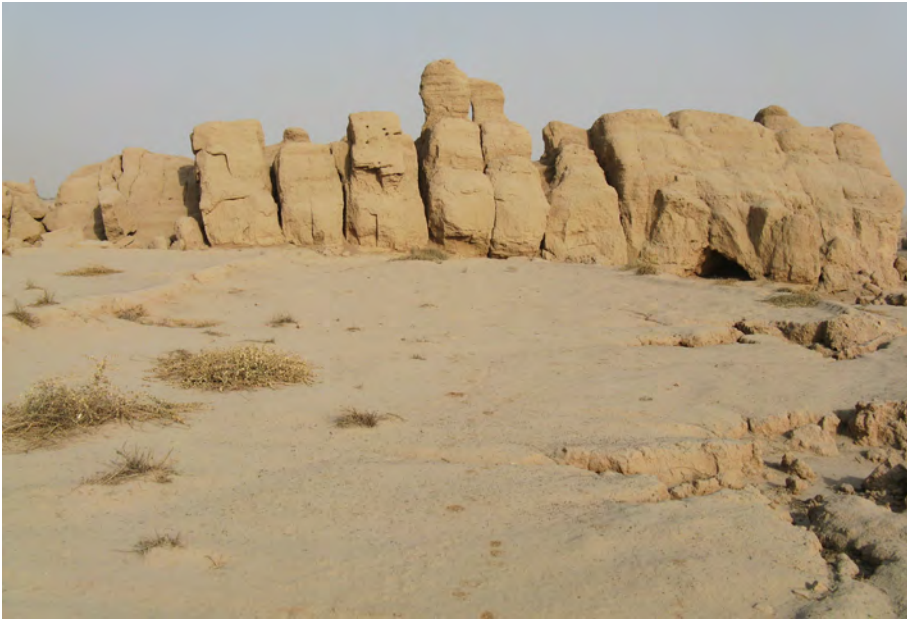
Fig. 4 Fissures on rammed earth walls

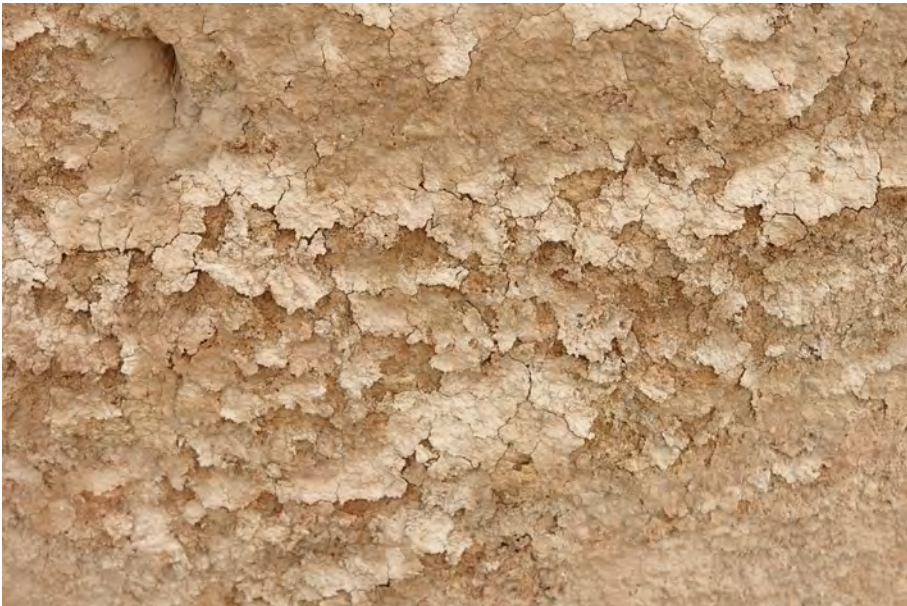
Fig. 5 Thin layer formed on the surface of an earthen wall after rain, subsequently cracked and about to fall

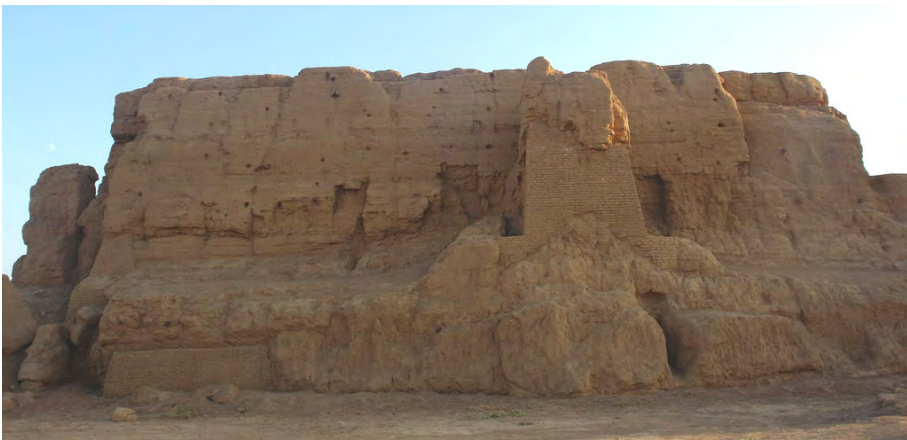
Fig. 8 General view of rammed earth walls after the construction of an adobe masonry support

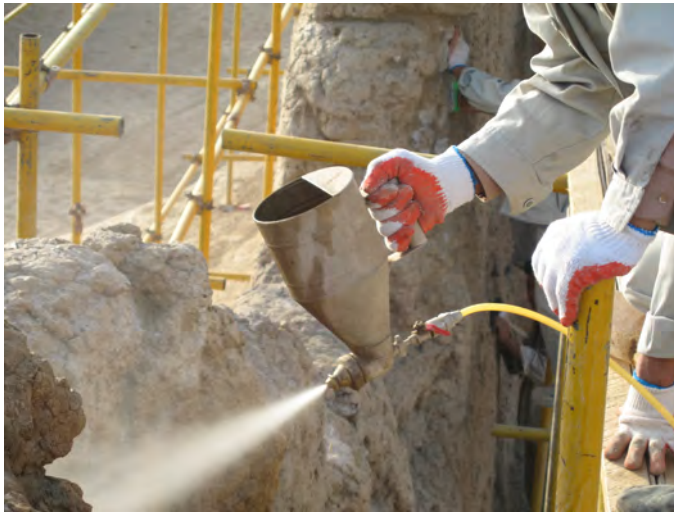
Fig. 10 Application of the consolidating product by spraying

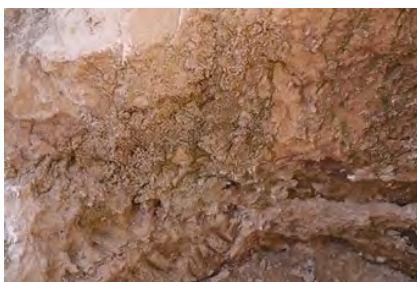
Fig. 1 Weathering of a southern surface of area F29 of the Lajia site

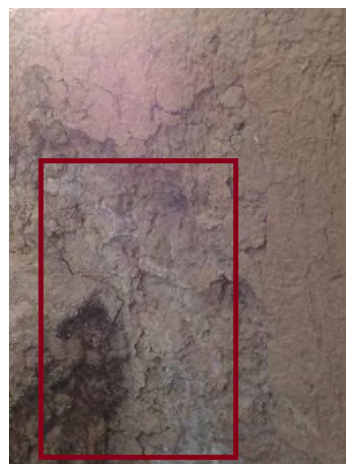
Fig. 4 Biodegradation caused by mould in area F29 (red square)

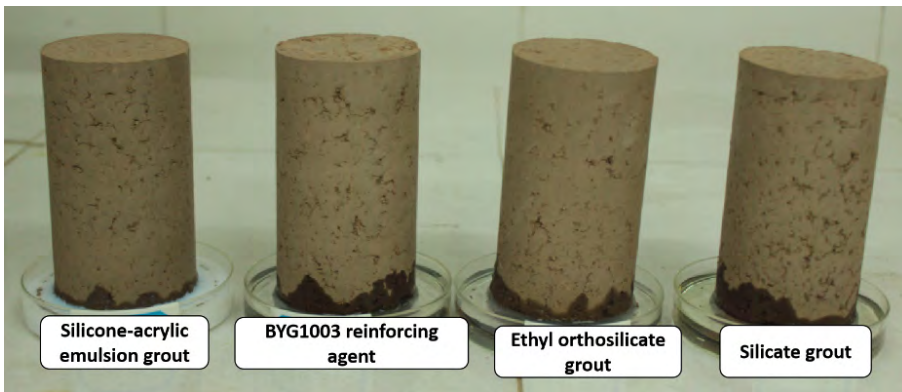
Fig. 7 Penetration depth test on cylindrical soil samples treated with four reinforcing materials

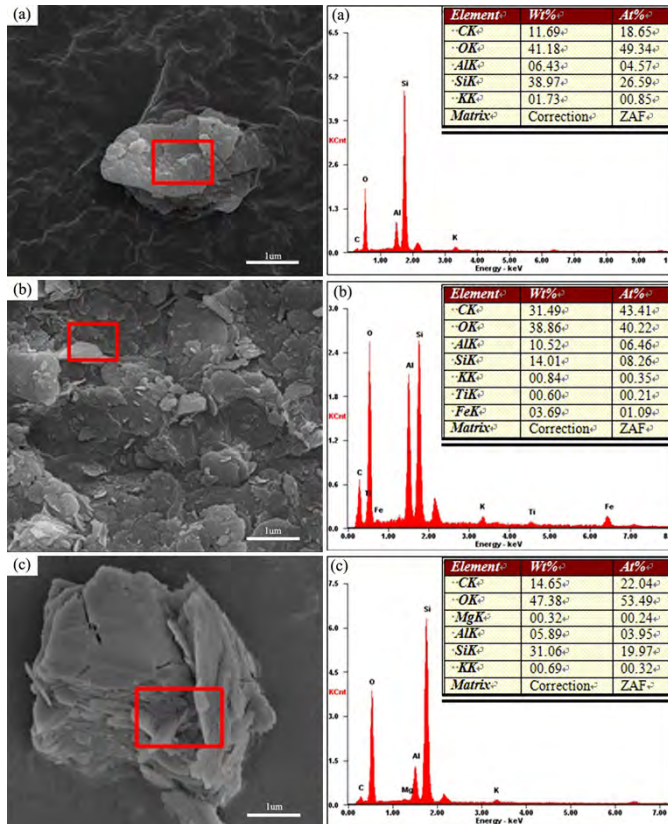
Fig. 2 SEM-EDX results of the three earthen samples; (a) 1# (earth inside the museum); (b) 2# (earth from the open-air); (c) 3# (earth from the ground surface)

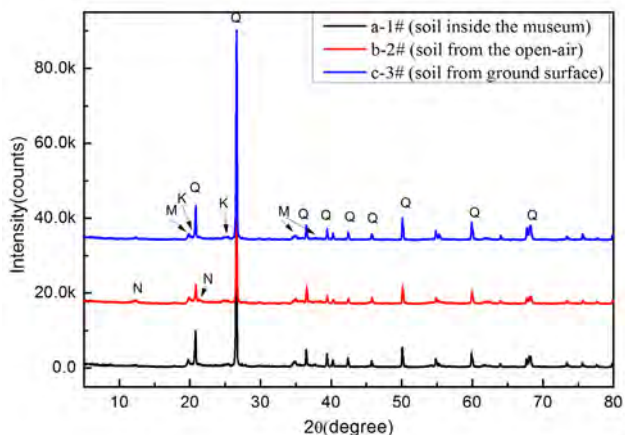
Fig. 3 XRD results of the earthen samples collected in the Tongguanyao site (Q-quartz, M-mica, K-kaolin, N-nacrinite)
