The case study of Cancia (Dolomites, Italy), a mountain village threatened by a debris flow

Abstract The village of Cancia, close to Cortina d'Ampezzo (Italian Dolomites), has been many times hit by destructive debris flows that caused deaths among dwelling people and severe damage to houses and roads; the most recent of these disastrous events happened in July 2009 and caused the death of two people. This study considers the cases of the most calamitous past debris-flow events: the morphological settings of the initiation area are illustrated, along with an analysis of the processes that led to the formation of this dangerous phenomenon. In particular the critical interaction between geological and anthropic systems are examined showing the hazardous effects of the realization of a tourist development in the area. A critical review of the countermeasures so far proposed concludes the study.

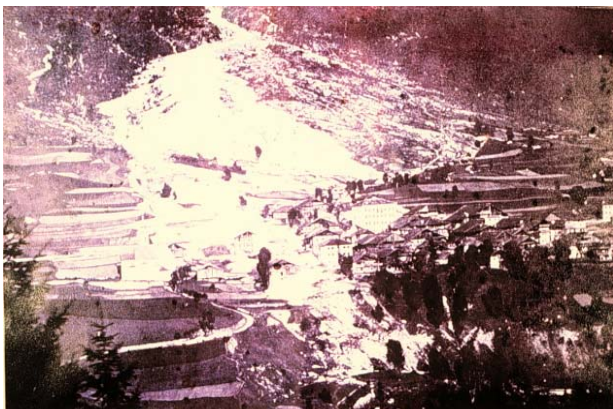
Figure 3 Photograph of Cancia village after the 27 July 1868 debris-flow event.

The earliest documented event is dated 1868: the debris flow deposited more than 100,000 m³ of material over an area of 203,000 m² (Fig. 3 and 4); it claimed 12 lives and destroyed 13 buildings.

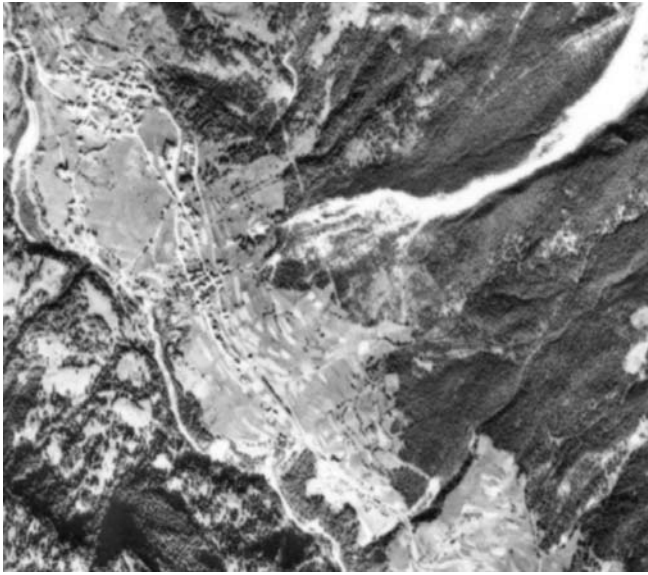
Figure 6 Cancia aerial photograph taken before the construction of the tourist cottages (1954).

Surely there is an effect of change in historical recording attitude with time, but it is as much sure that the tourist development built from the mid 1950s takes a big responsibility on the debris-flow frequency increasing that followed its realization for the big modifications of the previous natural setting of the fan. Before the construction of the tourist chalets, Cancia was a very small mountain village which comprised only a few dozen houses. After the disastrous events of the late 19th century the fan at the end of the debris-flow channel was left free from buildings and debris flows could spread freely on the fan (Fig. 6) for as long as almost 70 years. In particular, the development

comprehends many cottages and a large common structure; the construction started in the mid 50s and continued till the first 70s and the buildings are located mainly in the debris-flow deposition area (areas 2 and 3 in Fig. 5). Only the northern-most channel was left, while the others (visible in Fig. 6) were buried to build the first group of about 65 cottages; the resulting channel was narrowed and deepened, the curvature radius of the two bends on fan were reduced with the final consequence to shift down the deposition area of debris flows, much closer to the historical settlement of Cancia and just above it (Fig. 7). The memory of the disasters of 70 years before was lost.
