## Dynamic monitoring of a tunnel-like masonry structure via WSN

This paper reports an application of wireless sensor network technology to the long-term monitoring of a historic masonry tunnel-like structure located in Italy. The monitoring was performed within the activity of a research project aimed at providing a general framework to check the structural health of heritage structures and to real-time detect any potential damage that may compromise their safety. The tunnel-like structure was selected being, to the best of authors' knowledge, a challenging experiment both for the type of structure itself and for the technical solution to be employed for installing the monitoring system. This paper, after a brief description of the installed monitoring system and the design of the sensor layout, summarizes the lesson learned after one year of monitoring.

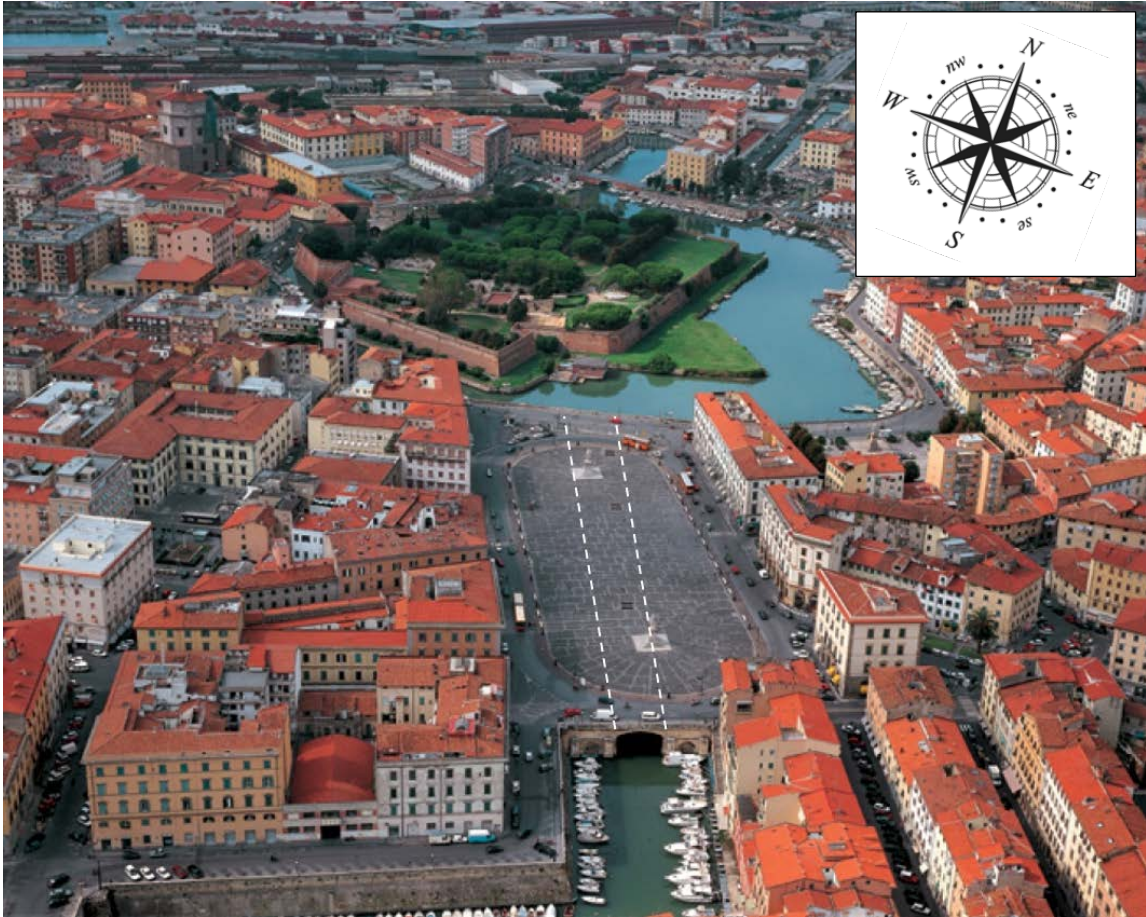
Figure 1. Piazza della Repubblica, Livorno (Tuscany, Italy). The southern entrance of the “Voltone” is visible in the lower part of the image. The white dashed lines indicate the underground tunnel-like structure.

This paper is focused on the “Voltone” (i.e. big vault), a 220-meter long vaulted masonry tunnel located under Piazza della Repubblica (Republic Square) in Livorno (Figure 1) and subject to traffic vibrations coming from the overlying streets, running around the square. The square (about 18000 m<sup>2</sup>) and the tunnel were built in the first half of the nineteenth century by the architect Luigi Bettarini, under the government of Leopoldo II d’Asburgo-Lorena (Bellinazzi and Contini, 2002), by burying a large area of the so-called “Fosso Reale” (Real Canal) and channelling the water under the tunnel.

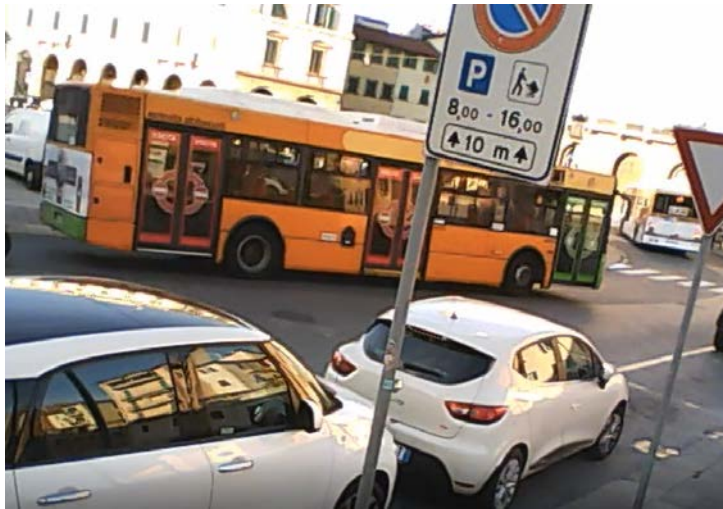
Figure 6. Event E2: (a) Passage of a bus over the vault (the camera is installed over “Via del Voltone”) and (b) spectrogram of the signal.

The results of this analysis are shown in Figure 5 (event E1), and Figure 6 (event E2); the energy peaks correspond to the frequency band identified in Figure 3, confirming the presence of the resonant frequencies shown in Figure 3. Furthermore, it is worth noting that the vehicle speed plays an important role on the PCPV; in fact, visual inspection of the videos recorded on the square revealed that the garbage truck was faster than the bus. Correspondingly, despite the lower weight, the dynamic effect of the truck on the vault results more evident than that of the bus, thus confirming the model proposed by Watts (Watts 1990). Concluding, the results of the dynamic test performed on the structure can be summarized as follows:

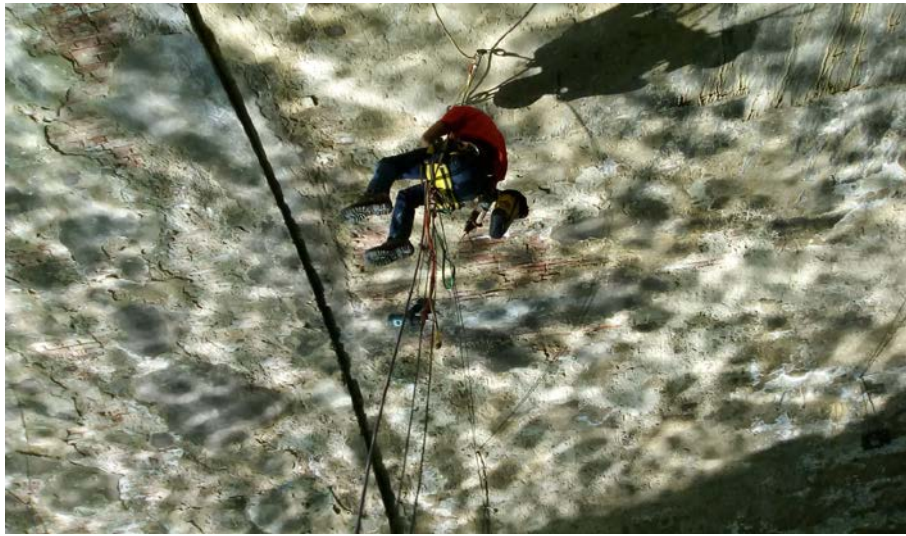
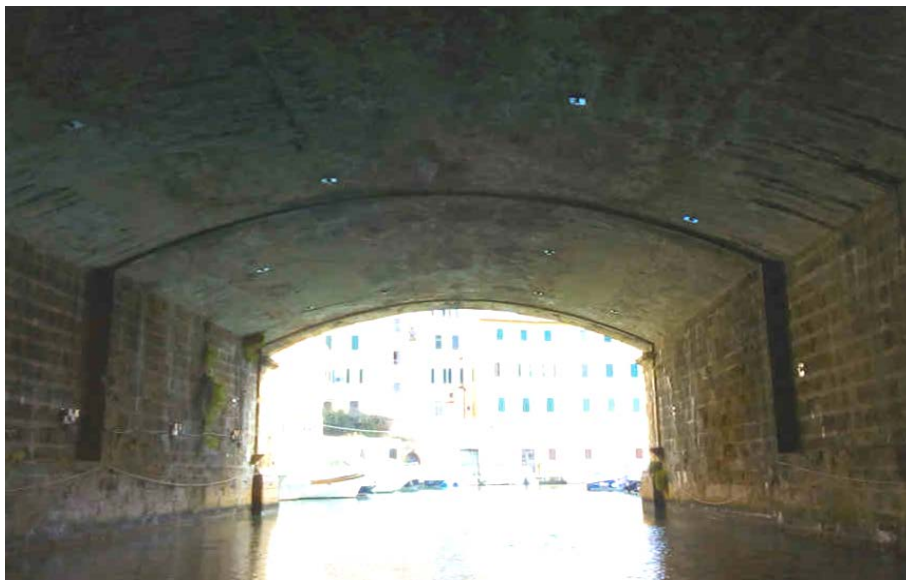
Figure 7. Long-term monitoring system: installation of the sensors (a) and final layout of the sensors in the southern end of the vault (b).

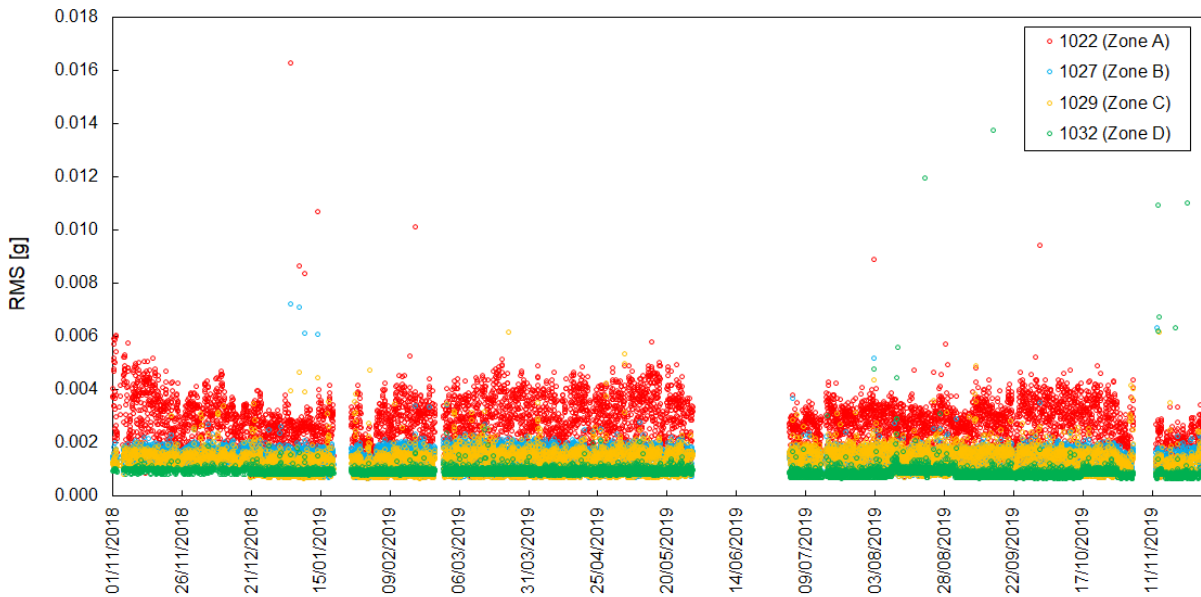
Figure 10. RMS of the signals recorded by the MOSCARDO accelerometers placed on the vault from 1 November 2018 to 30 November 2019

Figure 9 and Figure 10 show the RMS (maxima over the day) of the signals recorded in the areas from A to D. In particular, Figure 9 shows the values recorded in the tunnel’s lateral walls, while Figure 10 those recorded in the vault.

The energy content of the signals recorded in the vault turns out to be higher than that recorded in the lateral walls. Moreover, Figure 10 highlights the different energy content of the signals in the four areas of the vault: it is maximum in the first two areas (A and B), located under “Via del Voltone”, and tends to decrease going inward in the tunnel (D area),

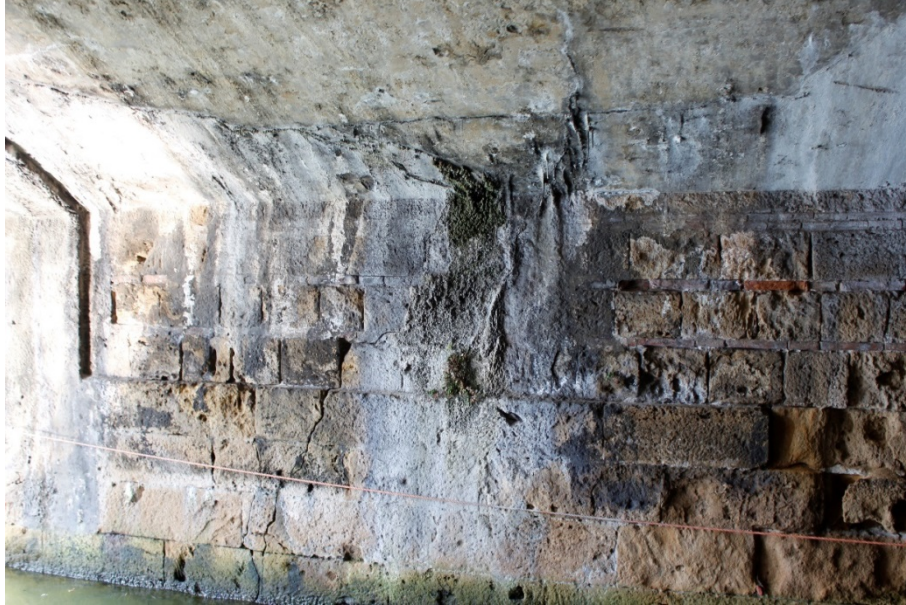
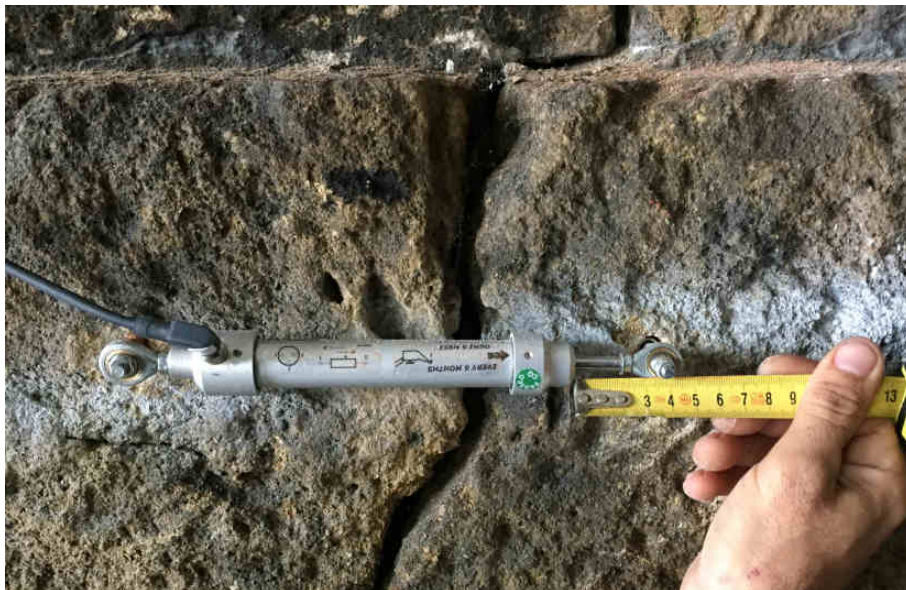
Figure 11. Crack in the eastern wall (a) and installation of the displacement transducer (b).

The “Voltone” is located in an environment with very high humidity levels. The effects of these adverse environmental conditions are well visible in the stone coverings of the facades and the material surfaces of the tunnel. The masonry structure appears, however, in fair maintenance conditions. The only visible crack inside the tunnel is in the northern part of the structure: the crack involves the eastern wall and a portion of the vault (see Figure 11). Two linear displacement transducers (indicated as 1050-1051) were installed on the crack, together with a sensor for temperature and humidity measurements.
