Chapter 17

Historical Climatology of Storm Events in the Mediterranean: A Case Study of Damaging Hydrological Events in Calabria, Southern Italy

Olga Petrucci and Angela Aurora Pasqua

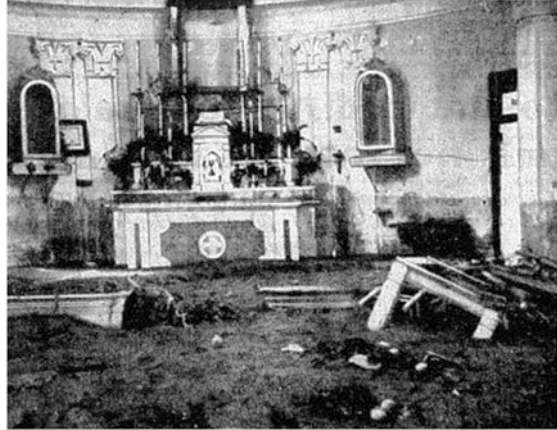
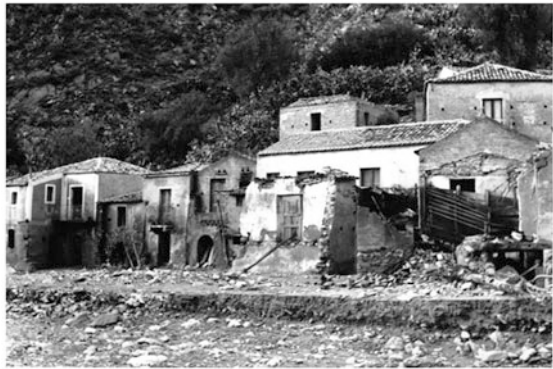
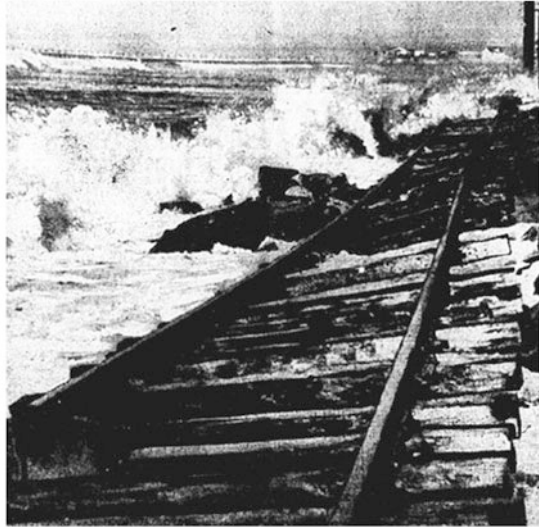
Fig. 17.3 1953 DHE.
Top image, the church of Oliveto village (Reggio C.) flooded by a torrent: the priest died near the altar (Photo from the archive of the newspaper *La Stampa*). In the *middle*, some houses of Oliveto village located along a river and damaged by the flood (Photo from the archive of the newspaper *L'Unità*). *Bottom*, the railway damaged by sea storms in Reggio C. province (Photo from the archive of the newspaper *La Stampa*).

The rain, very intense between 21st and 22nd, increased river flows causing rapid and highly damaging flash floods. An extraordinary violence characterized the floods of the basins located at the southernmost margin of the region, in Reggio Calabria province (Fig. 17.3).

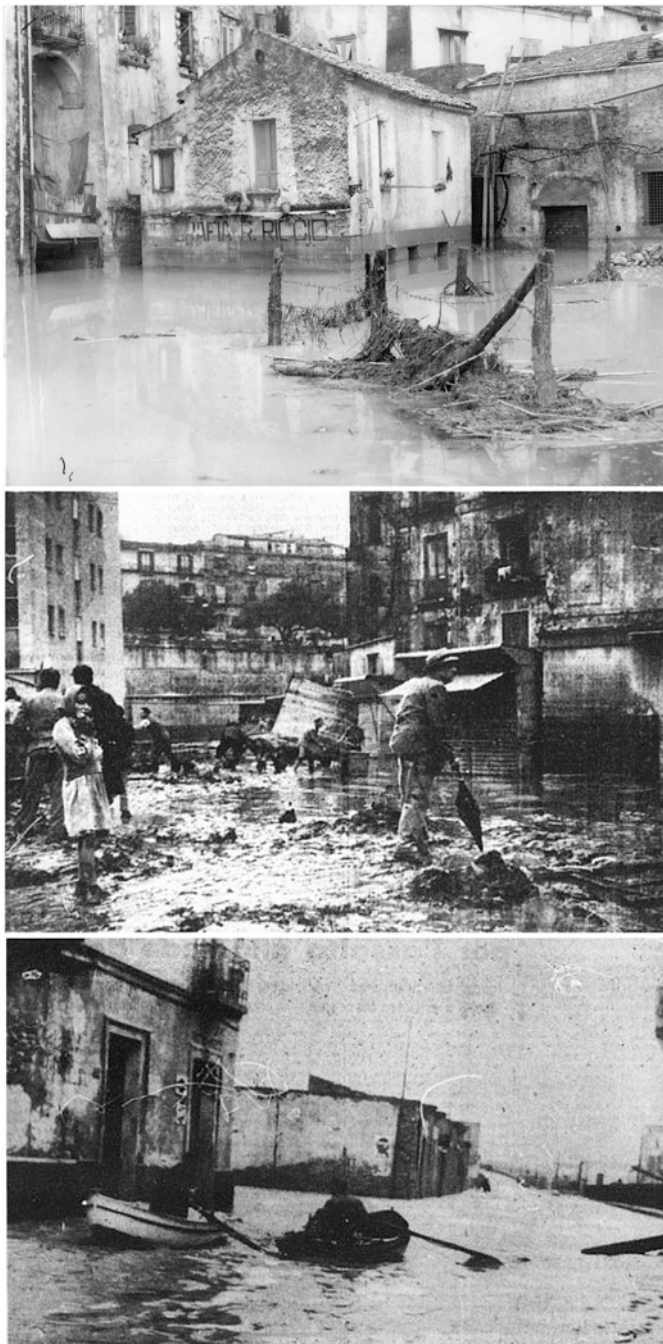
Fig. 17.4 1959 DHE. *Top and middle images: flood in Cosenza town (top, photo from Petrucci et al. 2009; middle, photo from the archive of the newspaper *La Stampa*). Bottom: Catanzaro town flooded (Photo from the archive of the newspaper *La Stampa*)*

On the south east area, damage was caused by both landslides and rivers overflowing which produced numerous roads and railways interruptions. On the northern sector, in the larger basin of the region (Crati Basin), the river and one of its tributaries overflowed the town of Cosenza by completely destroying the river-side neighbours (Fig. 17.4). On the medium-east sector, river floods and sea storms caused prolonged floods and rivers overflowing, as in the town of Catanzaro, while in the Crotona provinces, damage to industries and bridge collapses were recorded.

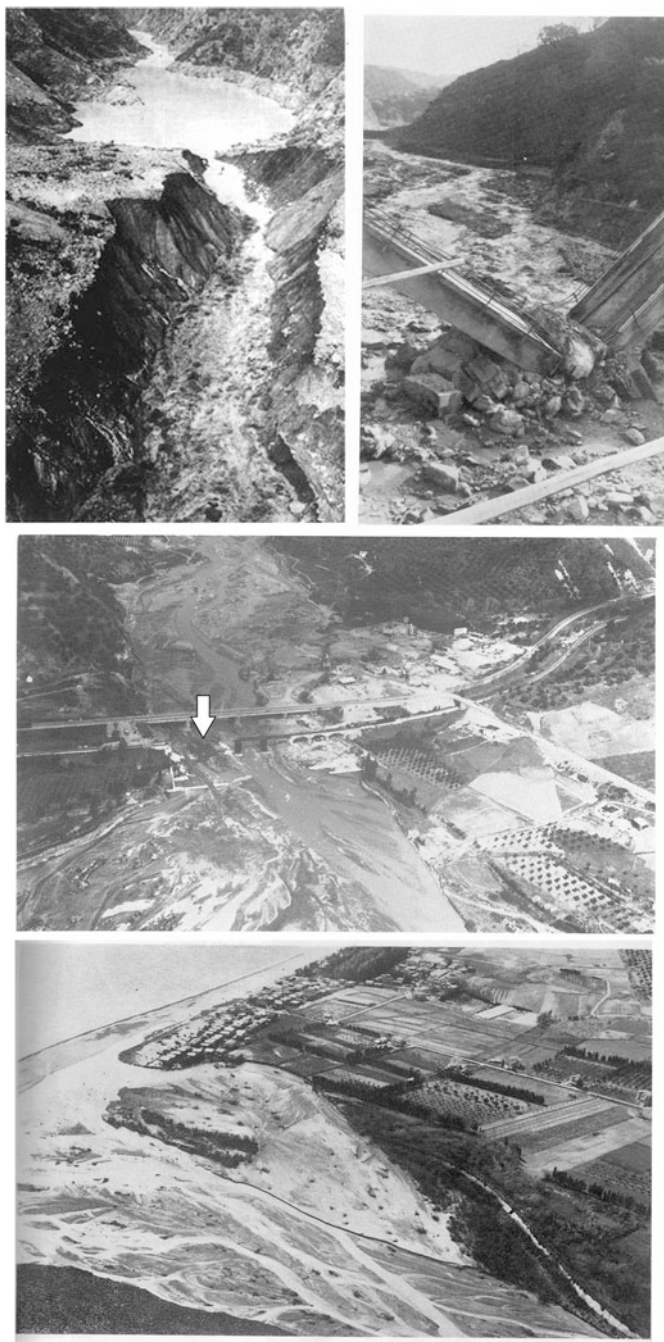
Fig. 17.5 1973 DHE. *Top left*: the Bonamico landslide lake (Delfino 2004); *top right*: the bridge on S. Agata river (Reggio C.). *Middle image*: the railway bridge on Corace river (*white arrow*). *Bottom image*: the Simeri coastal village threatened by Simeri river) (the last three photos were published in Giangrossi 1973)

Since high saturation level was reached because of the previous rain, this downpour caused the overflow of rivers located on the east sector, where violent sea storms further obstructed the flow of rivers into the sea. In the meanwhile, huge landslides were triggered, as the one that blocked the Bonamico River, in the Reggio C. province, creating a temporary lake which threatened a village on the riverside. The lake was artificially drained without causing further damage (Fig. 17.5).

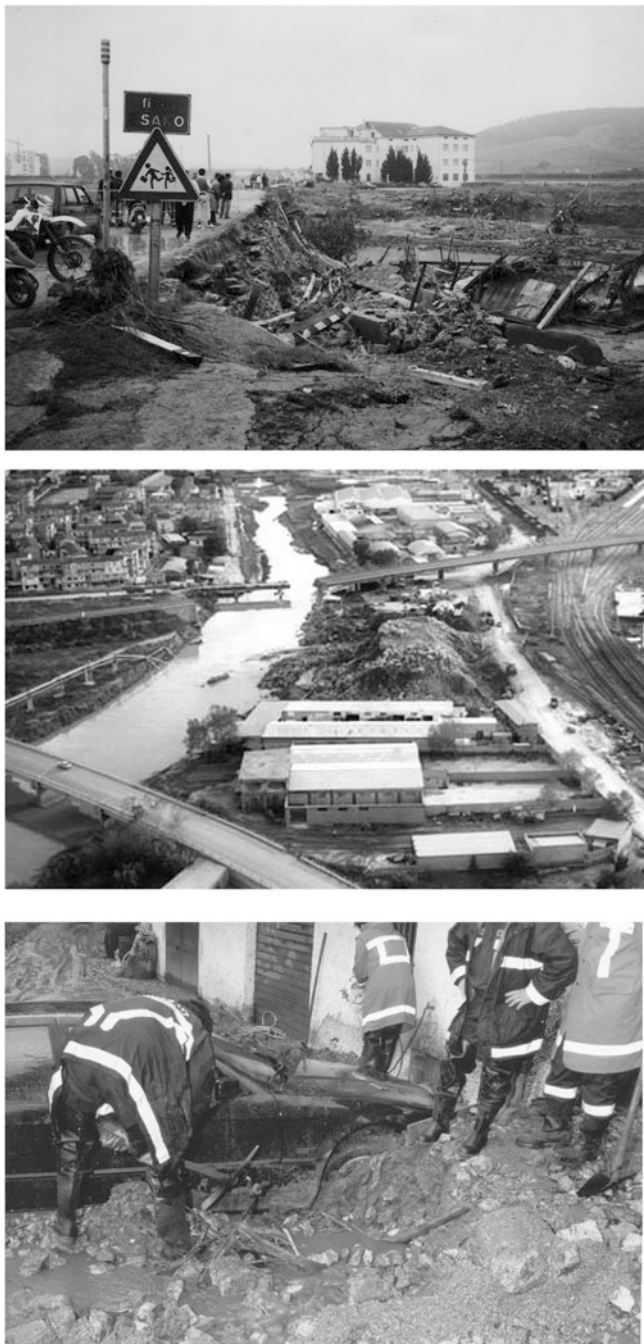
Fig. 17.6 Crotona DHE. *Top and middle photos*, Crotona town after the flood and a broken bridge. *Bottom image*: damage in Cosenza province (Cerisano village)

This rain caused impressive floods of the two basins passing thorough Crotona town (Esaro and Passovecchio Rivers) (Fig. 17.6).

Water overflowed and invaded industries, shops, ground floor of the riverside buildings – especially in the Gabelluccia and Fondo Gesù neighborhoods – swept away cars and destroyed a bridge in the town. In some neighborhoods, the overflowed water almost reached the height of 4 m.

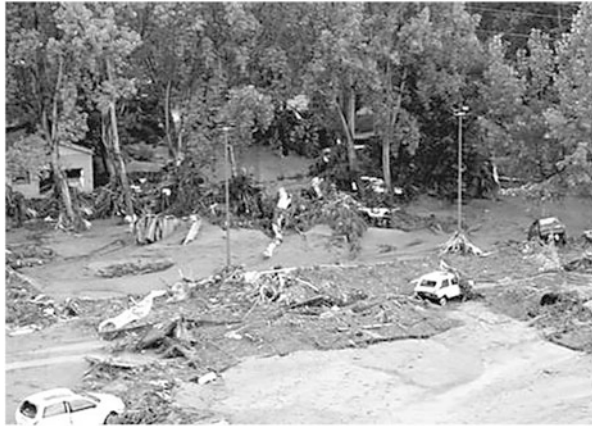
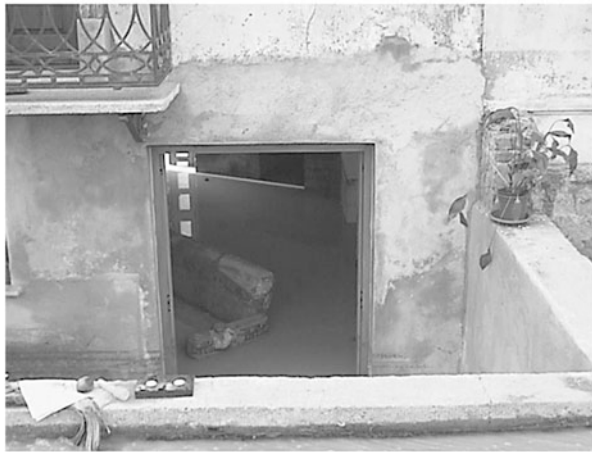
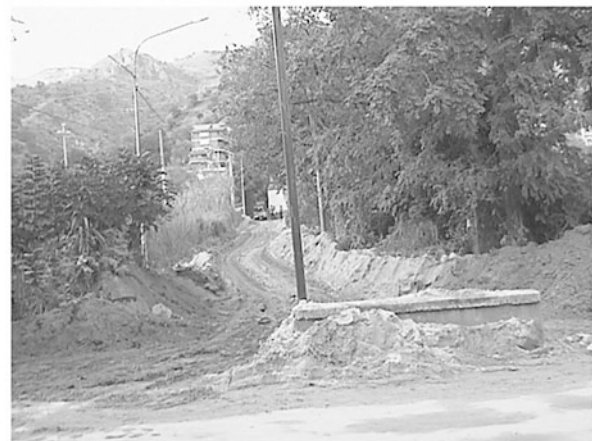
Fig. 17.7 Soverato DHE.
Top: the camping where victims occurred (From: http://www.strill.it/index.php?option=com_content&task=view&id). *Middle* and *bottom images*: rivers overflowing in Locri (Reggio C.)

Southward of this area, in the south-east sector of Reggio C. province, severe effects of urban flooding affected road network, private houses and commercial activities (Fig. 17.7). In Roccella village, more than 100 houses were evacuated because inundated by rivers outflowing, and more than 100 cars and numerous dustbins were carried by the water flowing along the urban streets until the sea.

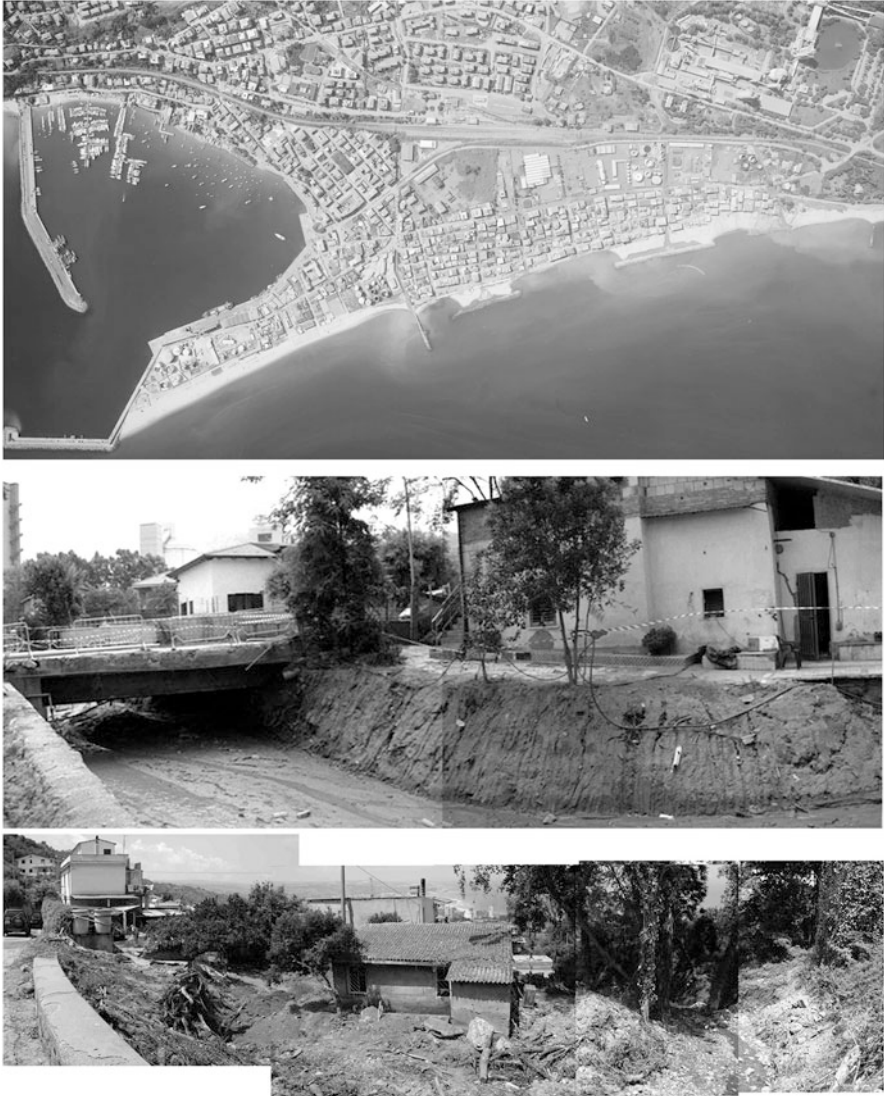
Fig. 17.8 Vibo Valentia DHE. At the *top*, air photo of Vibo harbor area where the turbidity of the sea and the mud in the urbanized area are represented by light grey tones. *Middle* and *bottom* images, debris dropped by floods

This intense rainfall triggered several debris flows along the slopes which rapidly conveyed a huge amount of debris into the river network where flash floods were starting. The solid/liquid mixture which originated had a volume exceeding the capability of both small and large bridges of the area. Then, all the torrent and rivers went out of their beds, especially in the places where bridges acted as a bottle neck to the river flow. At the end of this short event, a wide urbanized area along the coast was completely inundated by mud, and mud plumes in the sea marked the river mouths for several days. Similar plumes were also detected at the end of roads developing perpendicular to the coast: this happened because these roads behaved as rivers, by conveying the mixture of mud and water to the sea (Fig. 17.8).
