Article

ERS-1/2 and Sentinel-1 SAR Data Mining for Flood Hazard and Risk Assessment in Lima, Peru

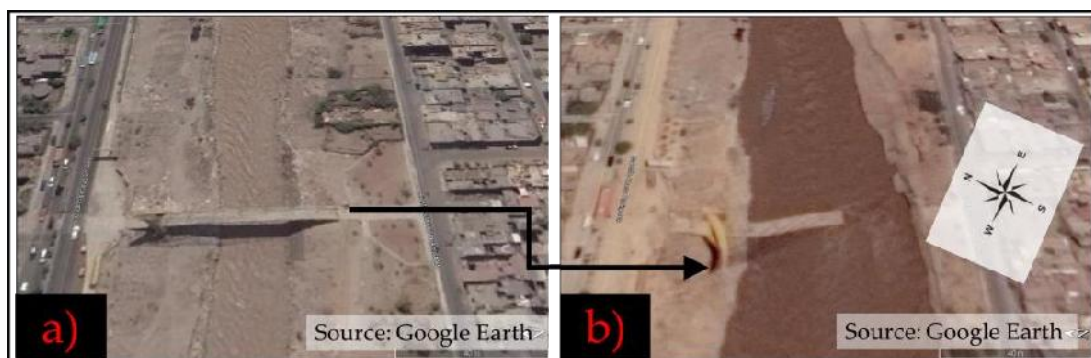
Figure 11. Google Earth imagery (© 2020 Maxar Technologies) acquired on (a) 28/01/2017 and (b) 21/03/2017 showing the Talavera Bridge prior and after the collapse due to the 16/03/2017 flood event, respectively. In (b) the increase of the water flow of the Rímac River is apparent.

Another example was found in the Talavera Bridge, in San Juan de Lurigancho. As also documented in a video published online [88], the part of the bridge collapsed down into the river water during the flood event occurred on 16/03/2017 (Figures 11 and 12). This bridge had been built only six and a half years before.

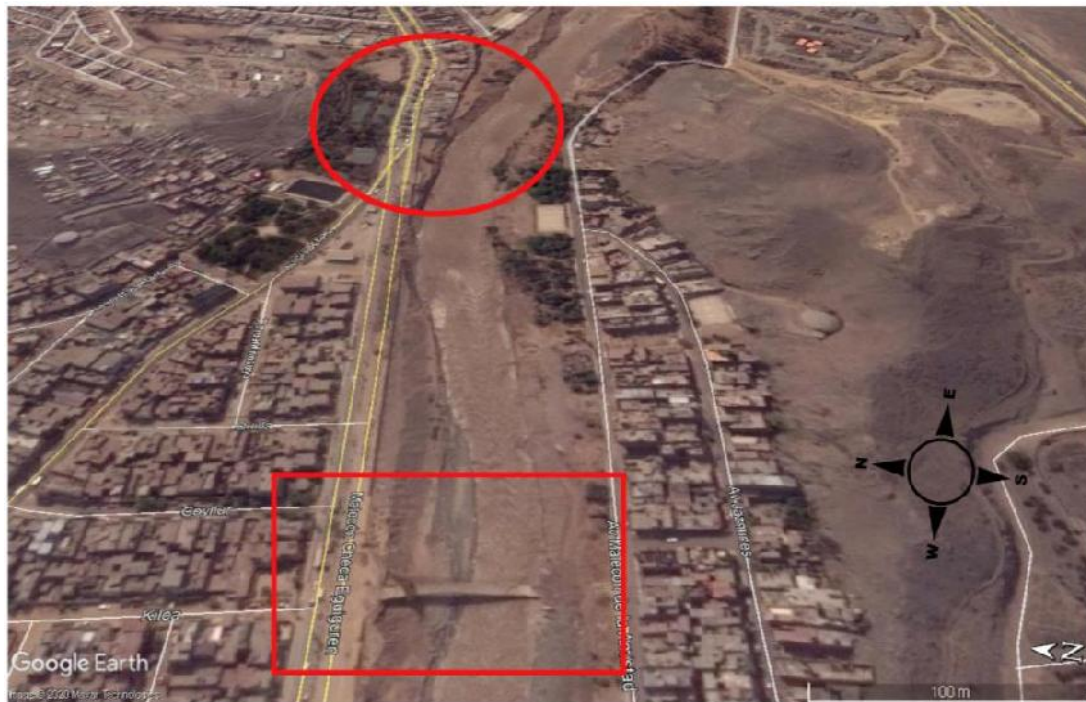
Figure 12. Google Earth synoptic view of the riverbank (red circle; see Figure 10e) and the Talavera Bridge (red square; see Figure 11) collapses on 26/03/2017.

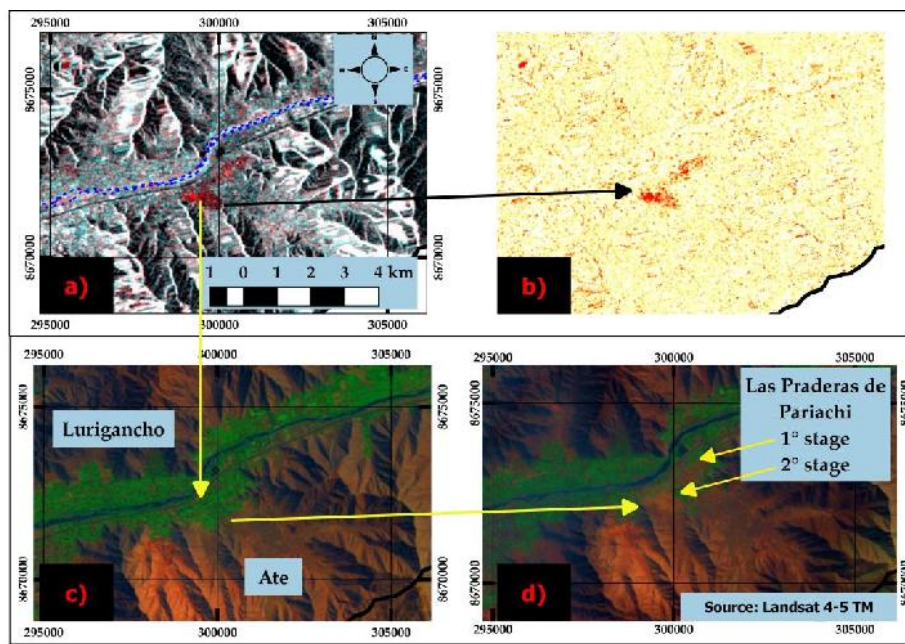
Figure 15. Example of NF2 change “Vegetation cover—cropland changes”: (a) ERS-2 RGB composite and (b) ratio map of the cross-event pair 10/04/1996—20/05/1998 (see Appendix A, Table A1) show a clear pattern of radar backscatter decrease in Las Praderas de Pariachi on the left bank of the Rímac River that, until mid-1996, was occupied by agricultural fields and, afterwards, was subject to urban sprawl, in specific for the development of the residential district [48]. The land-cover transition is confirmed in the band combination 7-4-2 (“natural-like” [89]) of Landsat 4-5 Thematic Mapper (TM) images collected on (c) 14/04/1996 and (d) 22/05/1998.

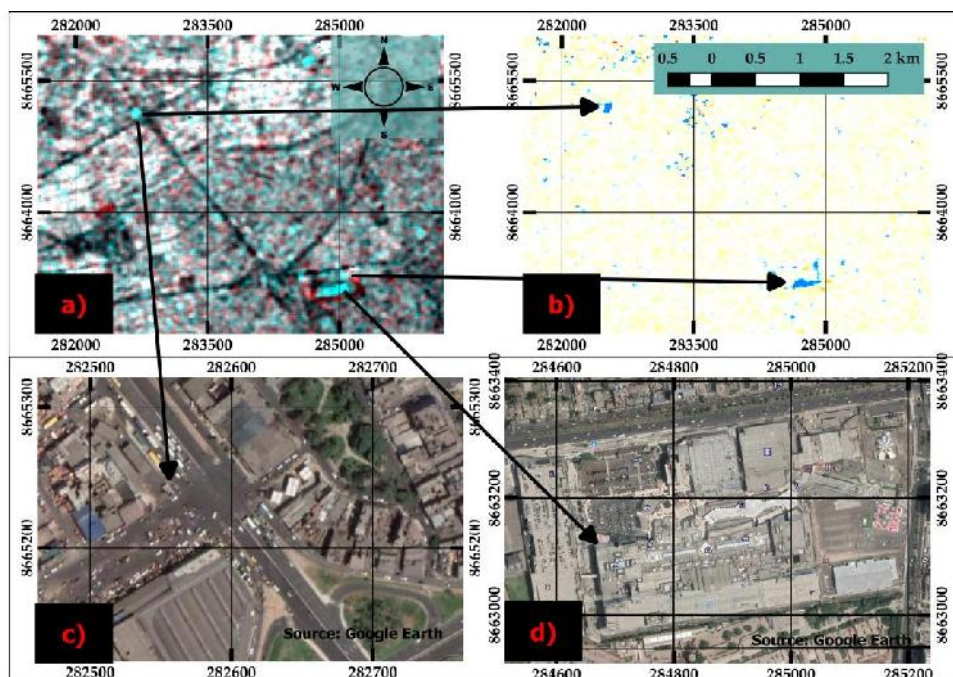
Figure 16. Examples of NF3 change “Ephemeral changes” and NF9 change “New building constructions”. (a) ERS-2 RGB composite and (b) ratio map highlight patterns of increased radar backscatter, in one case matching with (c) vehicles parked near the principal wholesale fruit market in Lima, in the other with (d) the start of the construction activities of the Jockey Plaza shopping center (April 1996) [90].

- Ephemeral changes: increase in the radar backscatter was observed in 15 areas as a consequence of an increase in the number of vehicles parked (Figure 16). These changes are located on a slope between A and B-class, on alluvial deposits, with eight changes on non-urbanized areas, and the other seven on urban areas.

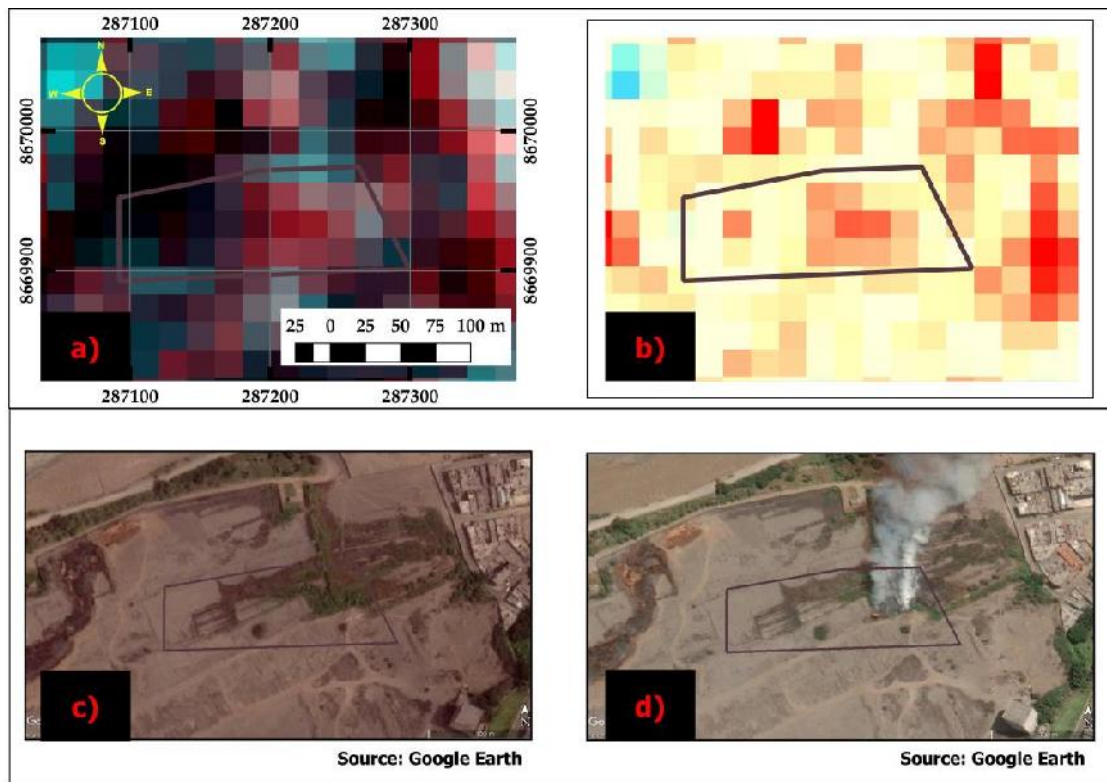
Figure 17. Example of NF13 change “Archaeological excavations”: (a) Sentinel-1 RGB composite and (b) ratio map highlight a decrease in radar backscatter (dark lilac polygon) in an archaeological site where fires may have altered the vegetation coverage, as identified in the optical imagery acquired on (c) 08/02/2017 and (d) 03/03/2017 (Google Earth images © 2020 Maxar Technologies). Contains modified Copernicus Sentinel-1 data.

- Archeological excavations: four changes in the radar backscatter show decrease in the signal in areas with archaeological remains. In one case, the decrease in the backscatter signal could be influenced by the decrease in vegetation in the archaeological area due to a fire (Figure 17). These changes are located on alluvial deposits, on a non-urban area with an A-class slope.
