Frescoed wall conditions assessment with non-invasive GPR survey: the case of the Crypt of San Francesco in Irsina (Basilicata, Southern Italy)

Capozzoli L.¹ Boccia M.P.³, De Martino G.¹, Gizzi F.T.², Sileo M.², Masini N.²

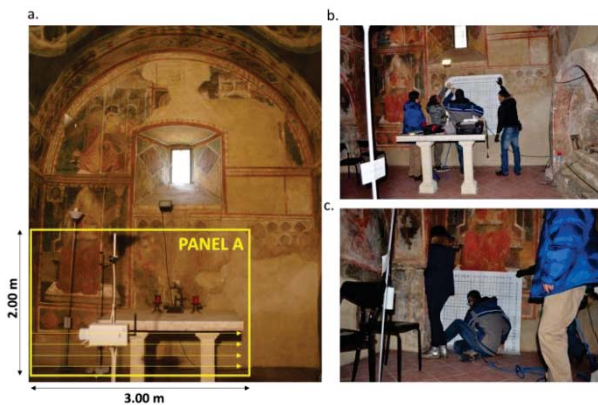
Investigations were carried out with the SIR-3000 GPR System (GSSI Instrument) coupled to the 2000 MHz antenna and a metric encoder measuring wheel (Fig. 3). To avoid damaging the frescoes and achieve a high accuracy, for the manual acquisition, a towel including a grid was placed on the investigated areas and the antenna was moved directly on its surface. The acquisitions are performed recording the profiles along the longer size of the panels, from left to right and from the bottom to up (Fig.3b and 3c).

Fig. 3. a) Localization of the areas investigated with the GPR on the South panel (Panel A), b), c) acquisition phases and the geophysical adopted set-up.

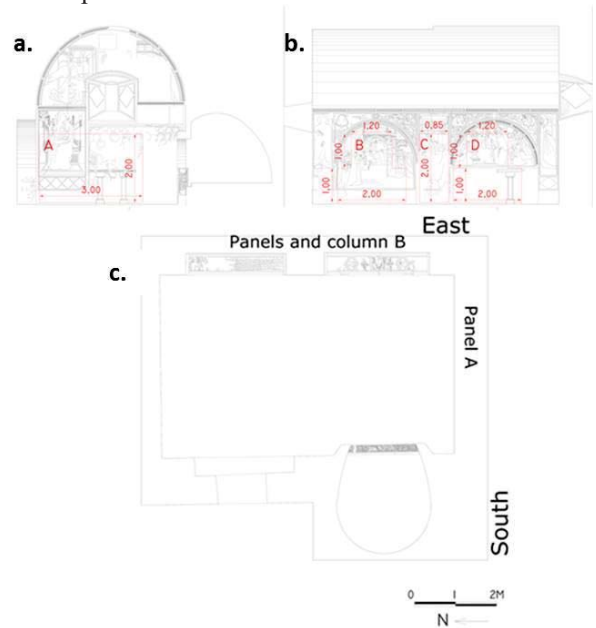
Data were gathered in only one direction through the acquisition of radargrams located according to a grid including parallel lines equi-spaced only 0.05 m. The frequency adopted was used for providing the best resolution for the investigation of the first 30 cm of the walls, in order to identify the areas characterized by advanced deterioration phenomena. Three panels and a column are investigated as showed in Fig.3 and 4.

Fig. 4. Schematic map of the frescoed walls investigated in the Crypt: a) the panel A investigated on the south wall; b) the masonry elements (panels B and D, column C) investigated on the east wall; c) the plan of the Crypt with indication of the investigated areas.
