# AN INNOVATIVE FOUNDATION SYSTEM FOR TIMBER BUILDINGS: STEEL WELDED MESH GABION BOXES INFILLED WITH AGGREGATES

**KEYWORDS:** removable foundation system, timber buildings, prefabrication, experimental tests

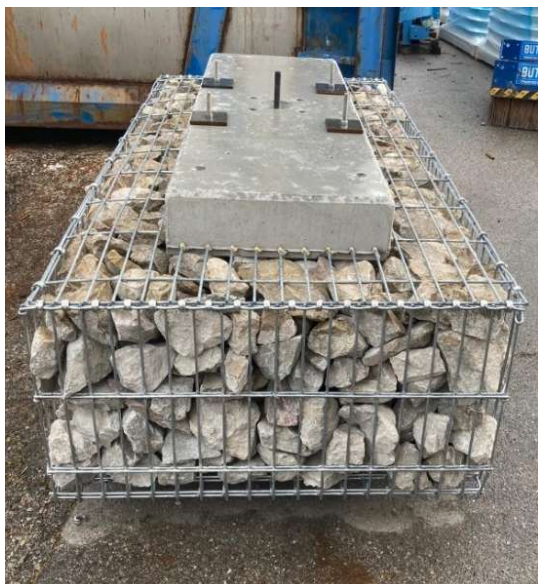
Figure 1. The welded mesh gabion box filled with aggregates (left) and the hinge connection (right)

The LSF system is based on a welded mesh gabion box filled with stone aggregates, the dimensions are: 1000mm width (w) x 2000mm length (l) x 500mm height (h). The box is closed at the top by a precast reinforced concrete C45/50 element 500mm (w) x 1500mm (l) x 150mm (h);

the top welded mesh is a part of reinforcement and it is fixed to the other panels via metal C-rings connectors, as shown in Fig. 1 (left). Four steel rebars (d=12mm) were applied to the gabion box in order to anchor the precast concrete element (RC beam) to the bottom welded mesh panel through M12 nut and steel plate (at the top) and a hook (at the bottom). At the centre of each precast concrete element there is a hole with a diameter equal to 100mm. A 4.8 class M20 threaded rod (named “hinge connection” because it is able to transfer only lateral and axial forces), welded to a steel plate, was positioned according to Fig. 1. The portion of the rod which protrudes from the hole is used to level (nut and locknut) and anchor the capping beam (the element that connect the different welded mesh gabion boxes on the same alignment). Designer can choose to use different material capping beam: steel, reinforced concrete or timber. Moreover, the hinge connection enables adjusting the in-plane position up to  $\pm 2\text{cm}$ . Then, the hole is filled with gap-filling mortar, in order to create a discrete support. All the capping beams have to be connected as showed in Fig. 2 in order to create a continuous alignment of the walls of timber structures. The orthogonal beams have to be connected as reported in Fig. 3. When all the welded mesh gabion boxes are connected one to each other by the capping beams, the upper timber structure can be fixed by metal plates to the LSF system using nails/screws for timber elements while bolts and chemical/mechanical anchors for steel and reinforced concrete, respectively. The durability of the LSF system steel elements (under the ground) was tested to guarantee at least 50 years of service life [15]. Metallurgica Ledrense Cooperative Company applied for an European Assessment Document (EAD) to certificate LSF system as a construction product.

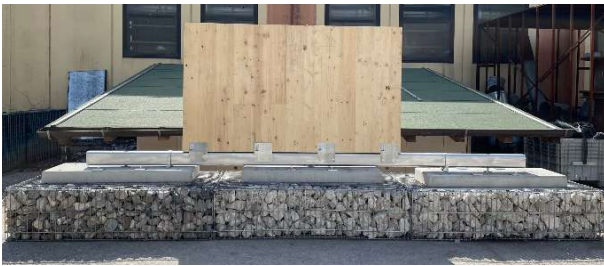
Figure 2. Single alignment of the LSF system (left) and its schematization (right)

levelled and then was fixed to the LSF element through a gap-filling mortar casting around the threaded rod protruding from the RC beam (Fig. 2) of each LSF element. The specimen was placed in the steel frame test apparatus of LPM according to Fig. 5. A monotonic horizontal load was applied through the ±400 kN hydraulic jack at the upper corner of the CLT wall panel. No vertical load was applied during the test. The LSF element number 1, according to Fig. 5, was restrained through a 100mm (w) x 150mm (h) and 10mm thick rectangular cross-section S355 that does not allow horizontal displacements at the base corner of the element. The lateral restraint was placed in order to avoid simultaneous sliding of the three LSF elements. In LSF system tests nine LVDTs were applied to the specimen according to Fig. 5 in order to measure horizontal and vertical displacements of each selected element (Table 2).

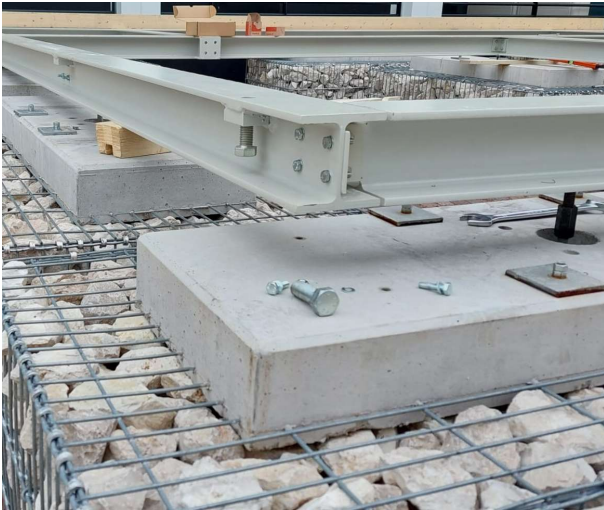
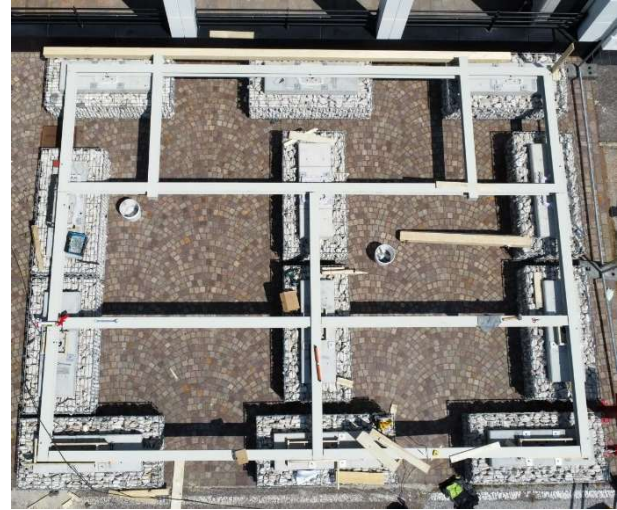
Figure 3. Example of connection between orthogonal capping beams (left) and LSF system (right)

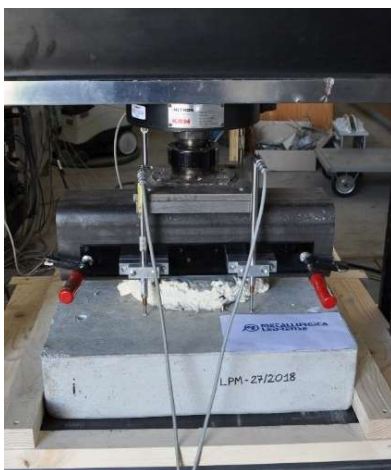
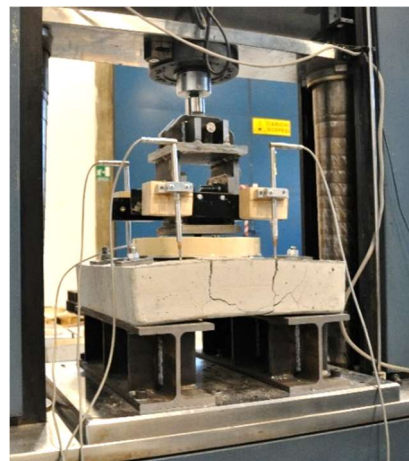
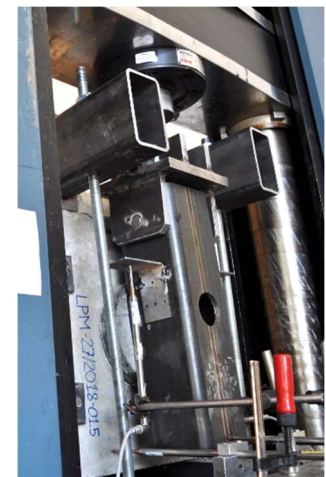
Figure 6. Hinge connection at the end of the test: compression (left) tensile (centre) and shear (right)

Specimens tested in compression were not failed during the experimental campaign. The tests were stopped just before the limit load of the testing machine (250kN). After testing no cracks were observed in the specimens (Fig. 6). The expected failure mode was the punching of the RC beam. Bending failure occurs in specimens tested in tensile configuration, large cracks formation was observed in RC beam (Fig. 6). In all tests, tensile load was transferred by the hinge connection without relative sliding between the gap-filling mortar and the RC beam and was greater than the expected self-weight of the LSF element equal to 18,82 kN (see Table 3). The shear tests were interrupted due to large deformations (>15mm); no cracks were observed either in RC beam and gap-filling mortar layer (Fig. 6). According to EN26891:1991 [16], the stiffness was calculated taking into account the maximum load reached during the test before 15mm of displacement.

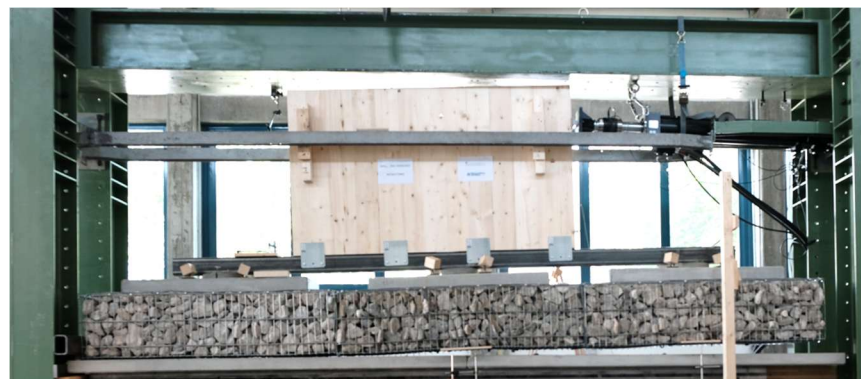
Figure 7. LSF system failure modes: hinge connection failure (left) and rigid body rotation (right)

At the end of the test all the specimens reached 100mm of displacement ( $\delta_{LPM057,max}$ ) at the top of CLT wall panel according to [16] and showed the same failure mode related to a rigid body rotation mechanism (Fig. 7): LSF elements 2 and 3 were not in contact with the lean concrete layer (uplift) and the LSF system rotated around the lateral restrain. All the shear force was transferred from the upper structure to the lateral restrain through the hinge of LSF element 1.

In specimen LPM-012, at the end of the test, a local failure of LSF element 1 hinge was observed: the gap-filling mortar results cracked (Fig.7). The values of base shear in full-scale tests are similar to the resistances obtained at connection level tests. In LSF system tests the
